Pit, Below-Grade Tank, or
Proposed Alternative Method Permit or Closure Plan Application

BP AMERICA PRODUCTION COMPANY
SAN JUAN BASIN, NORTHWEST NEW MEXICO

BELOW-GRADE TANK CLOSURE PLAN

GCU 191

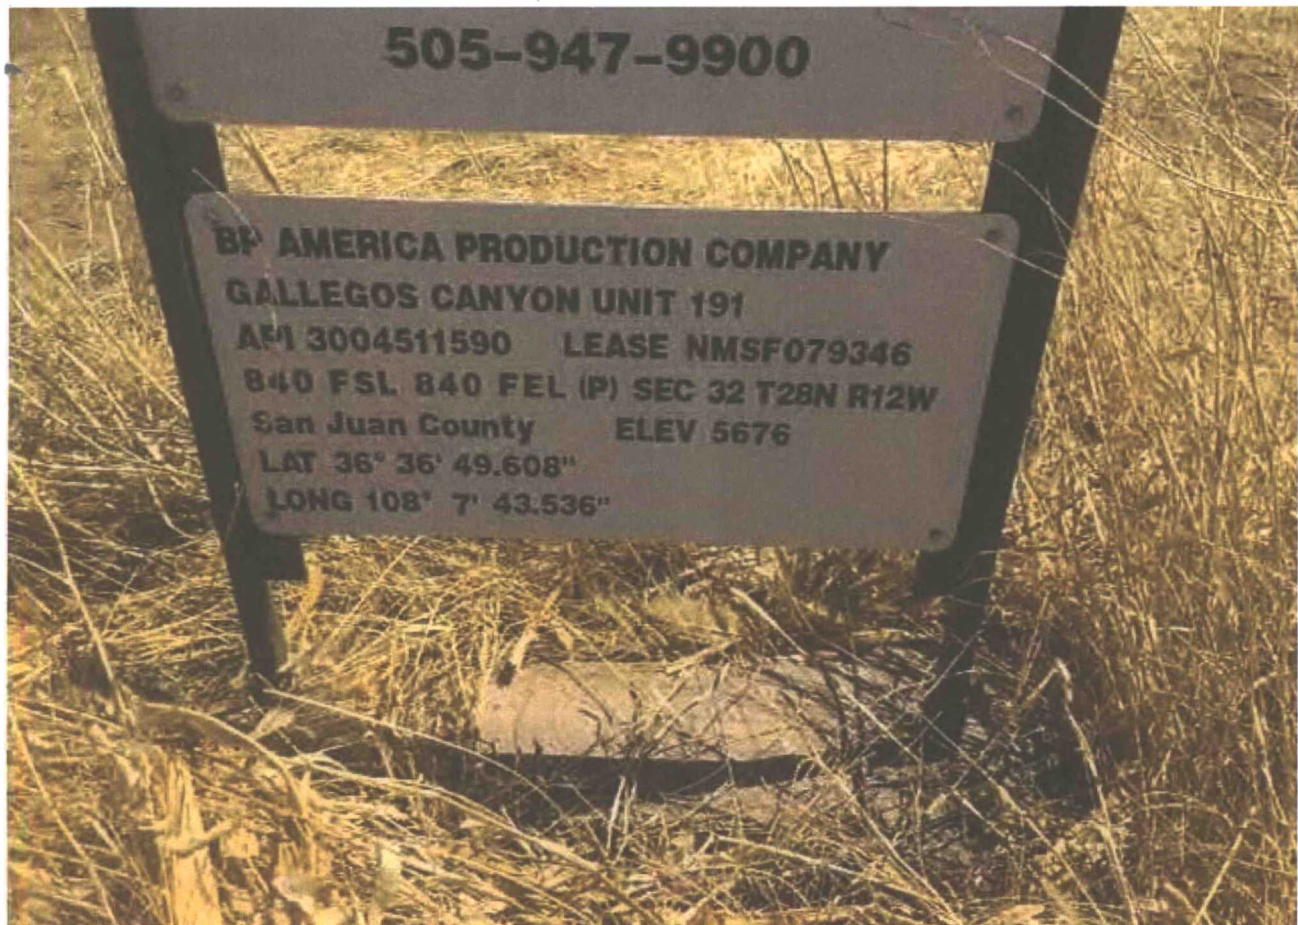
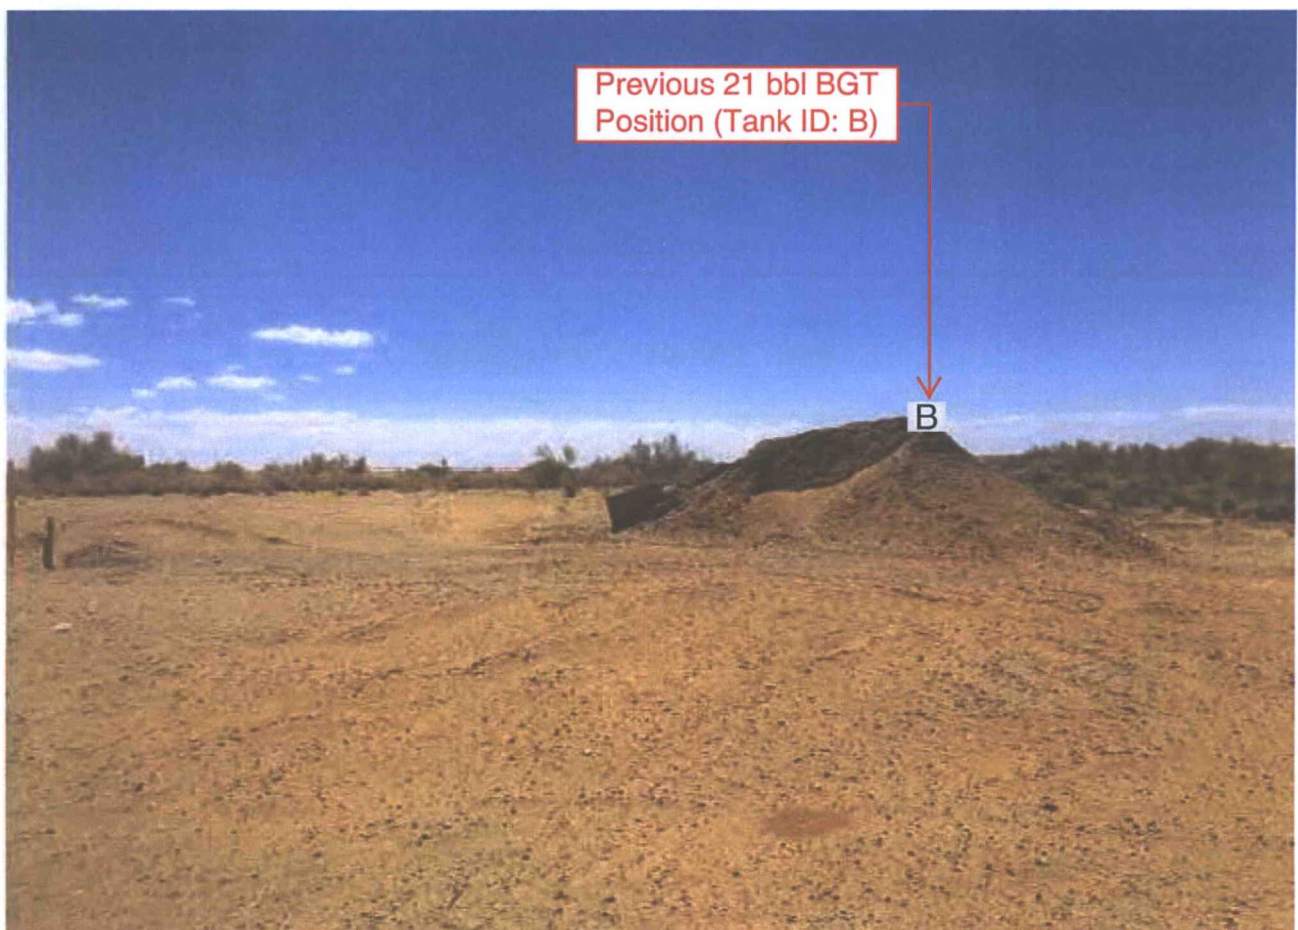
The area has been backfilled and BGT location's surface condition is clear. The location will be reclaimed once the well is plugged and abandoned.
