BELOW-GRADE TANK CLOSURE PLAN

ELLIOTT GC T 001

API No. 3004520297

Unit Letter B Section 26 T 30N R 09W

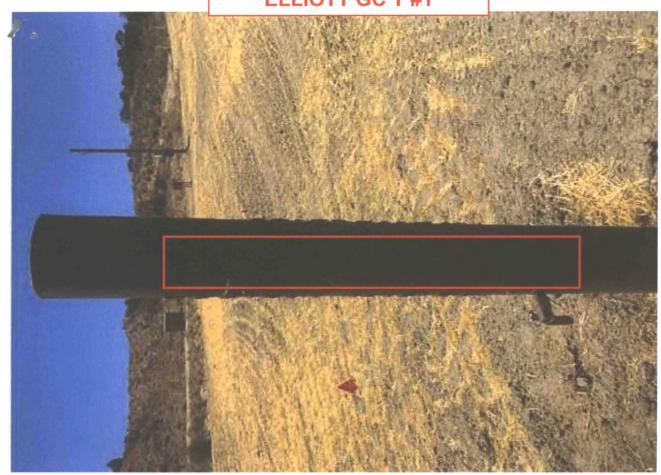
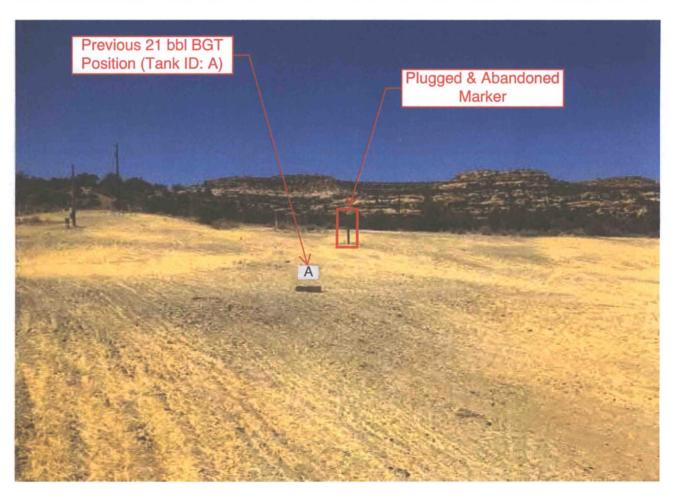
ELLIOTT GC T #1

The gas well has been plugged and abandoned, BGT location's surface condition is clear.

Closure report on C-144 form is included including photos of reclamation completion.
