Pit, Below-Grade Tank, or
Proposed Alternative Method Permit or Closure Plan Application

BP AMERICA PRODUCTION COMPANY
SAN JUAN BASIN, NORTHWEST NEW MEXICO

BELOW-GRADE TANK CLOSURE PLAN

GARTNER A 016

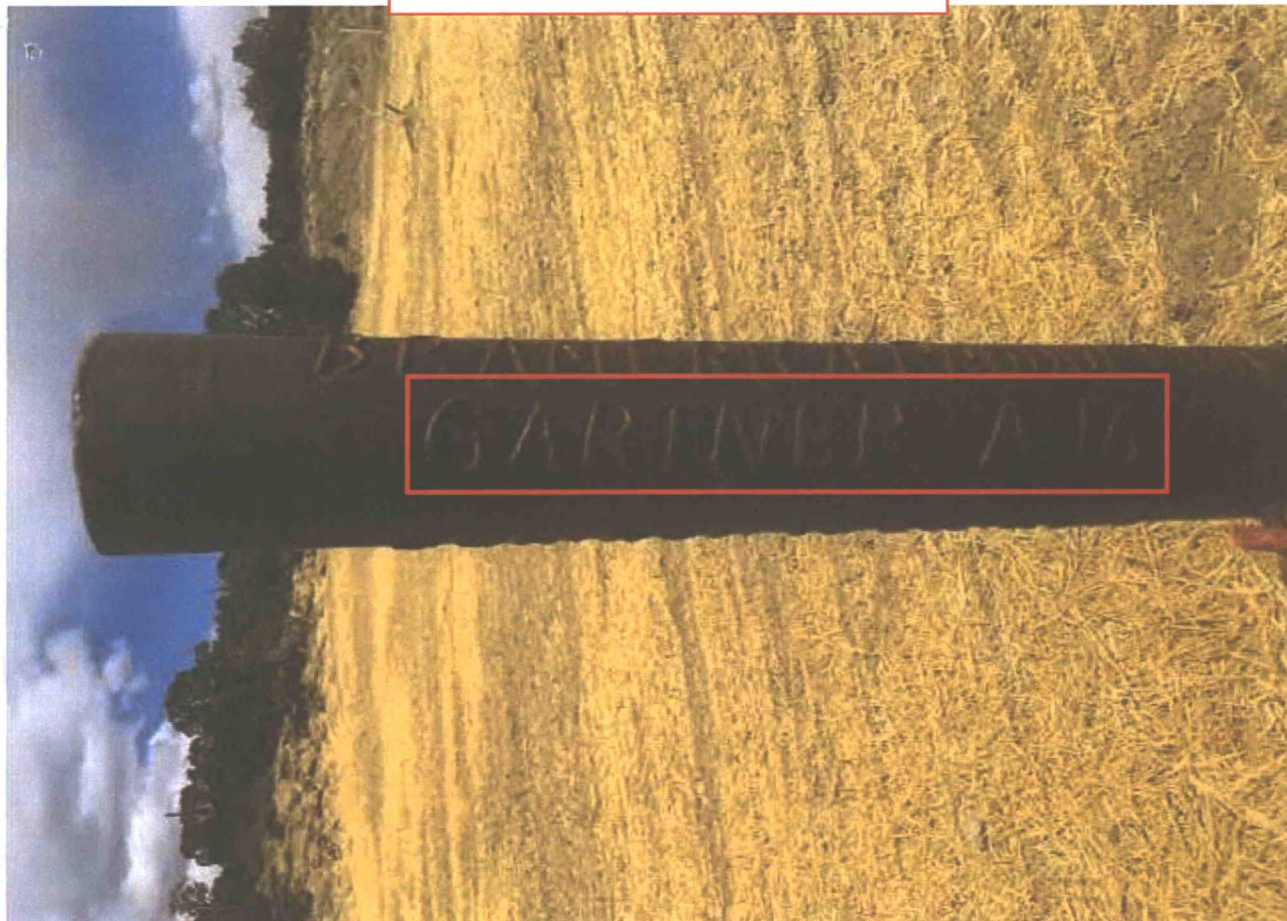
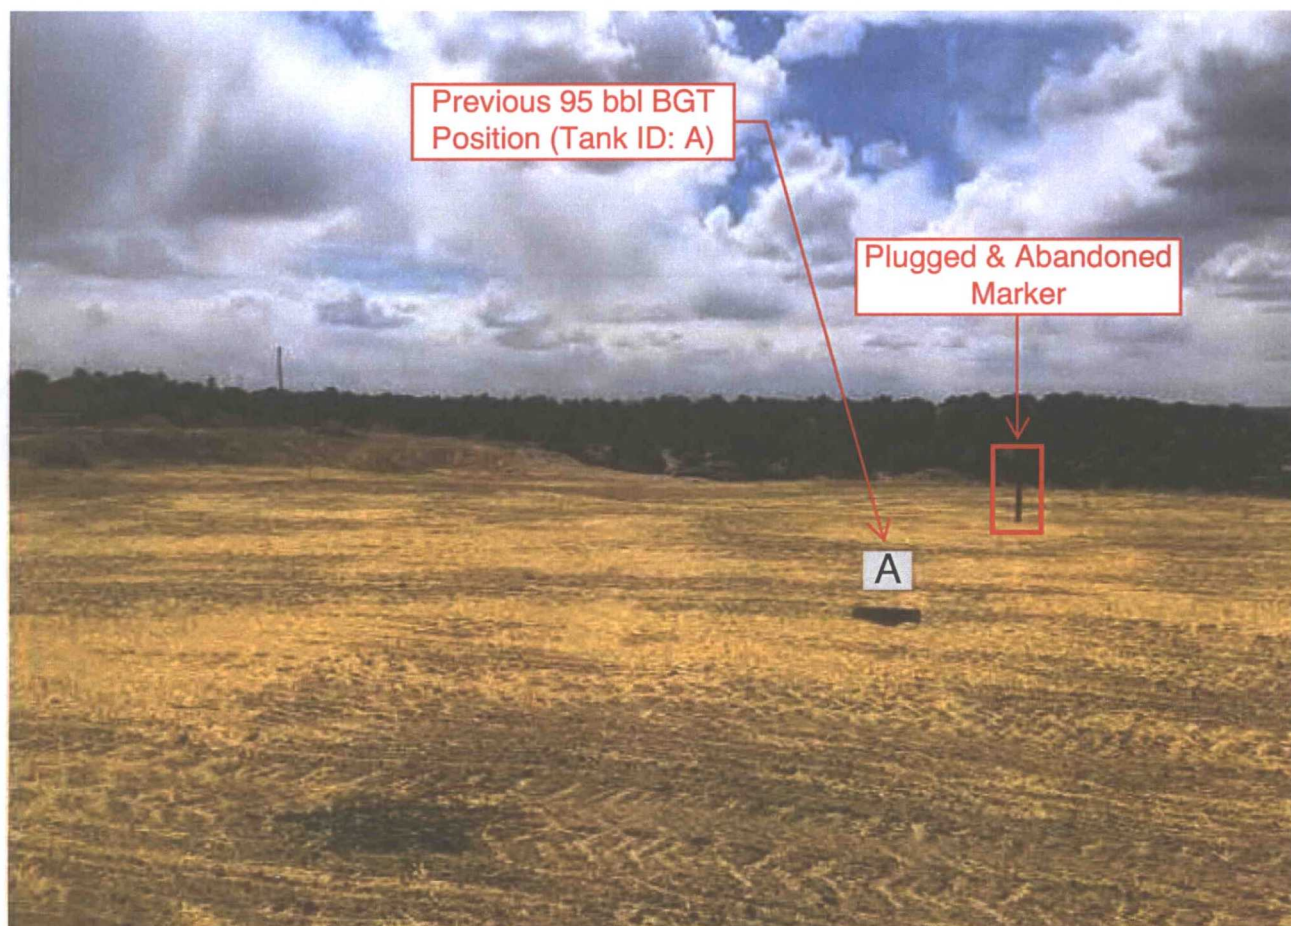
GARTNER A #16

The gas well plugged & abandoned, BGT location's surface condition is clear.
