16362  
Pit, Below-Grade Tank, or  
Proposed Alternative Method Permit or Closure Plan Application

**BP AMERICA PRODUCTION COMPANY**  
**SAN JUAN BASIN, NORTHWEST NEW MEXICO**

**BELOW-GRADE TANK CLOSURE PLAN**

**CORNELL E 001**

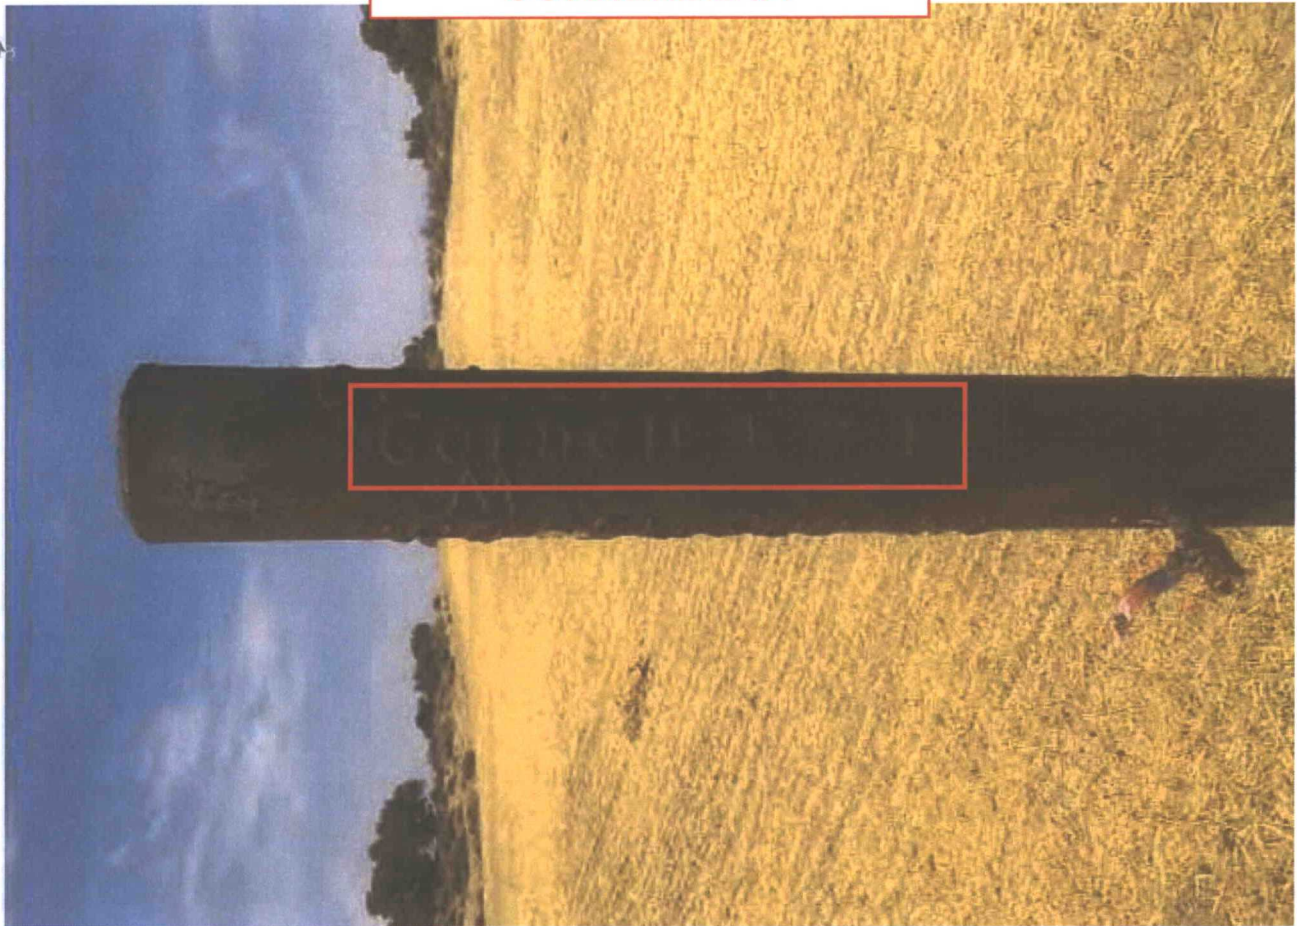
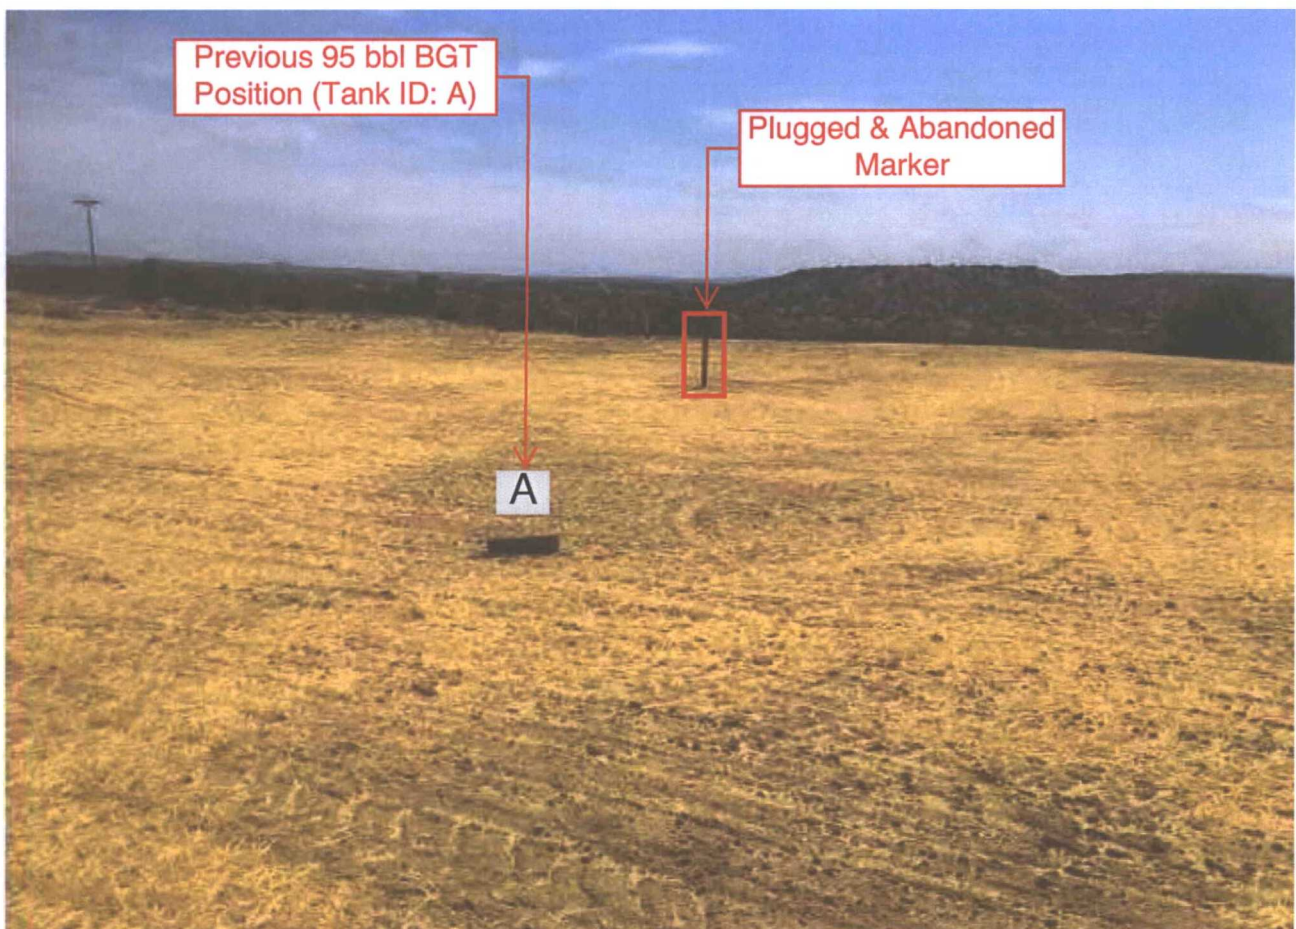
## CORNELL E #1

**The gas well has been plugged and abandoned. BGT location's surface condition is clear.**
