Pit, Below-Grade Tank, or
Proposed Alternative Method Permit or Closure Plan Application

BELOW-GRADE TANK CLOSURE PLAN

BOLACK D 001

API No. 3004523429

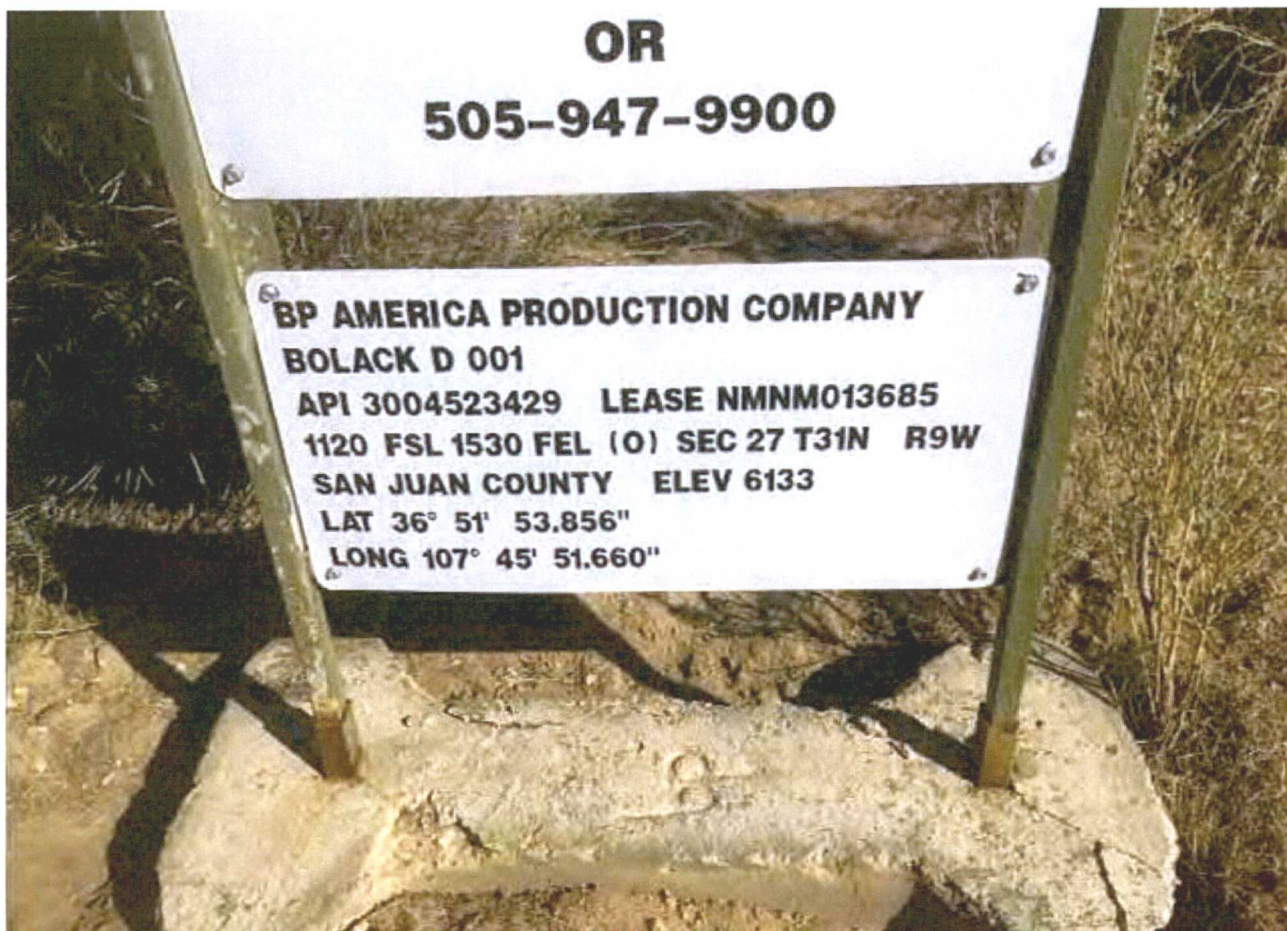
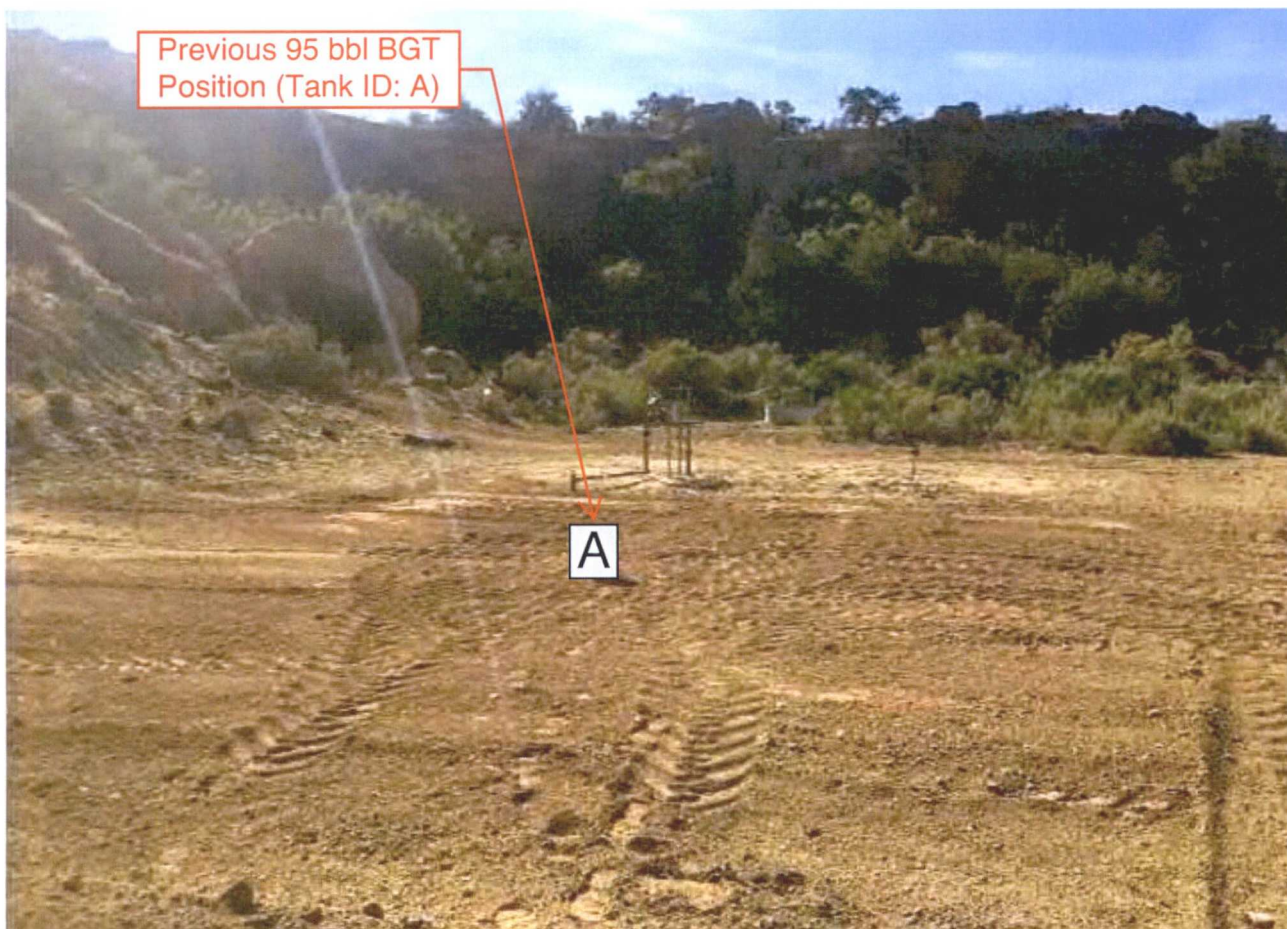
The area has been backfilled and BGT location's surface condition is clear, but within the site's operational area. The location will be reclaimed when the well is plugged and abandoned.
