Pit, Below-Grade Tank, or
Proposed Alternative Method Permit or Closure Plan Application

BELOW-GRADE TANK CLOSURE PLAN

STATE GC CB 001E

API No. 3004525297

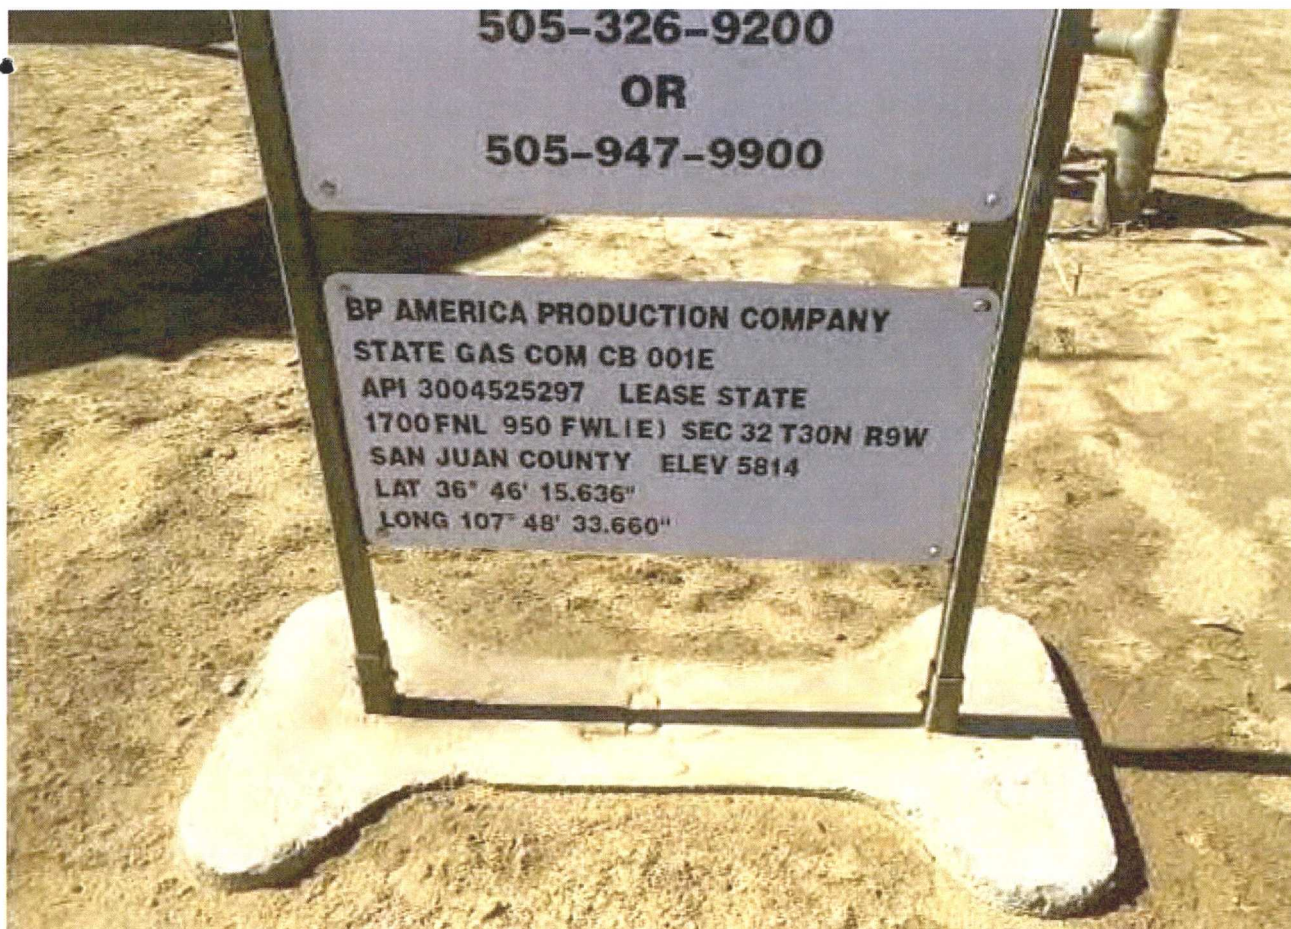
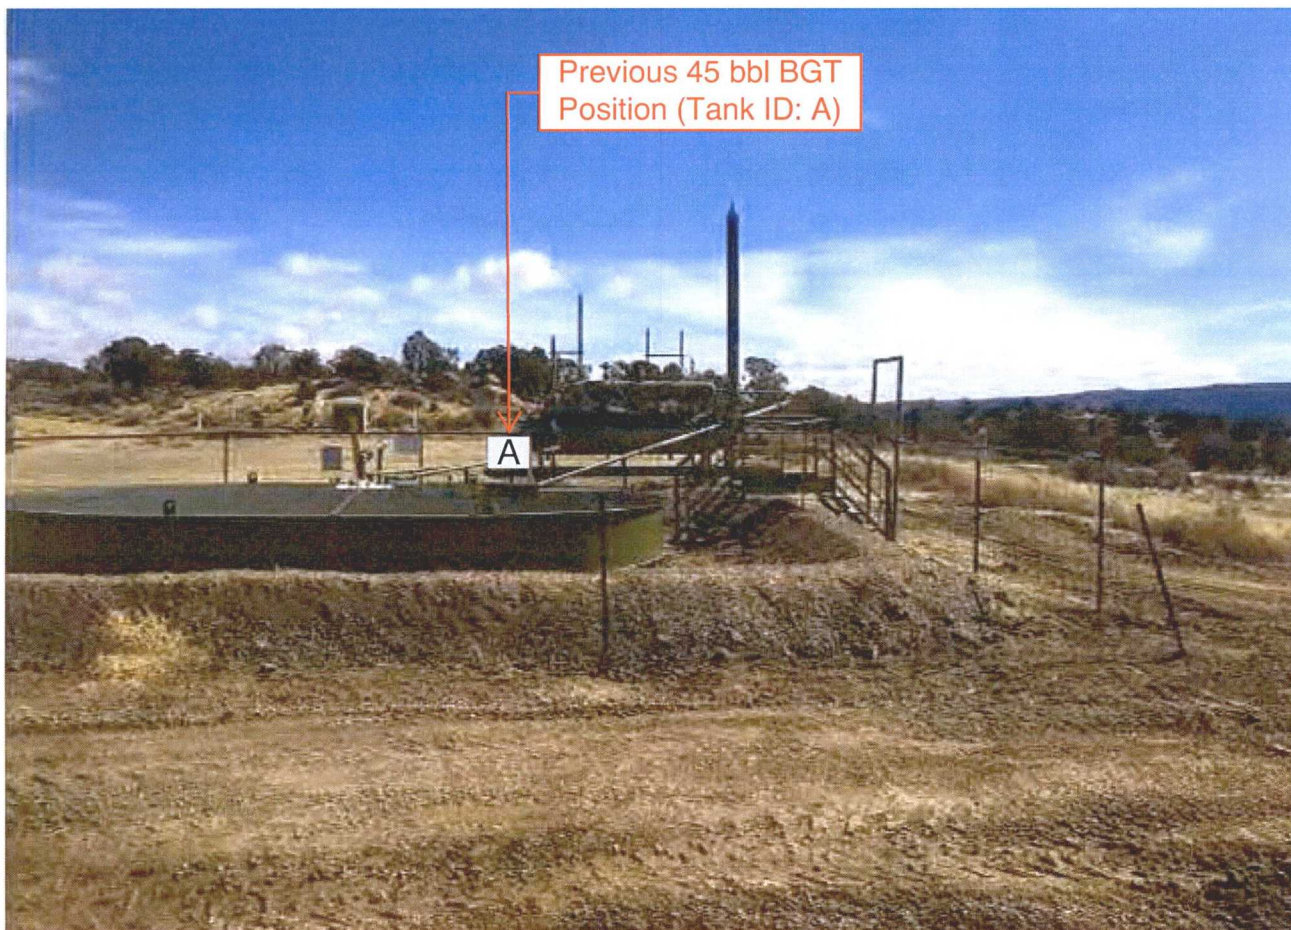
The area has been backfilled and a 105 BBL shallow low profile above-grade tank set atop BGT location. The location will be reclaimed once the well is plugged and abandoned.
