Pit, Below-Grade Tank, or
Proposed Alternative Method Permit or Closure Plan Application

BP AMERICA PRODUCTION COMPANY
SAN JUAN BASIN, NORTHWEST NEW MEXICO

BELOW-GRADE TANK CLOSURE PLAN

GCU 307 SWD

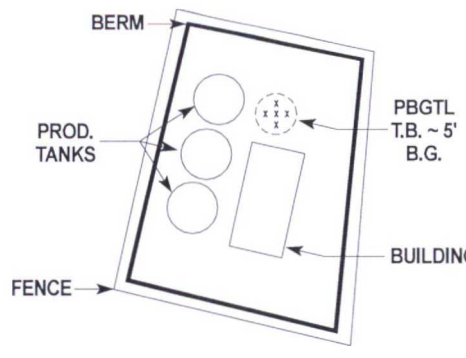
CLIENT: BP	BLAGG ENGINEERING, INC. P.O. BOX 87, BLOOMFIELD, NM 87413 (505) 632-1199	API #: 3004524248 TANK ID (if applicable): A												
FIELD REPORT: (circle one): <u>BGT CONFIRMATION</u> / RELEASE INVESTIGATION / OTHER:		PAGE #: 1 of 1												
SITE INFORMATION: SITE NAME: GCU # 307 SWD QUAD/UNIT: L SEC: 30 TWP: 29N RNG: 12W PM: NM CNTY: SJ ST: NM 1/4 -1/4/FOOTAGE: 1,455'S / 510'W NW/SW LEASE TYPE: FEDERAL / STATE <u>FEE</u> INDIAN LEASE #: - PROD. FORMATION: - CONTRACTOR: BP - J. GONZALES		DATE STARTED: 03/26/18 DATE FINISHED: _____ ENVIRONMENTAL SPECIALIST(S): JCB												
REFERENCE POINT: WELL HEAD (W.H.) GPS COORD.: 36.69412 X 108.14694 GL ELEV.: 5,360' 1) 45 BGT (DW/DB) GPS COORD.: 36.69434 X 108.14706 DISTANCE/BEARING FROM W.H.: 81', N56W 2) _____ GPS COORD.: _____ DISTANCE/BEARING FROM W.H.: _____ 3) _____ GPS COORD.: _____ DISTANCE/BEARING FROM W.H.: _____ 4) _____ GPS COORD.: _____ DISTANCE/BEARING FROM W.H.: _____														
SAMPLING DATA: CHAIN OF CUSTODY RECORD(S) # OR LAB USED: HALL 1) SAMPLE ID: 45 BGT 5-pt. @ 5' SAMPLE DATE: 03/26/18 SAMPLE TIME: 1235 LAB ANALYSIS: 8015B/8021B/300.0 (CI) OVM READING (ppm): 0.2 2) SAMPLE ID: _____ SAMPLE DATE: _____ SAMPLE TIME: _____ LAB ANALYSIS: _____ 3) SAMPLE ID: _____ SAMPLE DATE: _____ SAMPLE TIME: _____ LAB ANALYSIS: _____ 4) SAMPLE ID: _____ SAMPLE DATE: _____ SAMPLE TIME: _____ LAB ANALYSIS: _____ 5) SAMPLE ID: _____ SAMPLE DATE: _____ SAMPLE TIME: _____ LAB ANALYSIS: _____														
SOIL DESCRIPTION: SOIL TYPE: <u>SAND</u> <u>SILTY SAND</u> SILT / SILTY CLAY / CLAY / GRAVEL / OTHER _____ SOIL COLOR: DARK YELLOWISH ORANGE PLASTICITY (CLAYS): NON PLASTIC / SLIGHTLY PLASTIC / COHESIVE / MEDIUM PLASTIC / HIGHLY PLASTIC COHESION (ALL OTHERS): <u>NON COHESIVE</u> SLIGHTLY COHESIVE / COHESIVE / HIGHLY COHESIVE DENSITY (COHESIVE CLAYS & SILTS): SOFT / FIRM / STIFF / VERY STIFF / HARD CONSISTENCY (NON COHESIVE SOILS): <u>LOOSE</u> FIRM / DENSE / VERY DENSE HC ODOR DETECTED: YES <u>NO</u> EXPLANATION - _____ MOISTURE: DRY / <u>SLIGHTLY MOIST</u> <u>MOIST</u> WET / SATURATED / SUPER SATURATED SAMPLE TYPE: GRAB <u>COMPOSITE</u> # OF PTS. 5 ANY AREAS DISPLAYING WETNESS: YES <u>NO</u> EXPLANATION - _____ DISCOLORATION/STAINING OBSERVED: YES <u>NO</u> EXPLANATION - _____														
SITE OBSERVATIONS: LOST INTEGRITY OF EQUIPMENT: YES <u>NO</u> EXPLANATION - _____ APPARENT EVIDENCE OF A RELEASE OBSERVED AND/OR OCCURRED: YES <u>NO</u> EXPLANATION: _____ EQUIPMENT SET OVER RECLAIMED AREA: <u>YES</u> <u>NO</u> EXPLANATION - SHALLOW LOW PROFILE ABOVE-GRADE TANK TO BE SET ATOP BGT LOCATION. OTHER: _____														
EXCAVATION DIMENSION ESTIMATION: <u>NA</u> ft. X <u>NA</u> ft. X <u>NA</u> ft. EXCAVATION ESTIMATION (Cubic Yards): <u>NA</u> DEPTH TO GROUNDWATER: <u><50'</u> NEAREST WATER SOURCE: <u>>1,000'</u> NEAREST SURFACE WATER: <u><1,000'</u> NMOC DTPH CLOSURE STD: 100 ppm														
SITE SKETCH BGT Located: off <u>on</u> site PLOT PLAN circle: <u>attached</u> <div style="display: flex; align-items: center;">

<div style="margin-left: 20px;"> <p>N</p> <p>X - S.P.D.</p> </div> </div>														
NOTES: BGT = BELOW-GRADE TANK; E.D. = EXCAVATION DEPRESSION; B.G. = BELOW GRADE; B = BELOW; T.H. = TEST HOLE; ~ = APPROX.; W.H. = WELL HEAD; T.B. = TANK BOTTOM; PBGTL = PREVIOUS BELOW-GRADE TANK LOCATION; SPD = SAMPLE POINT DESIGNATION; R.W. = RETAINING WALL; NA = NOT APPLICABLE OR NOT AVAILABLE; SW - SINGLE WALL; DW - DOUBLE WALL; SB - SINGLE BOTTOM; DB - DOUBLE BOTTOM.		MISCELL. NOTES WO: _____ REF #: P-952 VID: VHIXONEVB2 PJ #: _____ Permit date(s): 06/14/10 OCD Appr. date(s): 03/05/18

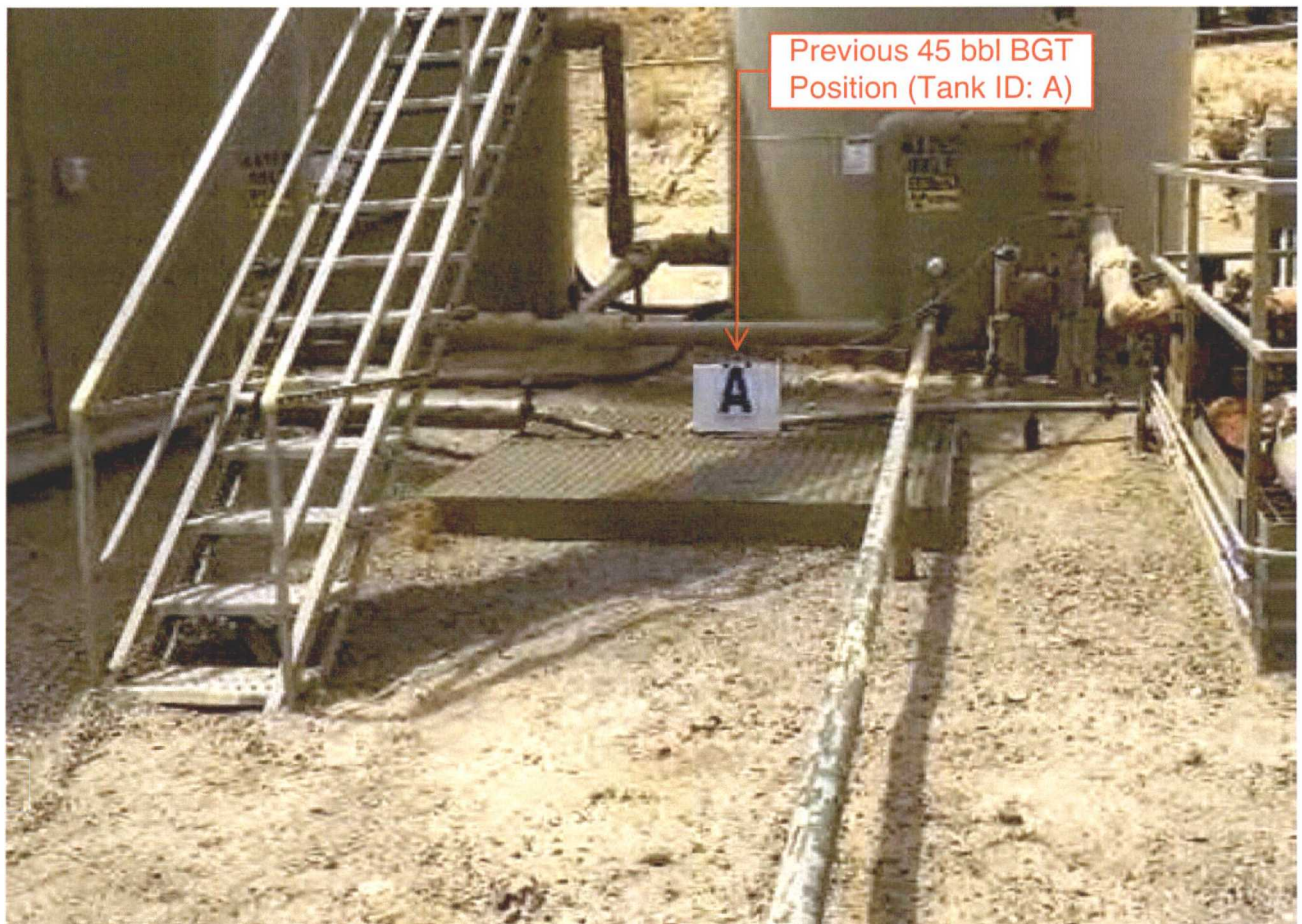
Previous 45 bbl BGT
Position (Tank ID: A)

Closure report on C-144 form is included including photos of reclamation completion.
