BP AMERICA PRODUCTION COMPANY SAN JUAN BASIN, NORTHWEST NEW MEXICO

BELOW-GRADE TANK CLOSURE PLAN

BARRETT 001E

API No. 3004526085

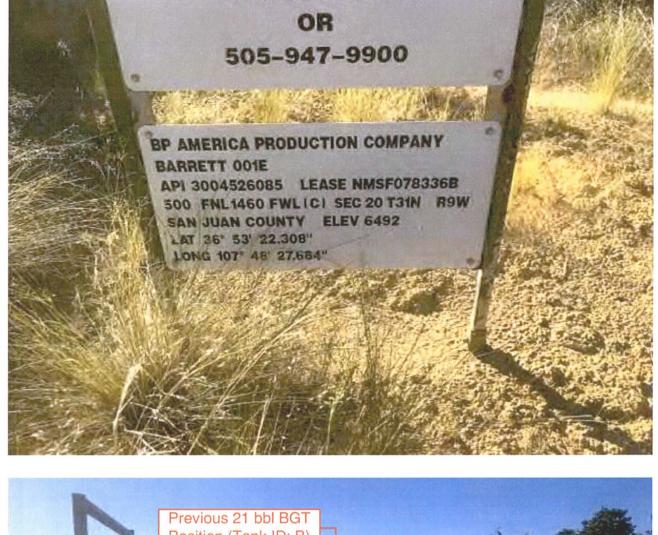
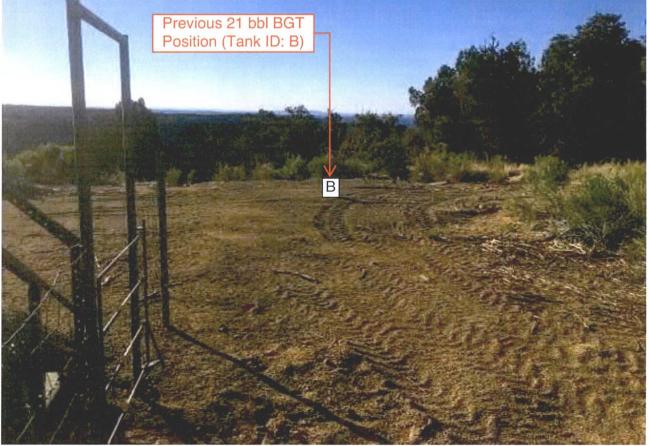
The area has been backfilled and BGT location's surface condition is clear, but within the site's operational area. The location will be reclaimed once the well is plugged and abandoned.

Closure report on C-144 form is included including photos of reclamation completion.
