Pit, Below-Grade Tank, or
Proposed Alternative Method Permit or Closure Plan Application

BP AMERICA PRODUCTION COMPANY
SAN JUAN BASIN, NORTHWEST NEW MEXICO

BELOW-GRADE TANK CLOSURE PLAN

FLORANCE AD 005

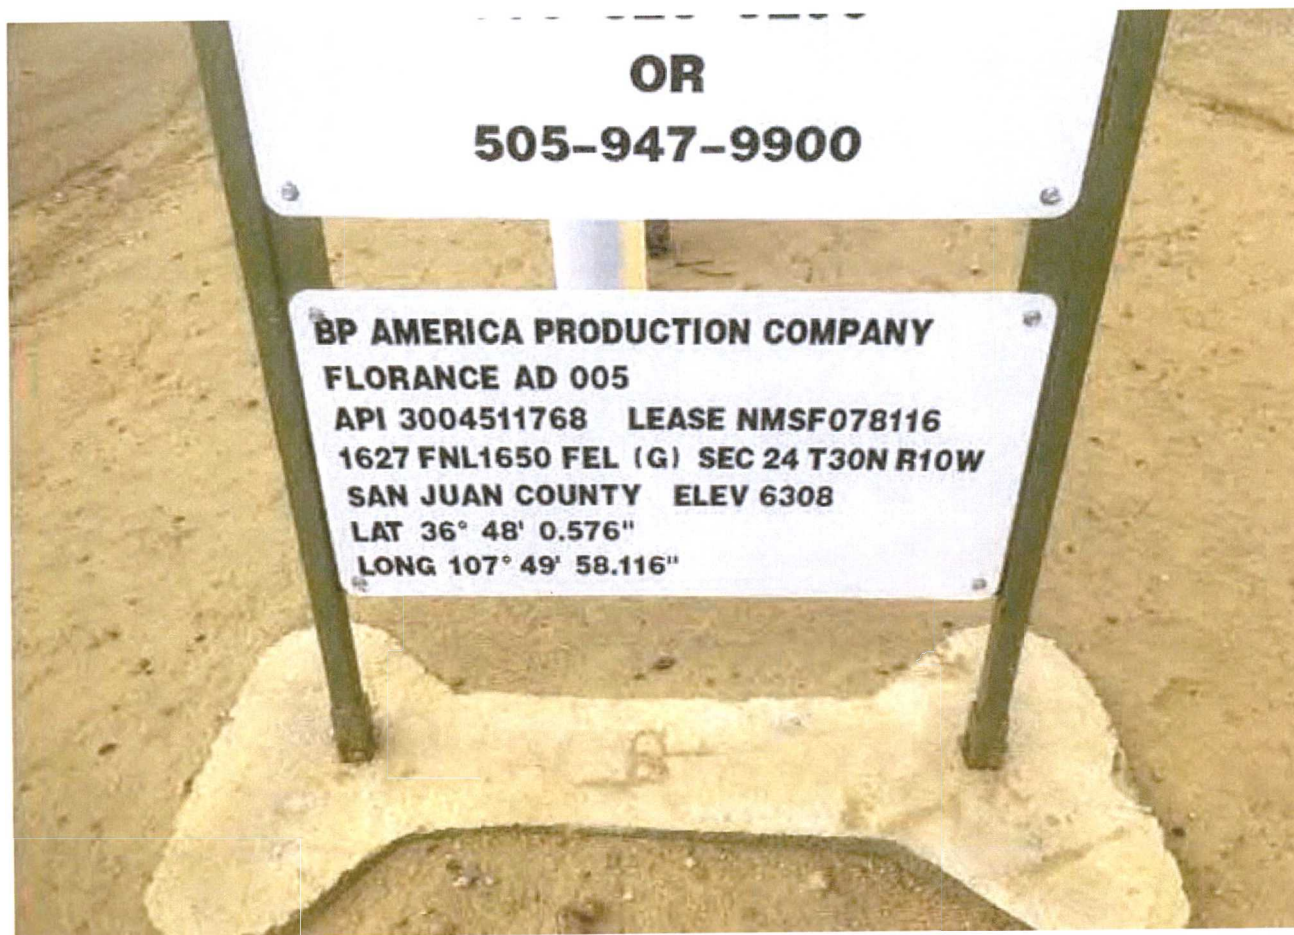
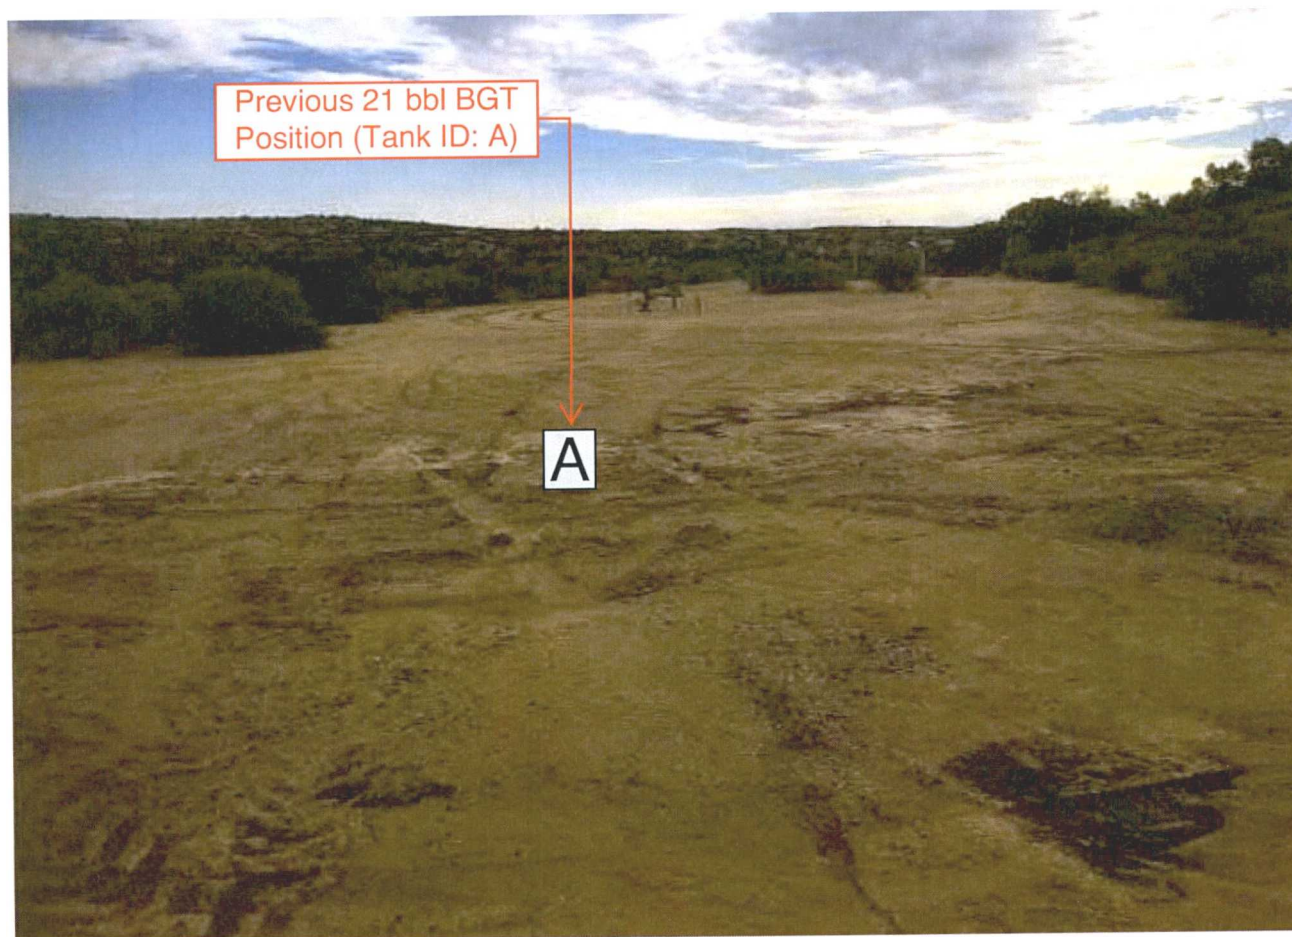
The area has been backfilled and BGT location's surface condition is clear, but within the site's operational area. The location will be reclaimed once the well is plugged and abandoned.

Closure report on C-144 form is included including photos of reclamation completion.
