16426
Pit, Below-Grade Tank, or
Proposed Alternative Method Permit or Closure Plan Application

BELOW-GRADE TANK CLOSURE PLAN

GCU 580

API No. 3004530679

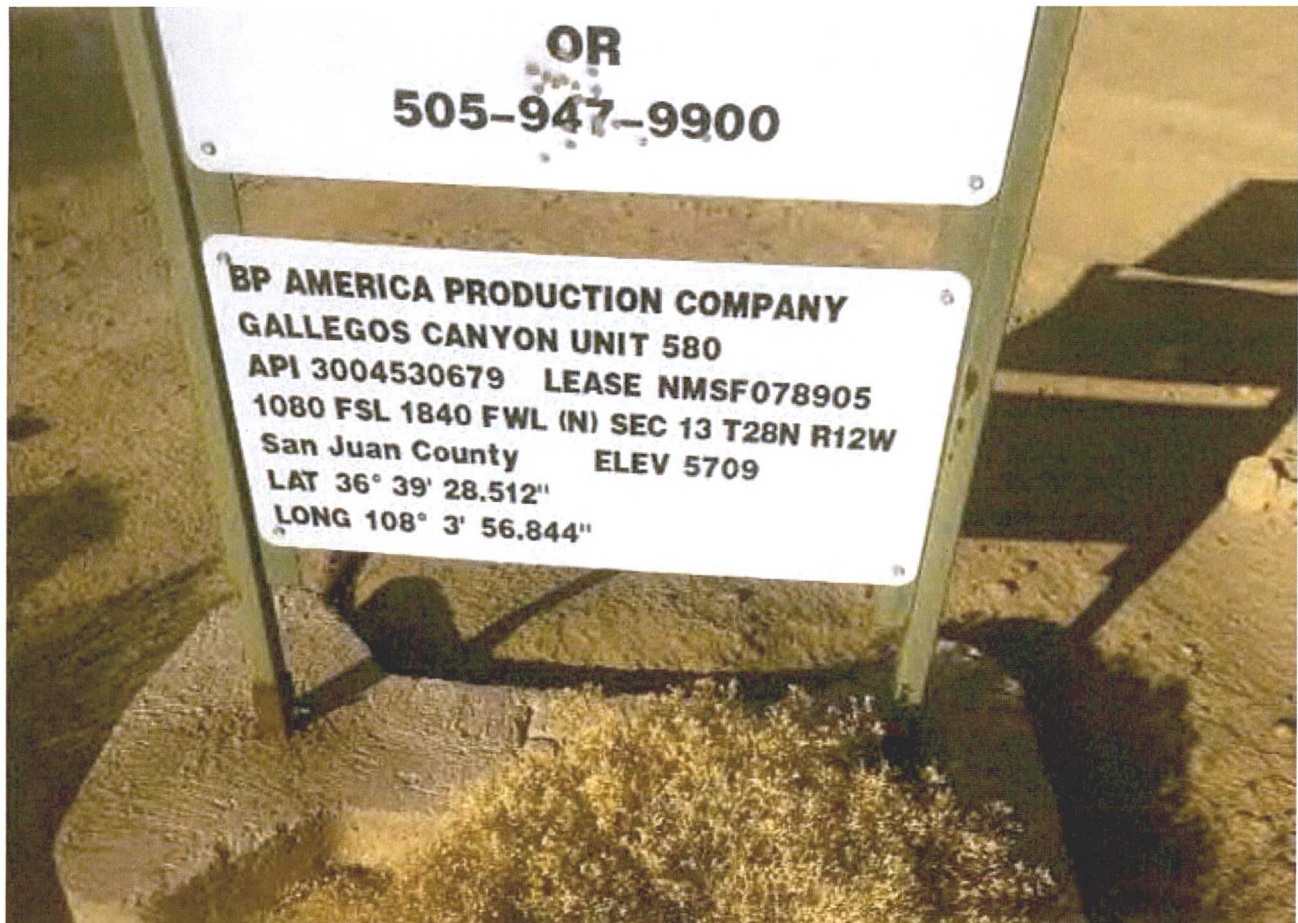
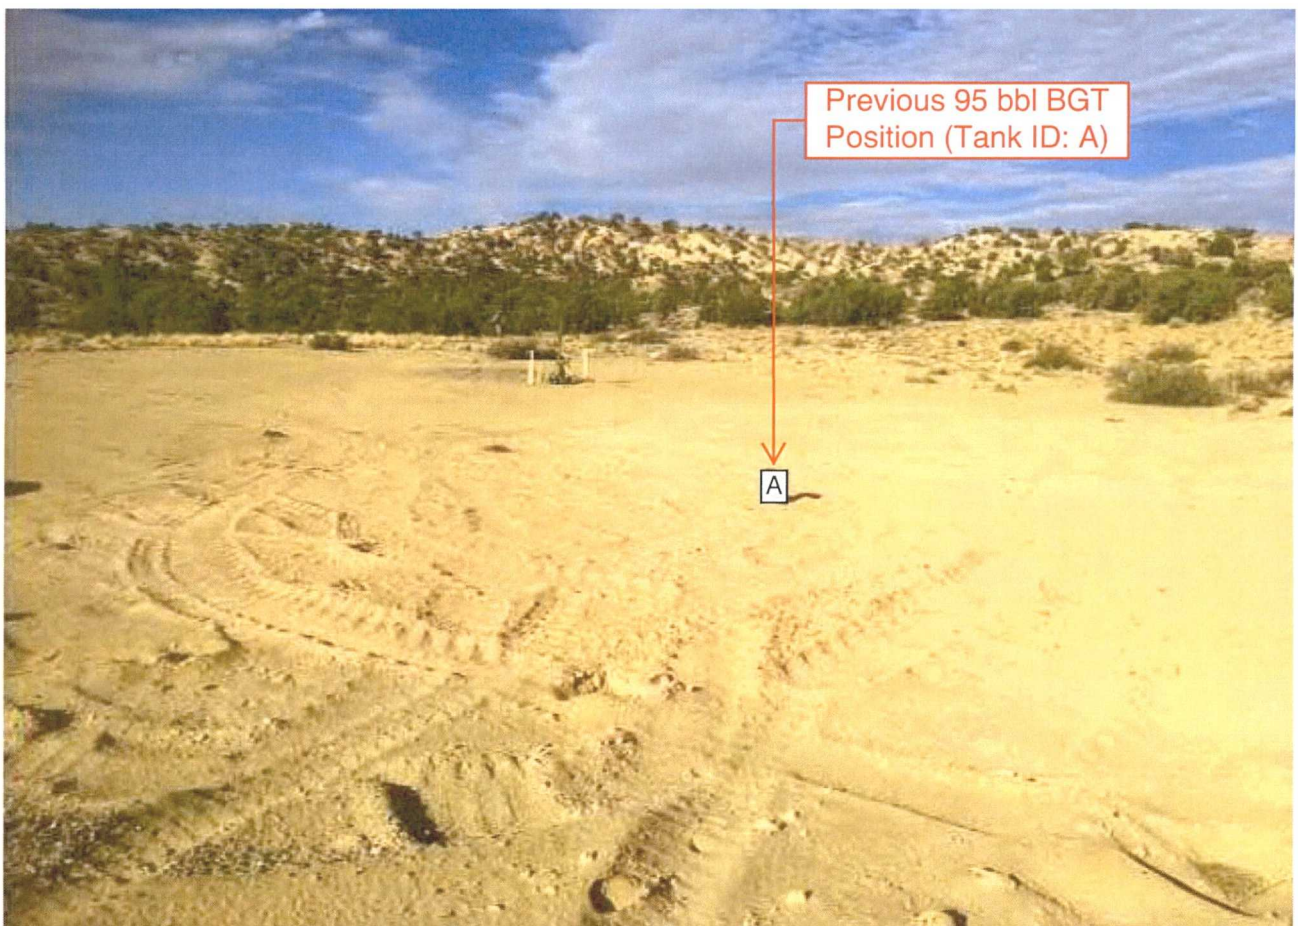
The area has been backfilled and BGT location's surface condition is clear, but within the site's operational area. The location will be reclaimed once the well is plugged and abandoned.
