**Pit, Closed-Loop System, Below-Grade Tank, or
Proposed Alternative Method Permit or Closure Plan Application**

BP AMERICA PRODUCTION COMPANY
SAN JUAN BASIN, NORTHWEST NEW MEXICO

BELOW-GRADE TANK CLOSURE PLAN

Storey LS # 9 – Tank ID: A

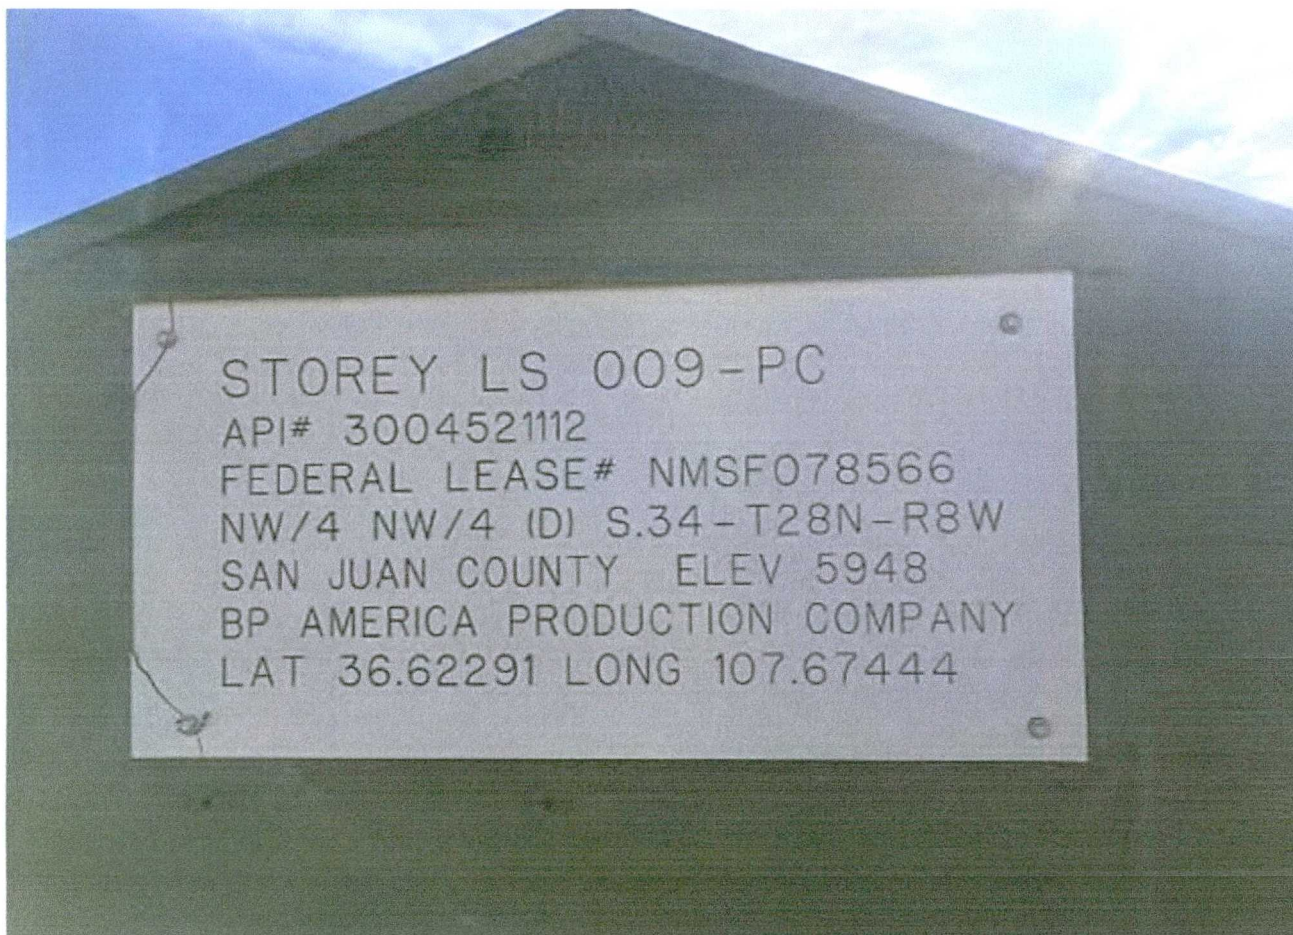
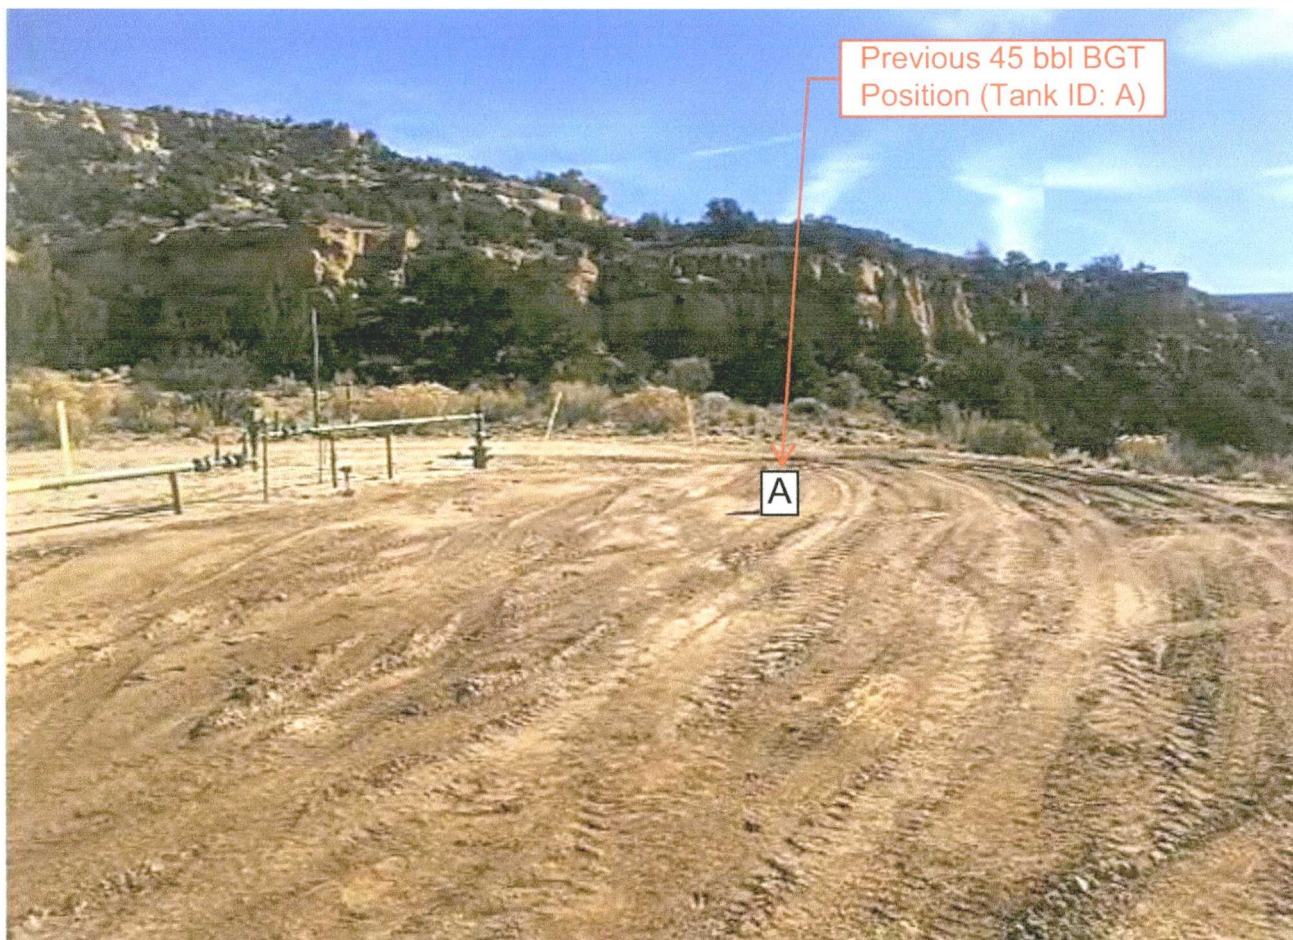
- e. site reclamation, photo documentation.**Closure report on C-144 form is included & contains a photo of the reclamation completion.**
16. BP shall certify that all information in the report and attachments is accurate, truthful, and compliant with all applicable closure requirements and conditions specified in the approved closure plan.
Certification section of C-144 has been completed.

10. BP shall reclaim the BGT location and all areas associated with the BGT including associated access roads to a safe and stable condition that blends with the surrounding undisturbed area. BP shall substantially restore the impacted surface area to the condition that existed prior to oil and gas operations by placement of the soil cover as provided in Subsection H of 19.15.17.13 NMAC, re-contour the location and associated areas to a contour that approximates the original contour and blends with the surrounding topography and re-vegetate according to Subsection I of 19.15.17.13 NMAC.
