Release Notification and Corrective Action

Name of Company Hilcorp Energy Company	Contact Lindsay Dumas
Address 1111 Travis St. Houston, TX 77002	Telephone No. (281)794-9159
Facility Name: San Juan 28-6 #148N	Facility Type: Gas

#1803751908

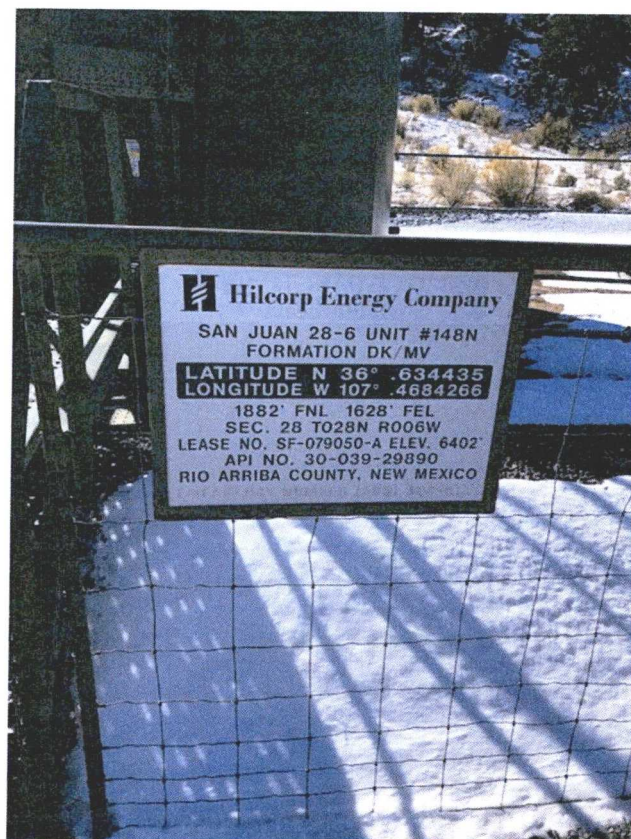
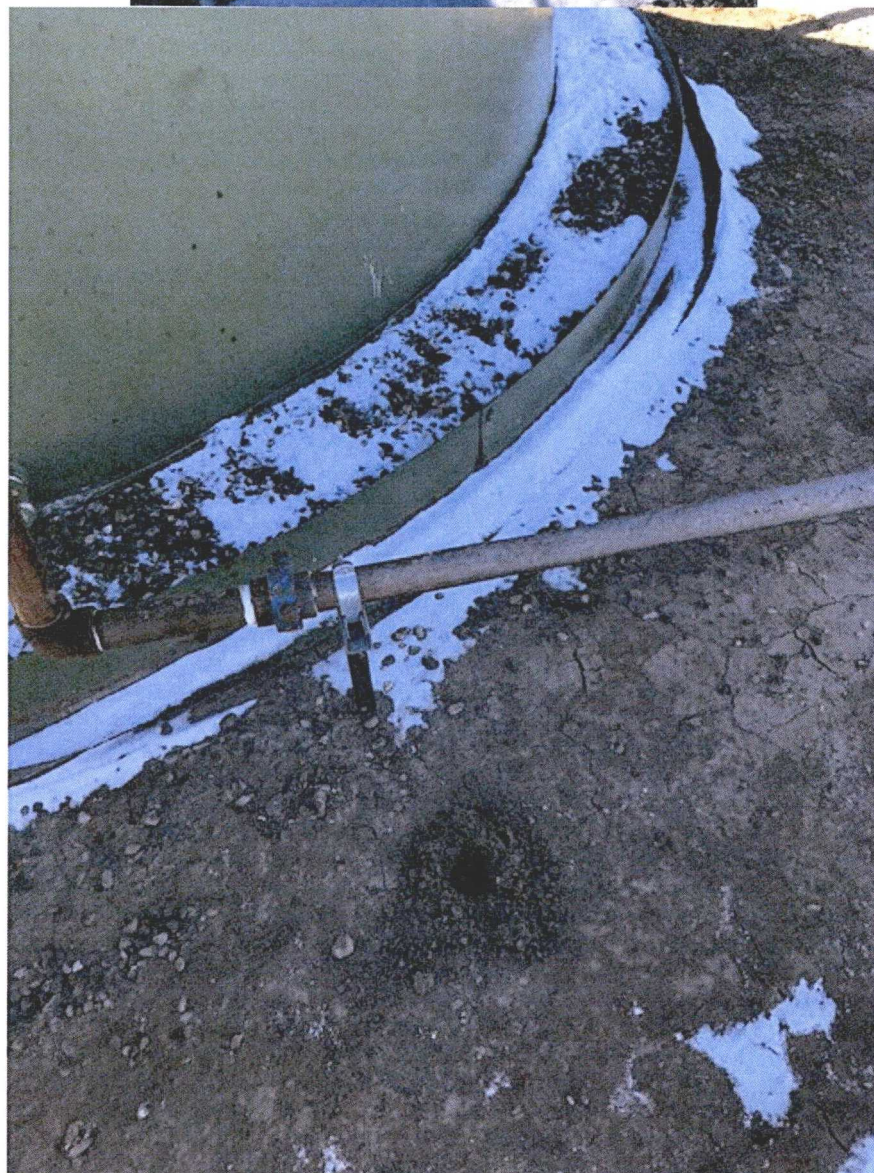
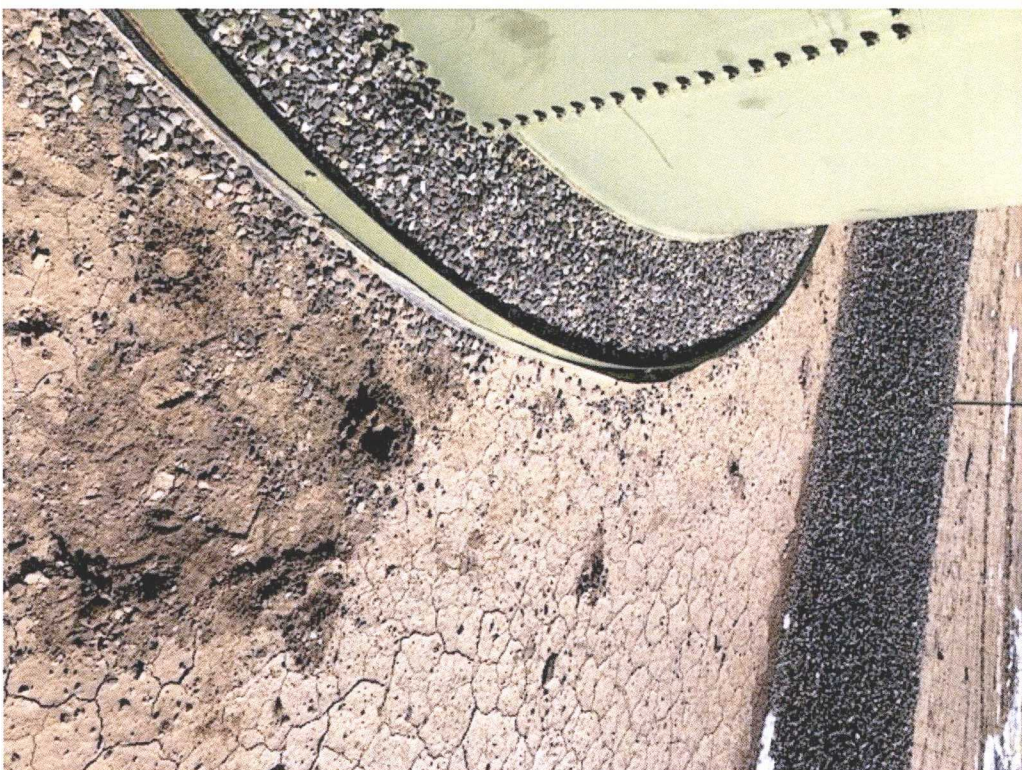
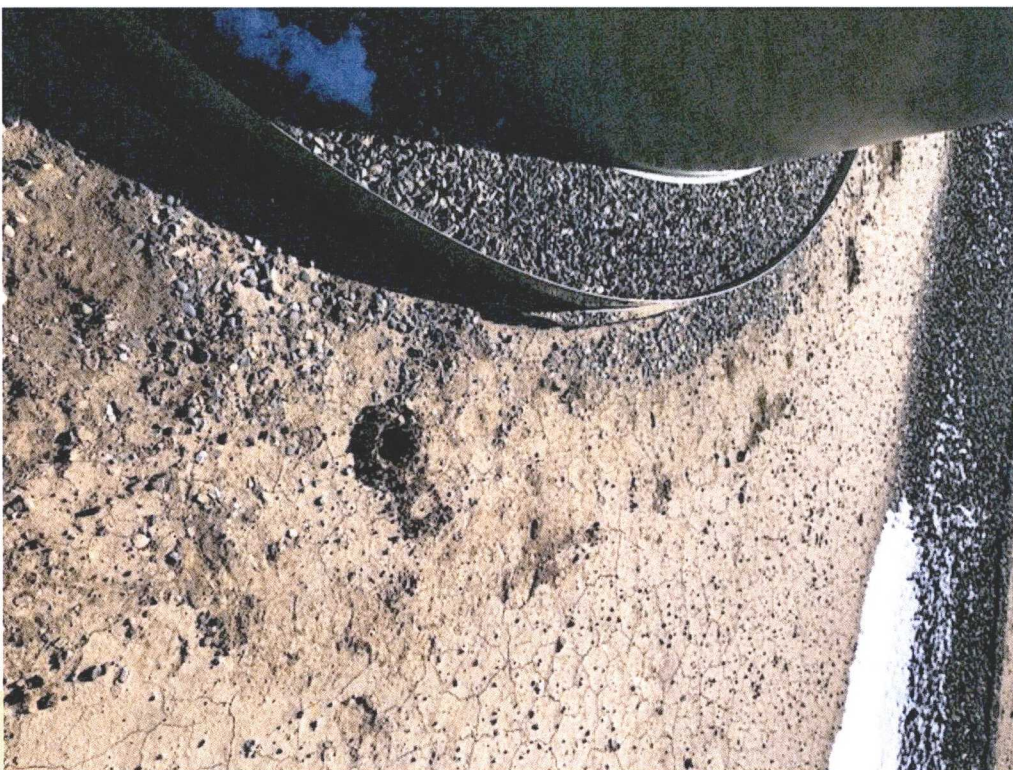
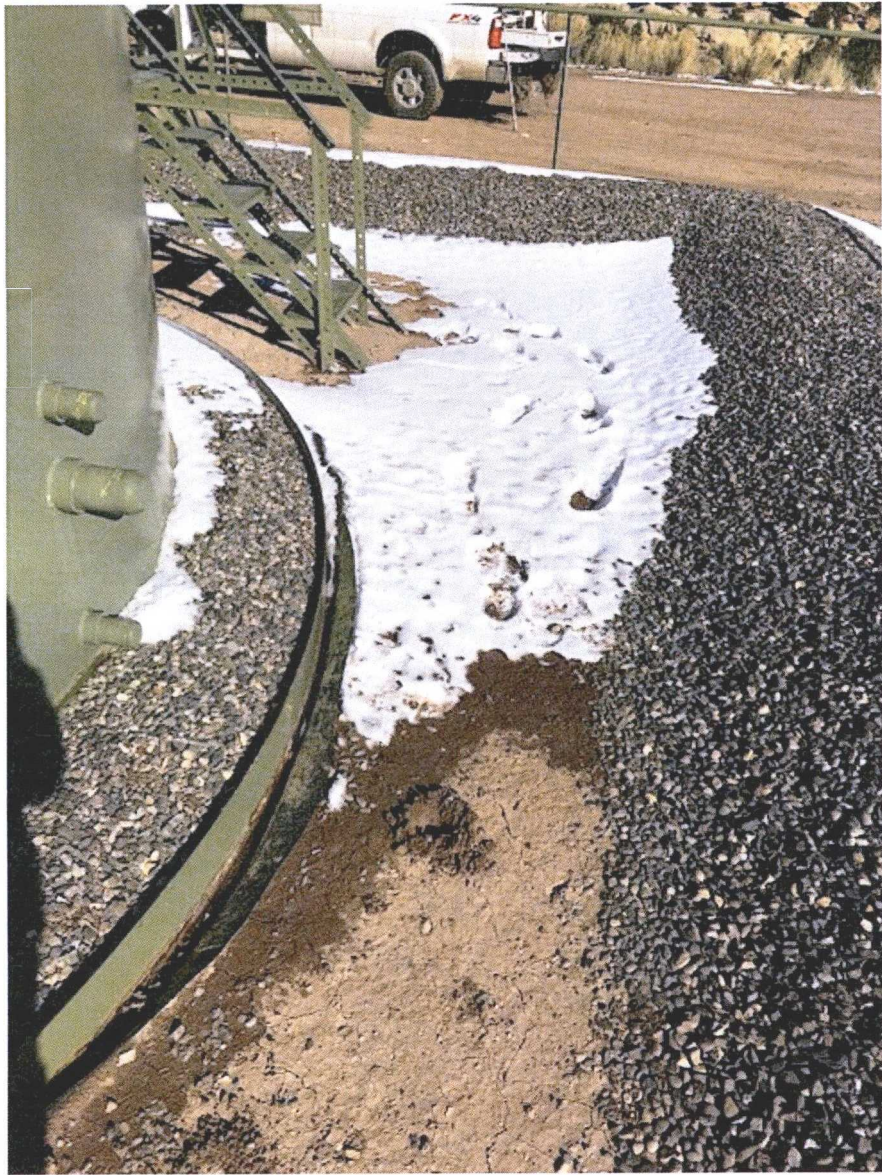
Describe Cause of Problem and Remedial Action Taken.* The release as a result of corrosion on the bottom of the production tank. There was no standing product to recover.

Describe Area Affected and Cleanup Action Taken.* The corroded tank sits on a liner, 4 samples approximately 1' down were taken on 1/22/18. Pictures are attached. Samples were submitted for BTEX 8021, TPH to include DRO-GRO-MRO 8015, and chlorides. All analytical results are below NMOCD action levels, no further remediation required.
--
