Pit, Closed-Loop System, Below-Grade Tank, or
Proposed Alternative Method Permit or Closure Plan Application

BP AMERICA PRODUCTION COMPANY
SAN JUAN BASIN, NORTHWEST NEW MEXICO

BELOW-GRADE TANK CLOSURE PLAN

Gallegos Canyon Unit # 202E – Tank ID: A

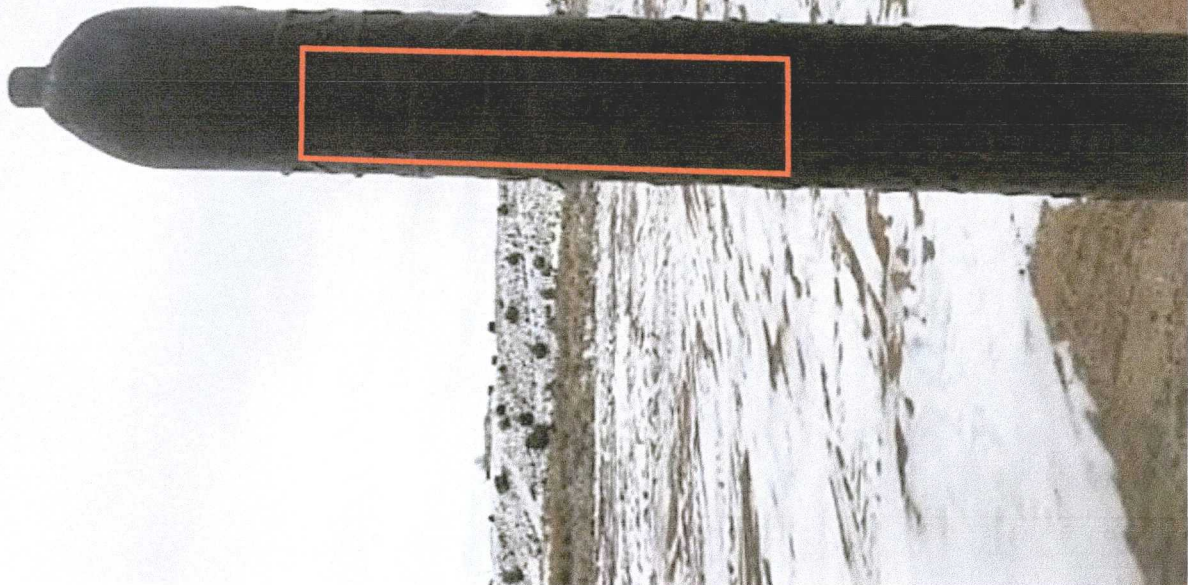
Plugged & Abandoned
Marker

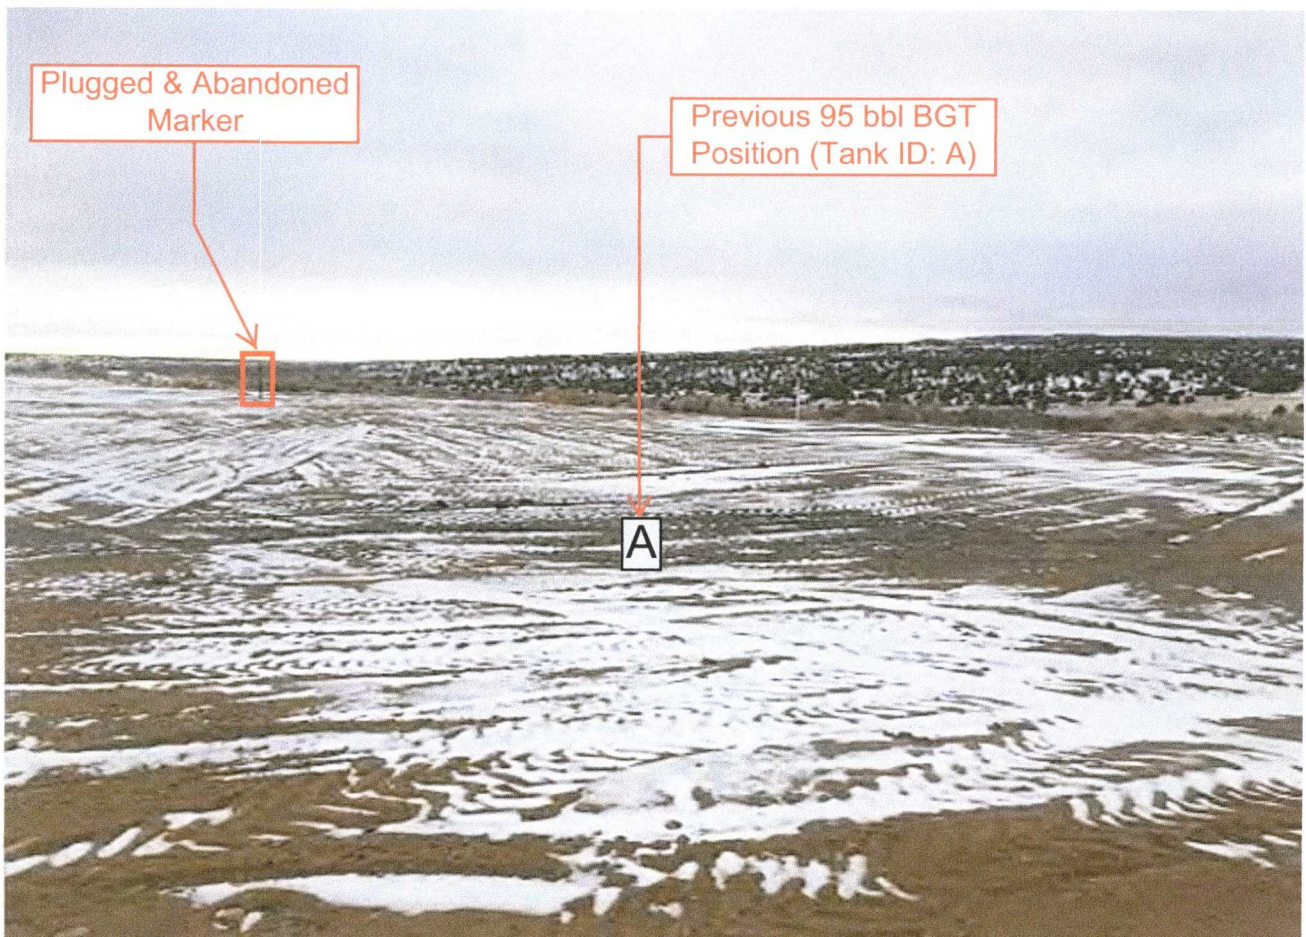
Previous 95 bbl BGT
Position (Tank ID: A)

10. BP shall reclaim the BGT location and all areas associated with the BGT including associated access roads to a safe and stable condition that blends with the surrounding undisturbed area. BP shall substantially restore the impacted surface area to the condition that existed prior to oil and gas operations by placement of the soil cover as provided in Subsection H of 19.15.17.13 NMAC, re-contour the location and associated areas to a contour that approximates the original contour and blends with the surrounding topography and re-vegetate according to Subsection I of 19.15.17.13 NMAC.
