Pit, Closed-Loop System, Below-Grade Tank, or
Proposed Alternative Method Permit or Closure Plan Application

BELOW-GRADE TANK CLOSURE PLAN

Barnes B # 21 – Tank ID: A

API #: 3004527743

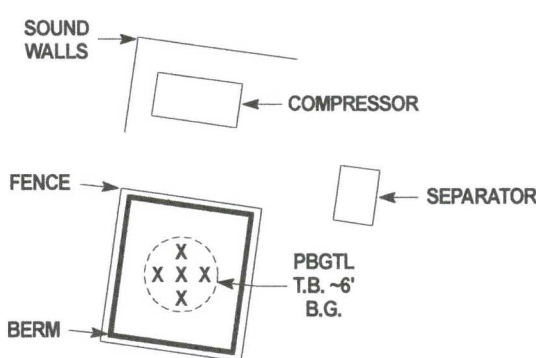
SAMPLING DATA: 1) SAMPLE ID: 5PC - TB @ 6' (45) SAMPLE DATE: 12/06/18 SAMPLE TIME: 0910 LAB ANALYSIS: 8015B/8021B/300.0 (CI) 2) SAMPLE ID: _____ SAMPLE DATE: _____ SAMPLE TIME: _____ LAB ANALYSIS: _____ 3) SAMPLE ID: _____ SAMPLE DATE: _____ SAMPLE TIME: _____ LAB ANALYSIS: _____ 4) SAMPLE ID: _____ SAMPLE DATE: _____ SAMPLE TIME: _____ LAB ANALYSIS: _____ 5) SAMPLE ID: _____ SAMPLE DATE: _____ SAMPLE TIME: _____ LAB ANALYSIS: _____		CHAIN OF CUSTODY RECORD(S) # OR LAB USED: HALL OVM READING (ppm) NA
SOIL DESCRIPTION: SOIL TYPE: SAND / SILTY SAND / SILT / SILTY CLAY / CLAY / GRAVEL / OTHER _____ SOIL COLOR: DARK YELLOWISH BROWN COHESION (ALL OTHERS): NON COHESIVE / SLIGHTLY COHESIVE / COHESIVE / HIGHLY COHESIVE CONSISTENCY (NON COHESIVE SOILS): LOOSE / FIRM / DENSE / VERY DENSE MOISTURE: DRY / SLIGHTLY MOIST / MOIST / WET / SATURATED / SUPER SATURATED SAMPLE TYPE: GRAB / COMPOSITE - # OF PTS. 5 DISCOLORATION/STAINING OBSERVED: YES NO EXPLANATION - _____ PLASTICITY (CLAYS): NON PLASTIC / SLIGHTLY PLASTIC / COHESIVE / MEDIUM PLASTIC / HIGHLY PLASTIC DENSITY (COHESIVE CLAYS & SILTS): SOFT / FIRM / STIFF / VERY STIFF / HARD HC ODOR DETECTED: YES NO EXPLANATION - _____ ANY AREAS DISPLAYING WETNESS: YES NO EXPLANATION - _____

SITE OBSERVATIONS: LOST INTEGRITY OF EQUIPMENT: YES NO EXPLANATION - _____ APPARENT EVIDENCE OF A RELEASE OBSERVED AND/OR OCCURRED: YES NO EXPLANATION: _____ EQUIPMENT SET OVER RECLAIMED AREA: YES / NO EXPLANATION - 105 BBL SHALLOW LOW PROFILE ABOVE-GRADE TANK TO BE SET ATOP BGT LOCATION. OTHER: NMOC D OR BLM REPS. NOT PRESENT TO WITNESS CONFIRMATION SAMPLING.		
EXCAVATION DIMENSION ESTIMATION: NA ft. X NA ft. X NA ft. EXCAVATION ESTIMATION (Cubic Yards): NA DEPTH TO GROUNDWATER: < 50' NEAREST WATER SOURCE: > 1,000' NEAREST SURFACE WATER: 300' < x < 1,000' NMOC D TPH CLOSURE STD: 100 ppm		
SITE SKETCH BGT Located: off / on site PLOT PLAN circle: attached		OVM CALIB. READ. = NA ppm RF=1.00 OVM CALIB. GAS = NA ppm TIME: NA am/pm DATE: NA

MISCELL. NOTES SIO #: 190040005402 REF #: _____ VID: VHIXONEV11 PJ #: _____ Permit date(s): 06/03/10 OCD Appr. date(s): 04/01/16 Tank ID: A OVM = Organic Vapor Meter ppm = parts per million BGT Sidewalls Visible: (Y) N BGT Sidewalls Visible: Y / N BGT Sidewalls Visible: Y / N Magnetic declination: 10° E

NOTES: BGT = BELOW-GRADE TANK; E.D. = EXCAVATION DEPRESSION; B.G. = BELOW GRADE; B = BELOW; T.H. = TEST HOLE; ~ = APPROX.; W.H. = WELL HEAD; T.B. = TANK BOTTOM; PBGTL = PREVIOUS BELOW-GRADE TANK LOCATION; SPD = SAMPLE POINT DESIGNATION; R.W. = RETAINING WALL; NA = NOT APPLICABLE OR NOT AVAILABLE; SW - SINGLE WALL; DW - DOUBLE WALL; SB - SINGLE BOTTOM; DB - DOUBLE BOTTOM. NOTES: GOOGLE EARTH IMAGERY DATE: 3/15/2015. ONSITE: 12/06/18

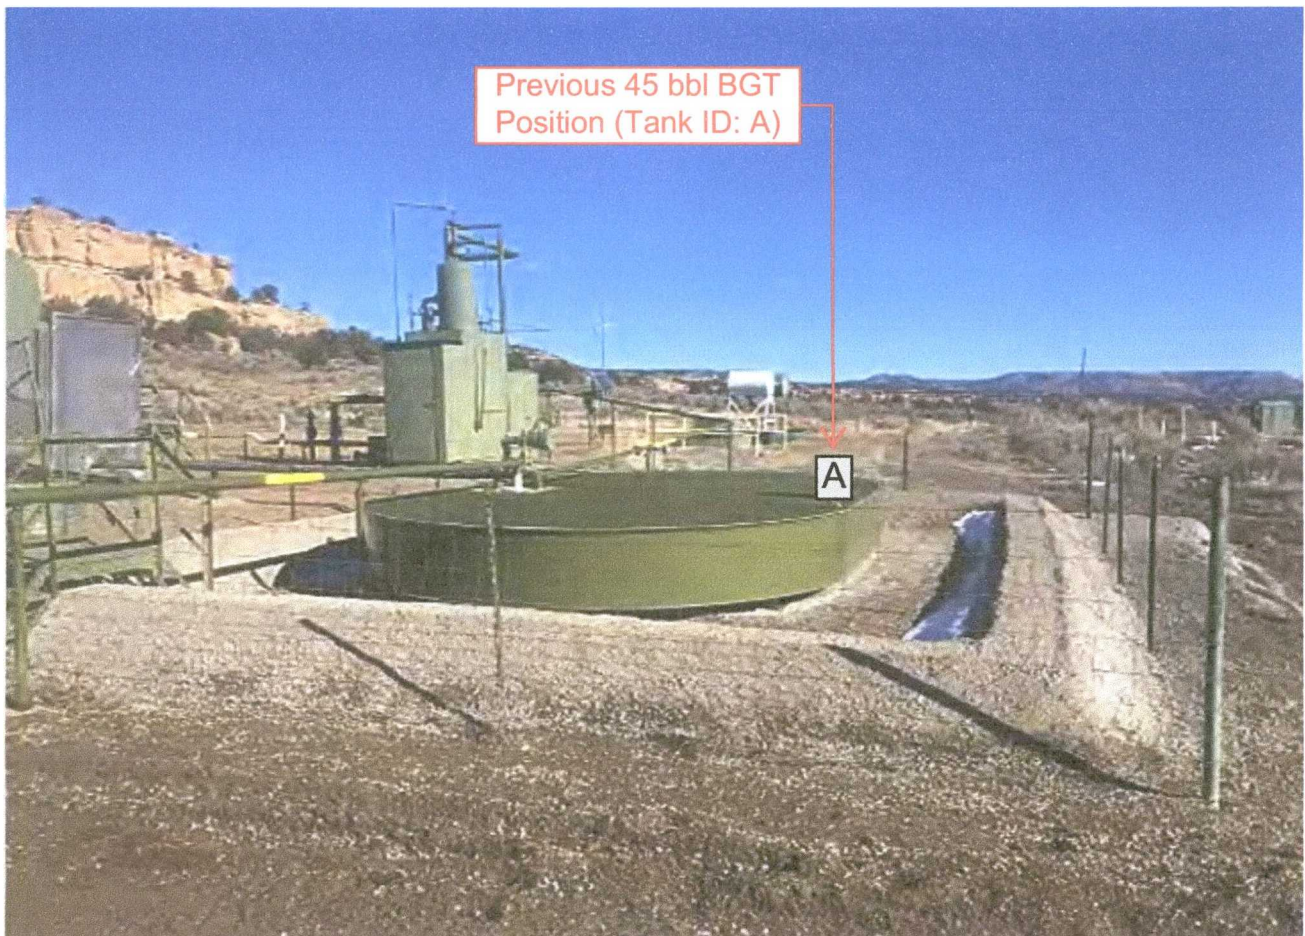
- e. site reclamation, photo documentation.**Closure report on C-144 form is included & contains a photo of the reclamation completion.**
16. BP shall certify that all information in the report and attachments is accurate, truthful, and compliant with all applicable closure requirements and conditions specified in the approved closure plan.
Certification section of C-144 has been completed.

Sampling results reveal no evidence of a release has occurred. Area was backfilled with clean, earthen material and is within the active well pad.

The BGT area has been backfilled and will be reclaimed once the well has been plugged & abandoned.
