**Pit or Below-Grade Tank Registration or Closure**

Type of action: Registration of a pit or below-grade tank ☐ Closure of a pit or below-grade tank ☒ **REVISED JUL 2007**

| Facility or well name: <u>Salazar 'G' Com. 21- #1</u> API #: <u>30-039-23051</u> U/L or Qtr/Qtr: <u>1650' FNL &amp; 1850' FEL, Unit 'G' of Sec 21 T 25N R6W</u> | | | |

**Additional Comments:** An improperly installed 40 Bbl. fiberglass tank was excavated & removed. The pit was excavated to 18' x 18' x 9' deep where a bottom test failed (121 PPM TPH vs. 100 PPM TPH Limit: 6/28/2004). Excavation to a Final 22' x 22' x 12' deep size on 7/7/2004 met site TPH Standards. The excavation was devoid of visible oil-staining & detectable odors. Approximately 215 cubic yards of soil were excavated from this pit & mixed with the Pre-Existing Land Farm Materials. The excavated & land-farmed materials were repeatedly tilled & fertilized with a total of 900# of Hi-N2 Fertilizer. The Site Diagram and Sample Results are attached. All FINAL sample results are less than the 100 ppm TPH standard for the site. This well has been Plugged & Abandoned & all site debris & oily material has been remediated on-site or removed in accord

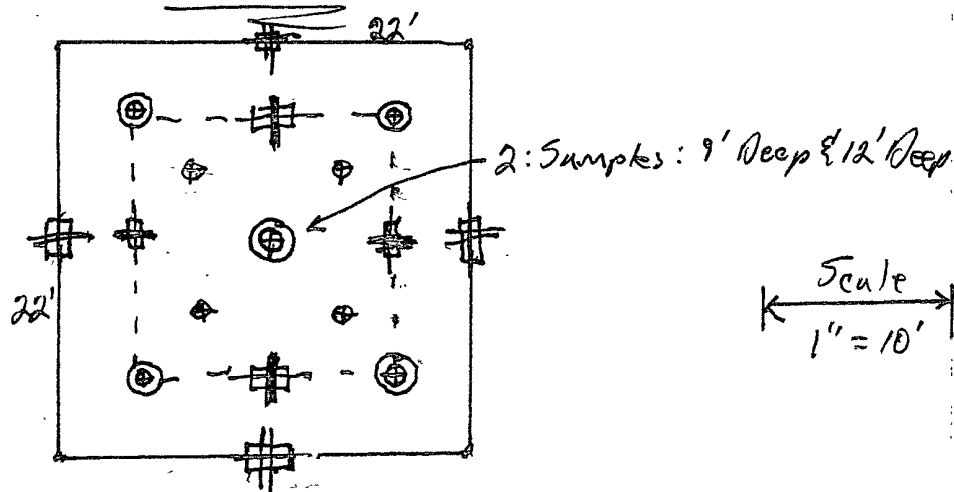
Section View

Fiberglass Tank  
30' x 30' Fenced Enclosure  
Excavated 18' x 18' x 9' Deep: Failed Test  
Excavated 22' x 22' x 12' Deep: Passed Test

At which time & Depth there was no visible oil-staining or noticeable odor.  
Final Samples @ Pit Bottom & Sides OK.

1. Remove Improperly Installed 40 Bbl. Fiberglass Tank.

4. Sampled Pit Pile & Excavation & Old Land Farm & Both Failed & Mixed Together

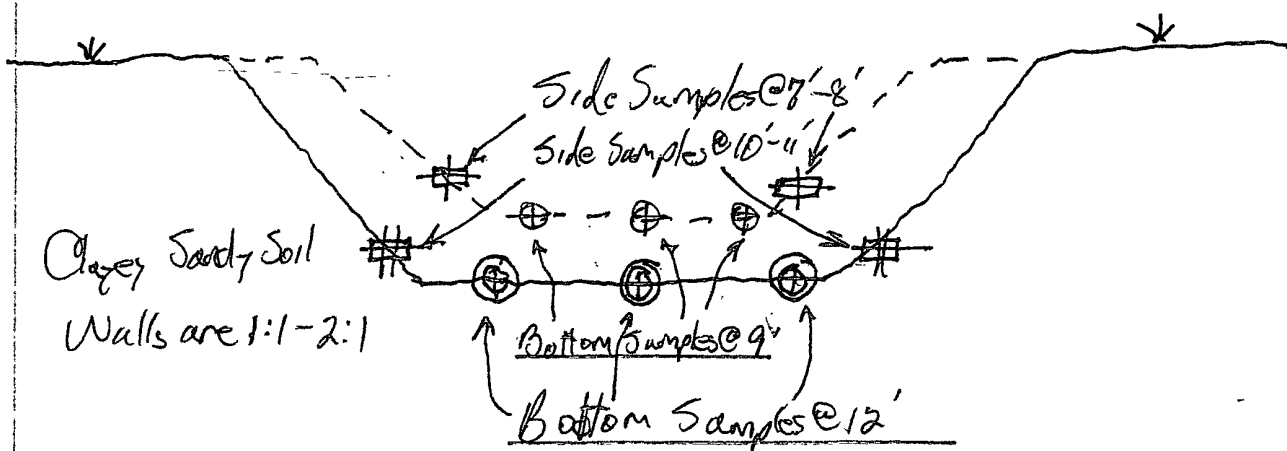
9' 12'  
⊗ ⊗ : Approx. Sampling Points : Bottom Composite Samples:  
5-Spot Pattern

7'-8' 10'-11'  
⊗ ⊗ : Approx. Sampling Points : Side Composite Samples:  
4-Spot Pattern

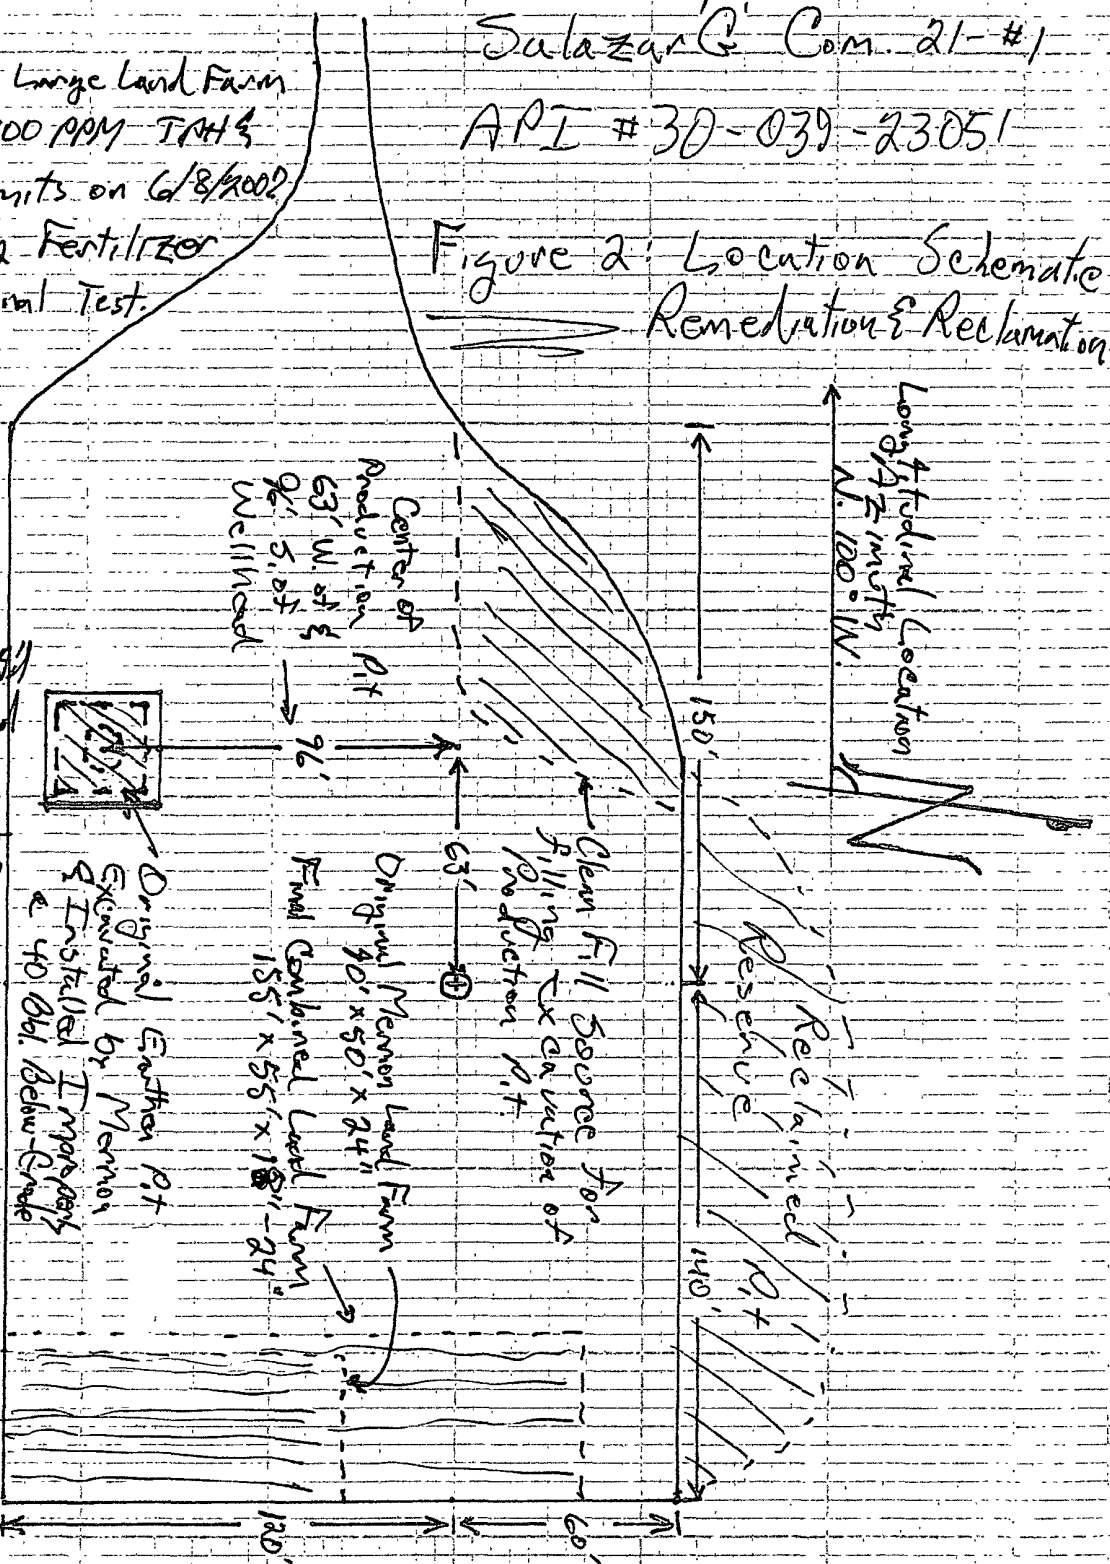
2. Excavate Pit & Sides to 18' x 18' x 9' Deep: Sampled 6/28/2004.  
to 22' x 22' x 12' Deep: Sampled 7/17/2004

3. Back-Fill Pit w/ 100# Hi-N<sub>2</sub> Fertilizer & Clean-Fill & NW Corner of Location.

5. Farm & Fertilizer Large Land Farm  
until Tested Below 100 PPM TAP &  
50 PPM BTEX Site Limits on 6/8/2002  
Applied 900# Hi-N<sub>2</sub> Fertilizer  
in Total prior to Final Test.

6. Spread Remediated  
Land-Farm Material  
over location mixed  
w/ 300# Additional  
Hi-N<sub>2</sub> Fertilizer.

7. This well-site was P&H  
& Tilled, Levelled & Restored  
to Original Contours  
& Re-seeded.

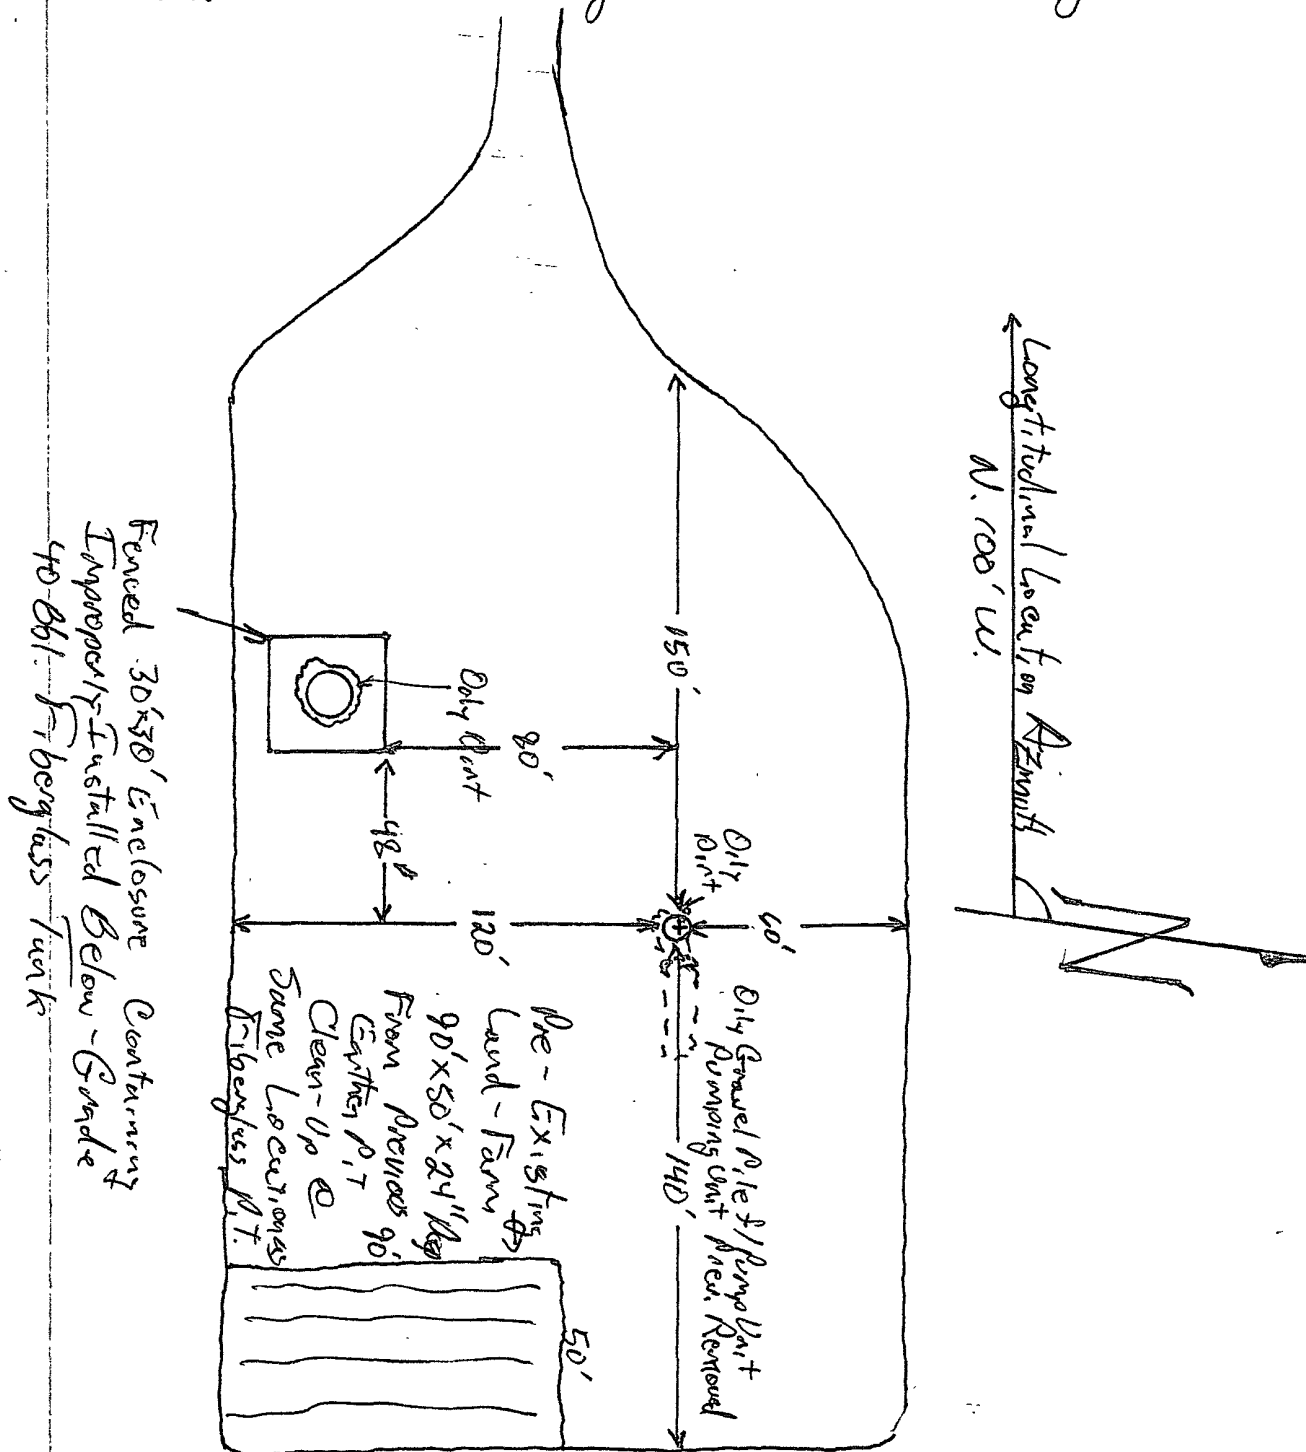
1. Empty F-Glass Tank.
2. Excavate & Remove & Test Tank Excavation until Clear.
3. Land-Farm all Oily Port on Location.
4. Well has no sign.
5. No Casing or Tubing Pressure
6. No Production Equip. On-Location. All removed by Merriam.
