PIT REMEDIATION AND CLOSURE REPORT

Operator: PNM Gas Services (Bayless) Telephone: 324-3764
Address: 603 W. Elm Street Farmington, NM 87401
Facility or Well Name: Axi Apache H-8
Location: Unit: M Sec. 5 T. 23 N R. 5 W County Rio Arriba
Pit Type: Separator ☒ Dehydrator ☐ Other ☐
Land Type: Jicarilla Apache

ON-SITE SOIL REMEDIATION REPORT

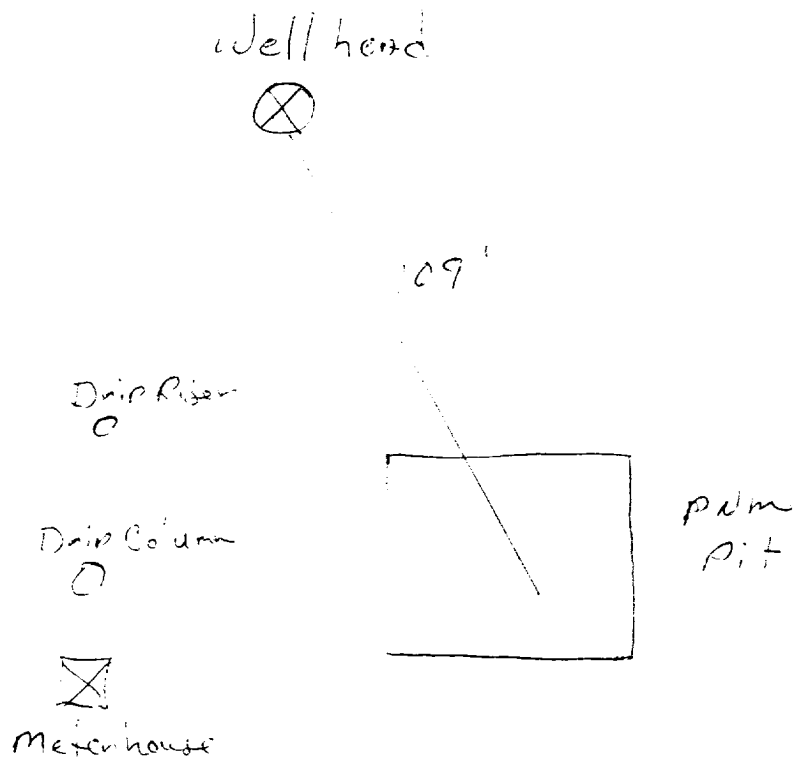
7x1 Apache H-8
Sec. 5 T.23N R.5W
Bayless

Pit Location: Pit dimensions: length 20' width 14' depth 8'
(Attach diagram) Reference: wellhead ☒ other ☐
Footage from reference: 109'
Direction from reference: 70 Degrees East North
West South

Removed contaminated soil from All four side walls and pit bottom as to get it below 100ppm head space remaining

Sample Location North East, South West side walls and pit bottom

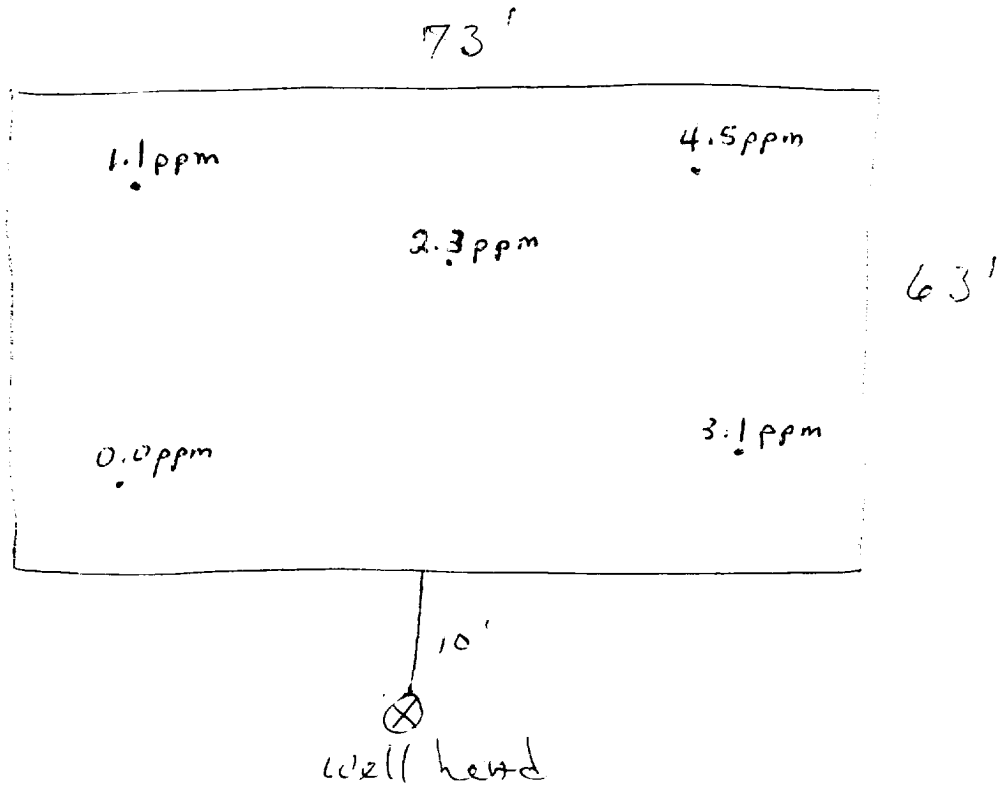
7x11 Apache H-8
Sec 5 T23N R5W
Bayless

Land farm
