PIT REMEDIATION AND CLOSURE REPORT

Operator: PNM Gas Services Bayless Telephone: 324-3764  
Address: 603 W. Elm Street Farmington, NM 87401  
Facility or Well Name: Axi Apache H-14  
Location: Unit: 0 Sec. 6 T. 23 N R. 5 W County Rio Arriba  
Pit Type: Separator X Dehydrator      Other       
Land Type: Jicarilla Apache

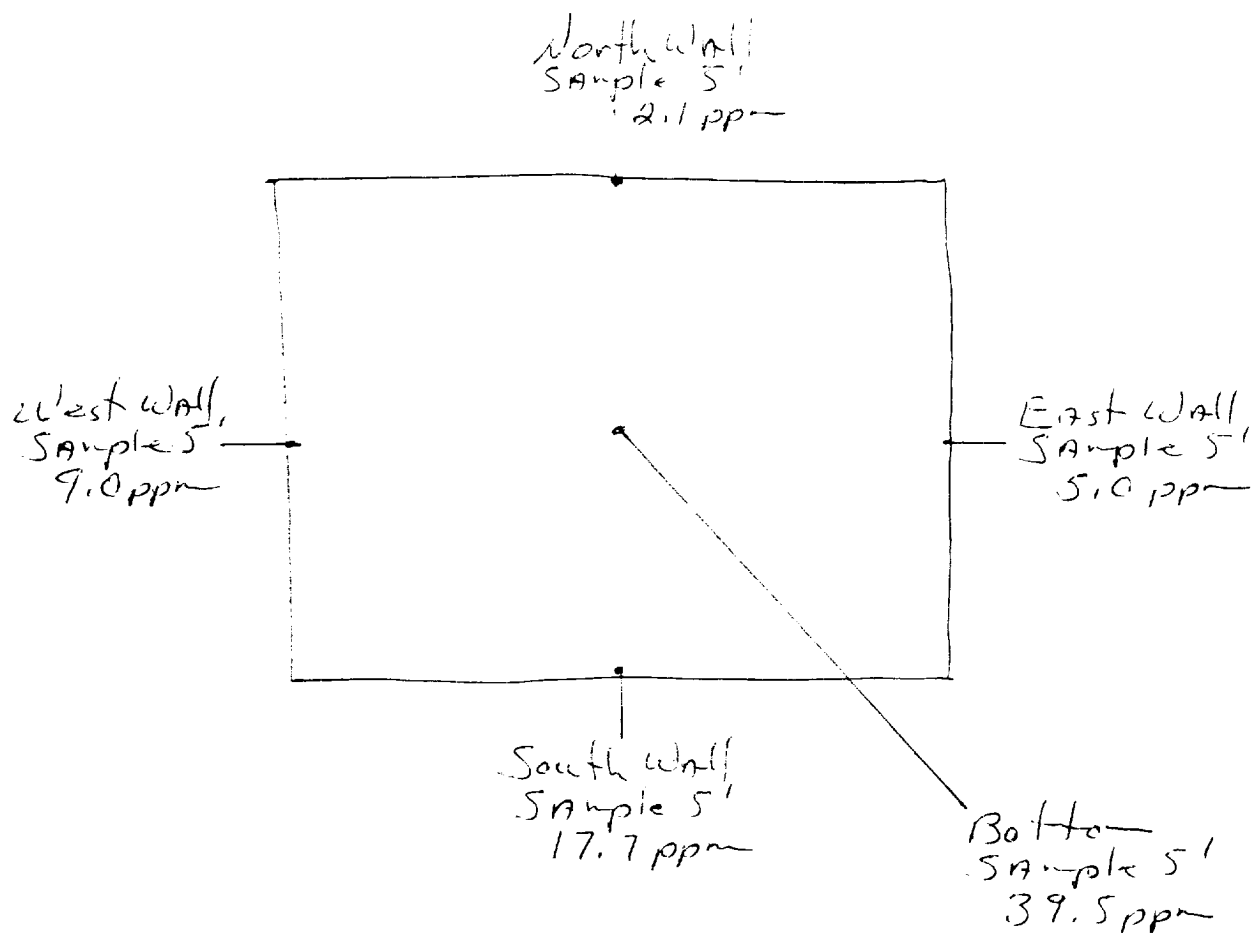
Hxi Apple H-14  
Sec. 6 T23N R5W  
Bayless

Pit Location: Pit dimensions: length 15' width 14' depth 5'  
(Attach diagram) Reference: wellhead X other       
Footage from reference: 24'  
Direction from reference: Straight Degrees X East North       
West of South

Sample Location North, East, South, West side walls and pit bottom

Sample depth 5'

1.5' x 14' x 5'
