PIT REMEDIATION AND CLOSURE REPORT

Operator: PNM Gas Services (Bayless) Telephone: 324-3764
Address: 603 W. Elm Street Farmington, NM 87401
Facility or Well Name: Ax. Apache H-9
Location: Unit: M Sec. 32 T. 24 N R. 5 W County Rio Arriba
Pit Type: Separator Dehydrator Other Drip
Land Type: Jicarilla Apache

ON-SITE SOIL REMEDIATION REPORT

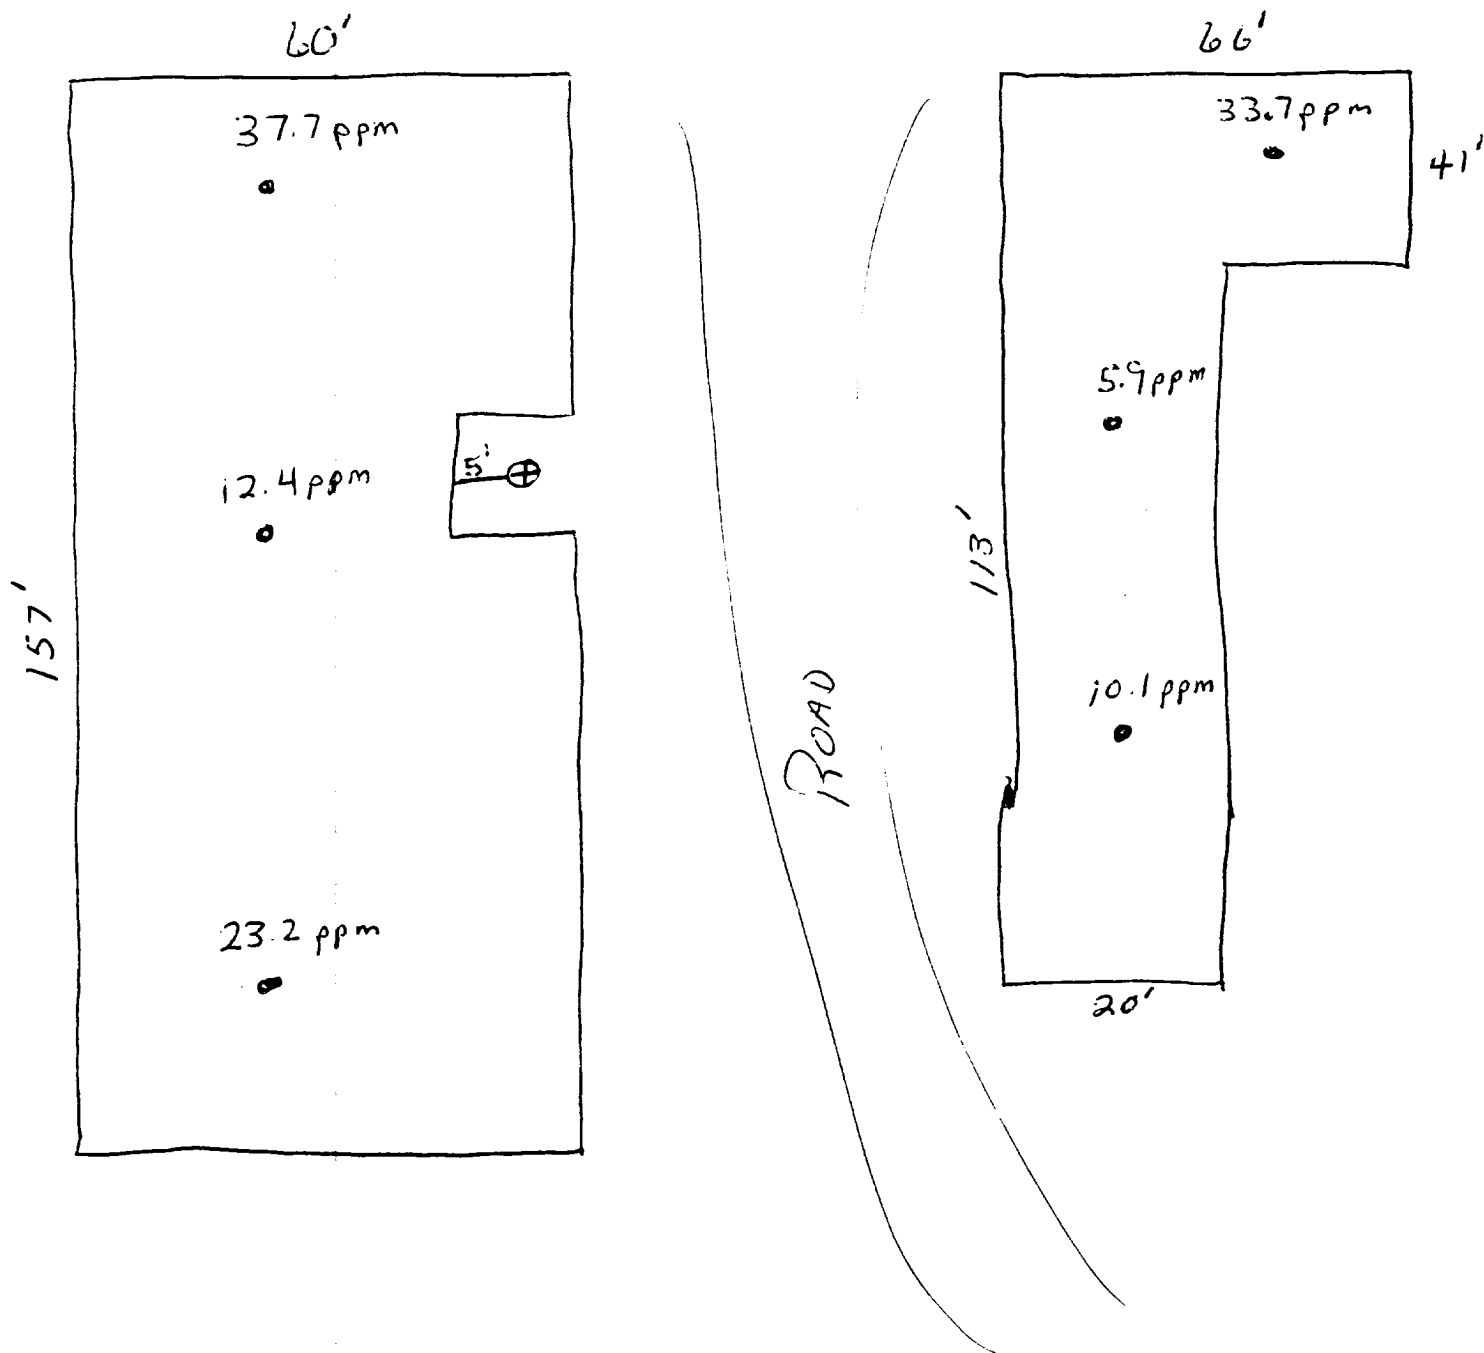
17xi Apache 14-9
Sec. 32 T24N R5W
Bayless

Land from
