## PIT REMEDIATION AND CLOSURE REPORT

Operator: Burlington Resources Telephone: (505) 326-9700

Facility Or: Canyon Largo Unit # 267

Location: Unit or Qtr/Qtr Sec M Sec 18 T 25N R 6W County Rio Arriba

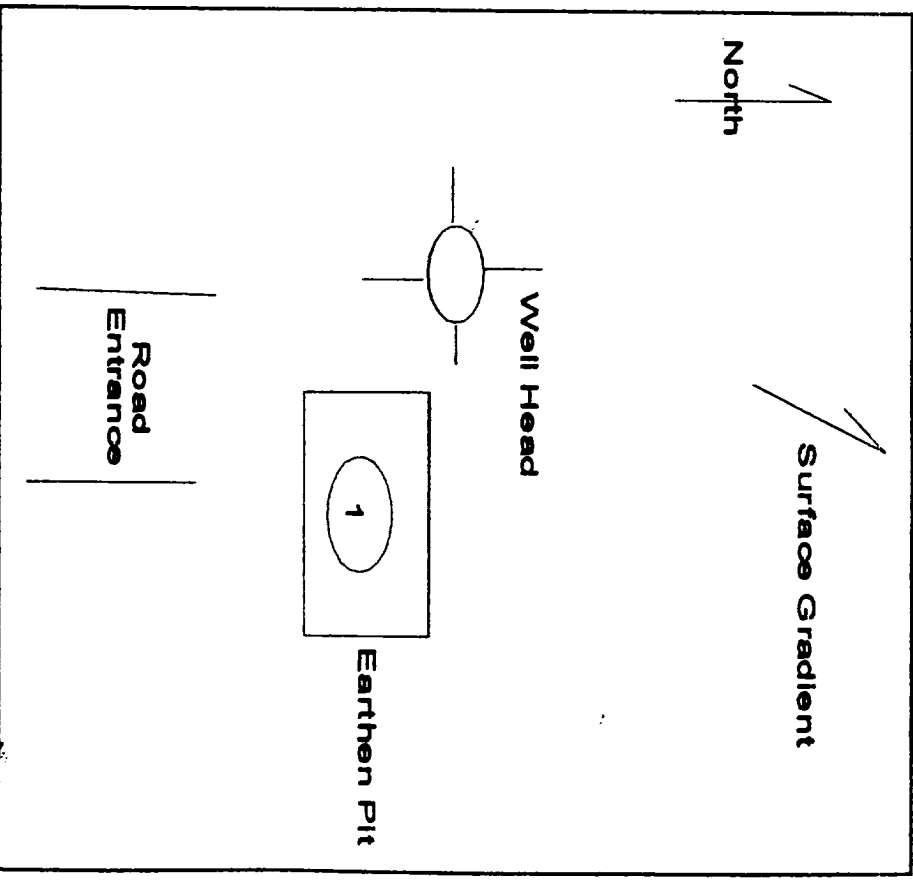
| Location : Canyon Largo Unit # 267 | | Overview of Location and Sampling : | | | | | | | | | | | | | | | | | | | | | | | | | | | | | | | | | | | | | | | | | | | | |
|---|---|---|---|---|---|---|---|---|--|--|---|--|--|---|--|--|---|--|--|---|--|--|---|--|--|---|--|--|---|--|--|---|--|--|---|--|--|---|--|--|---|--|--|---|--|--|
| Quad : M | Section : 18 |

| | | | | | | | | | | | | | | | | | | | | | | | | | | | | | | | | | | | | | | | | | | | |
| Range : 6W | Township: 25N | | | | | | | | | | | | | | | | | | | | | | | | | | | | | | | | | | | | | | | | | | | | | |
| Pit : Abandoned | | | | | | | | | | | | | | | | | | | | | | | | | | | | | | | | | | | | | | | | | | | | | | |
| Reference : 25° S 45 degrees W<br>from wellhead |

<table><tr><th>Sample #</th><th>Location</th><th>OVM</th></tr><tr><td>1</td><td>Cr Btm @ 5'</td><td>10.6</td></tr></table>

General Description of Remedial Action : On 5/18/99, the pit was sampled at a depth of 5 feet. A soil sample was obtained from the center bottom of the pit at a depth of 5 feet (3 feet below pit bottom) utilizing U.S.E.P.A. protocol and sent to Acculabs Inc. for GRO/DRO analysis. Results provided concentrations below NMOCD guidelines.

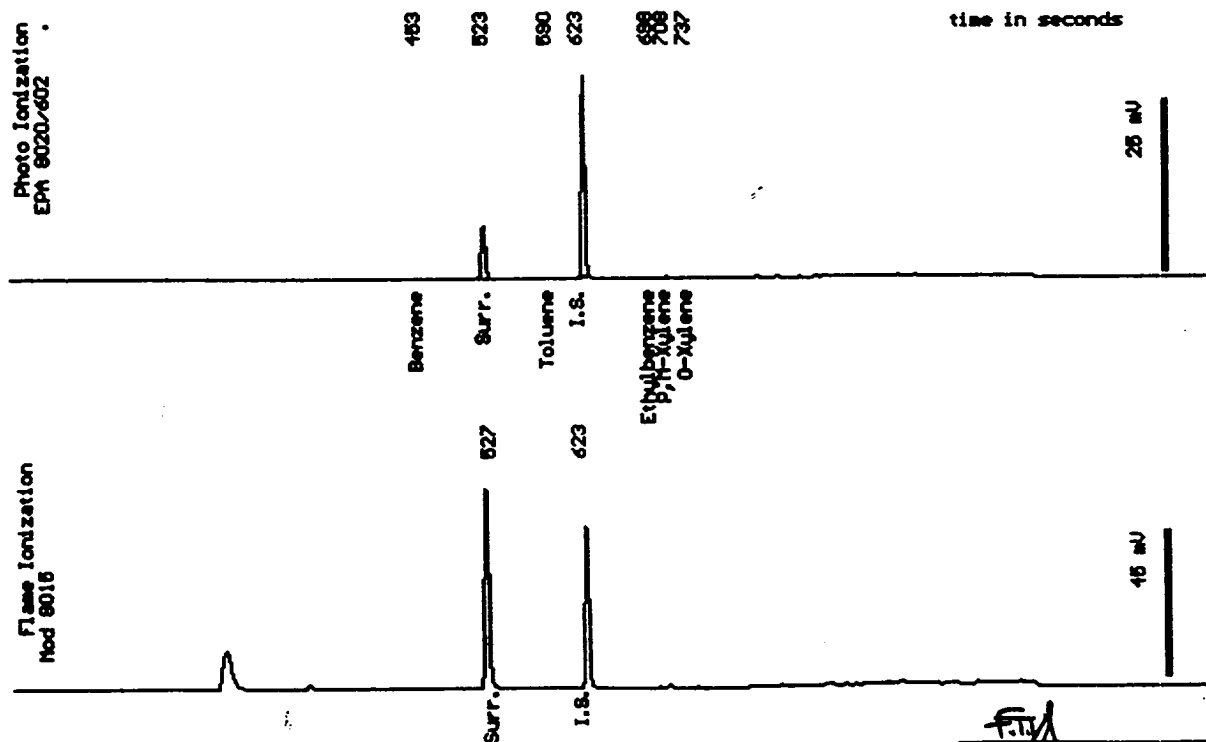
| Parameter | (MRL) $\mu\text{g/kg}$ | Measured Value $\mu\text{g/kg}$ |
|---|---|---|
| TPH as Gasoline | (1.0) | <1.0 |

Date Analyzed: 05-24-99  
Column : 0.53mm X 60m Restek Rtx-1301

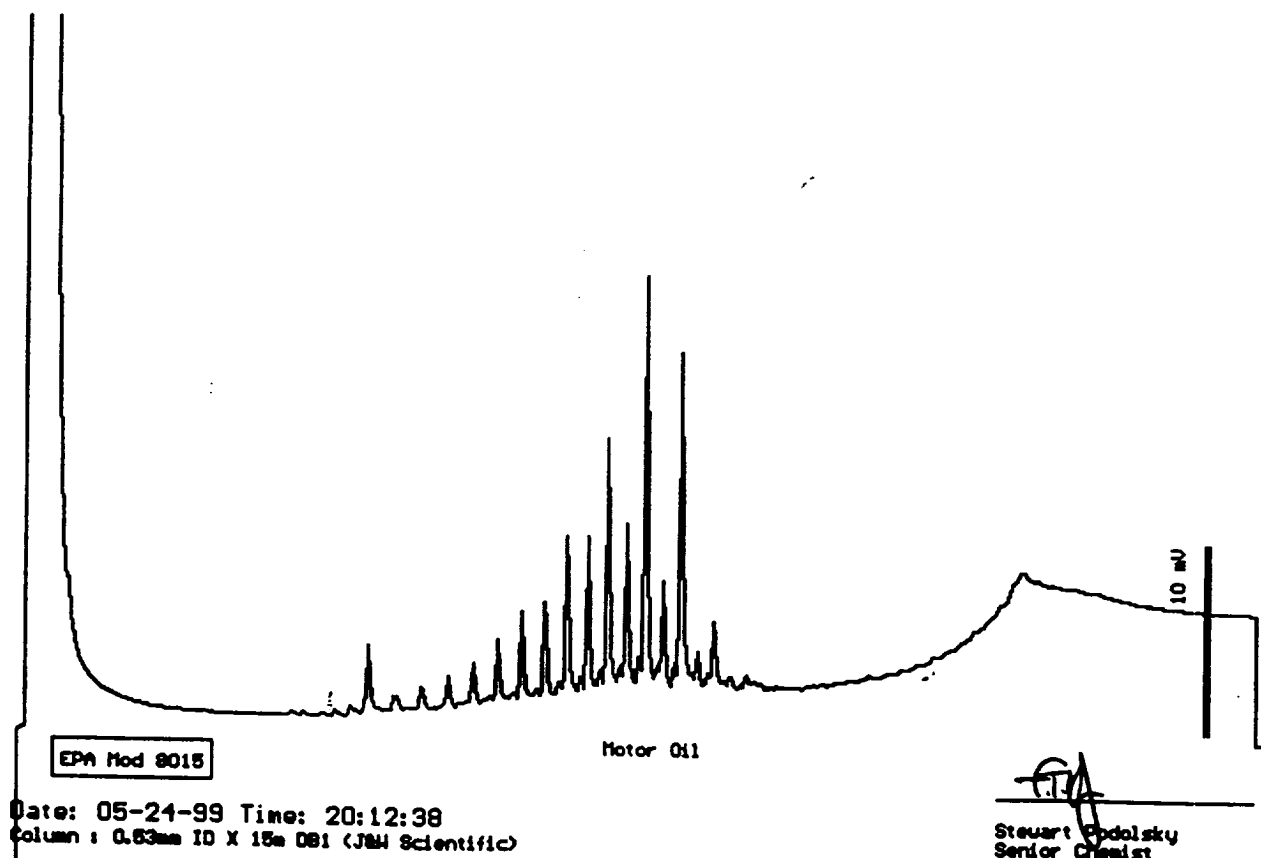
| Parameter | (MRL) mg/kg | Measured Value mg/kg |
|---|---|---|
| TPH as Diesel | (5.0) | <5.0 |
