# EL PASO EL PASO FIELD SERVICES

## FIELD PIT SITE ASSESSMENT FORM

| <b>GENERAL</b> | <p>Meter: <u>70540</u> Location: <u>BURNS 3</u></p> <p>Operator #: <u>6311</u> Operator Name: <u>Central Resources Inc.</u> P/L District: <u>Blanco</u></p> <p>Coordinates: Letter: <u>M</u> Section <u>4</u> Township: <u>26</u> Range: <u>7</u></p> <p>Or Latitude _____ Longitude _____</p> <p>Pit Type: Dehydrator _____ Location Drip: <input checked="" type="checkbox"/> Line Drip: _____ Other: _____</p> <p>Site Assessment Date: <u>5/18/99</u> Area: <u>03</u> Run: <u>72</u></p> |

## FIELD PIT REMEDIATION/CLOSURE FORM

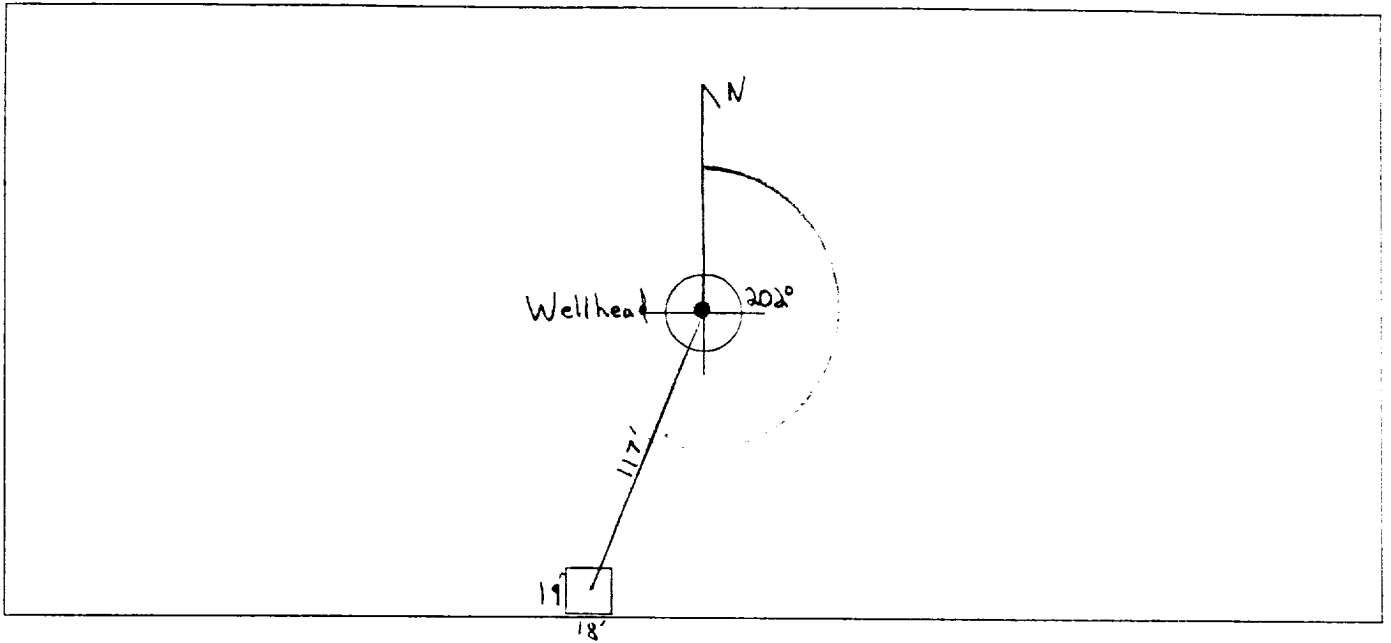
ORIGINAL PIT LOCATION

Original Pit : a) Degrees from North 202° Footage from Wellhead 117'  
 b) Length : 19' Width : 18' Depth : 2'
