PIT REMEDIATION AND CLOSURE REPORT

Facility or Well Name: Jicarilla J7

Project: Jicarilla Pit Remediation

ON-SITE SOIL REMEDIATION REPORT

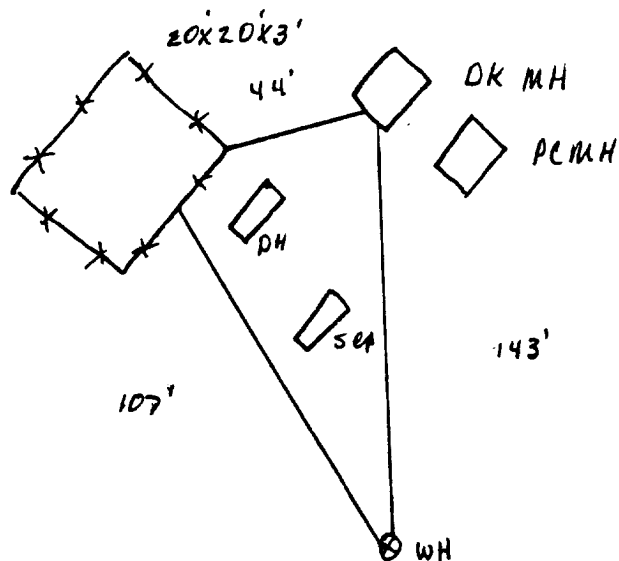
J.Pearson J7
 (E) 35-26N-5W
 Burlington
 9-28-88

Excavation Sampling

75'(N+S) x 53.5'(E+W) x 16'(D)

5' sample - 1560 ppm
 10' sample - 1208 ppm
 15' sample - 738 ppm
 16' sample - 564 ppm

west wall sample
 at 16' - 0.0 ppm

north wall sample
 at 16' - 0.0

East wall sample
 at 16' - 11.7

3 point Bottom sample
 at 16' - 371 ppm (Rock)

south wall sample
 at 16' - 10.6 ppm

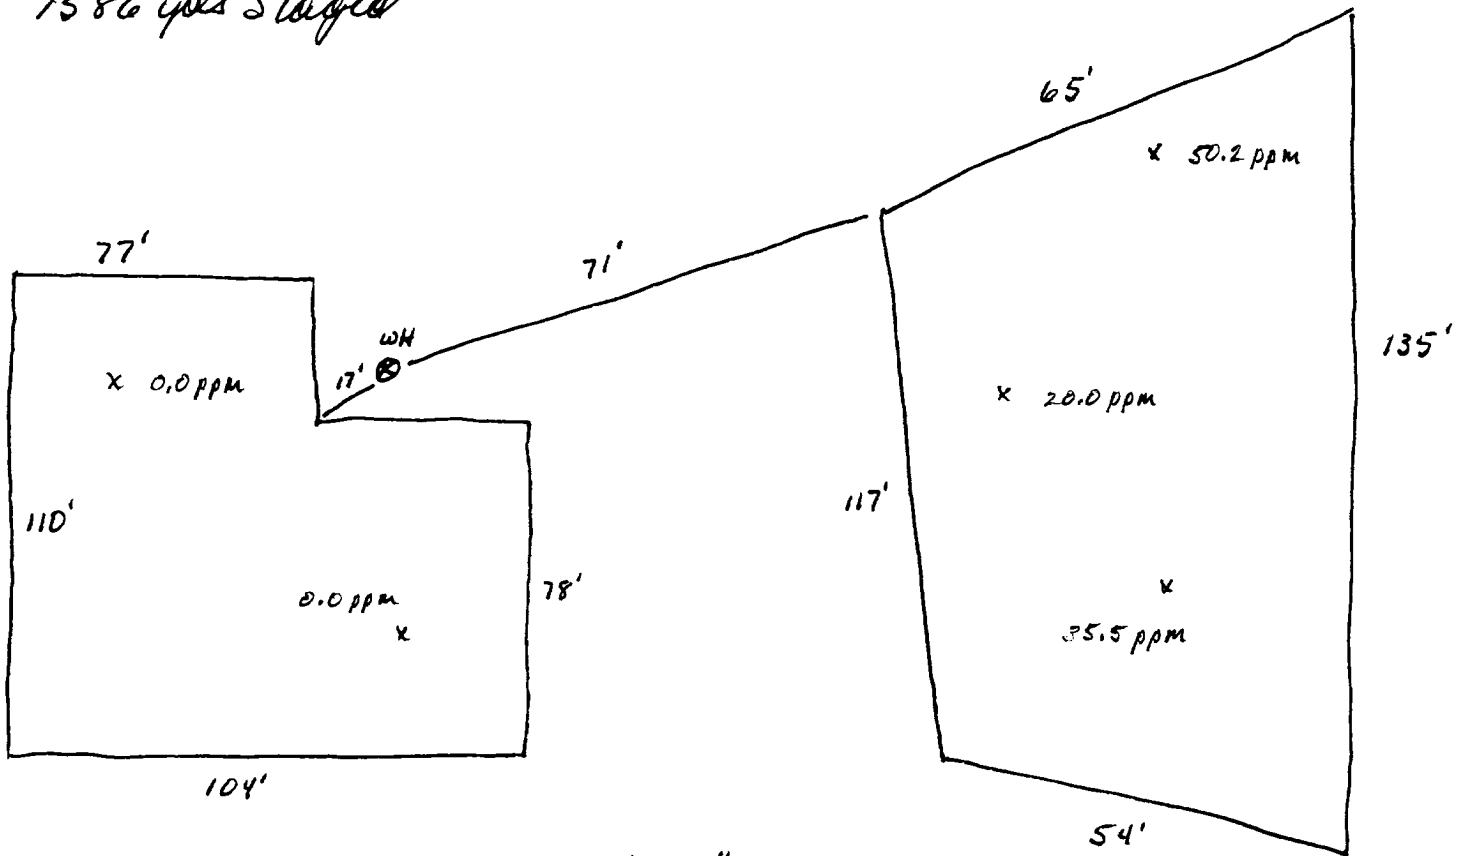
Jicarilla J7

792 yds farmed

1586 yds Staged

2" to 12"
Lead space
7.9 ppm
