## PIT REMEDIATION AND CLOSURE REPORT

| Facility Or: <u>San Juan 28-7 #132</u> | | | |
| Location: | Unit or Qtr/Qtr Sec | Unit K Sec | <u>15</u> T <u>27N</u> R <u>7W</u> County Rio Arriba |

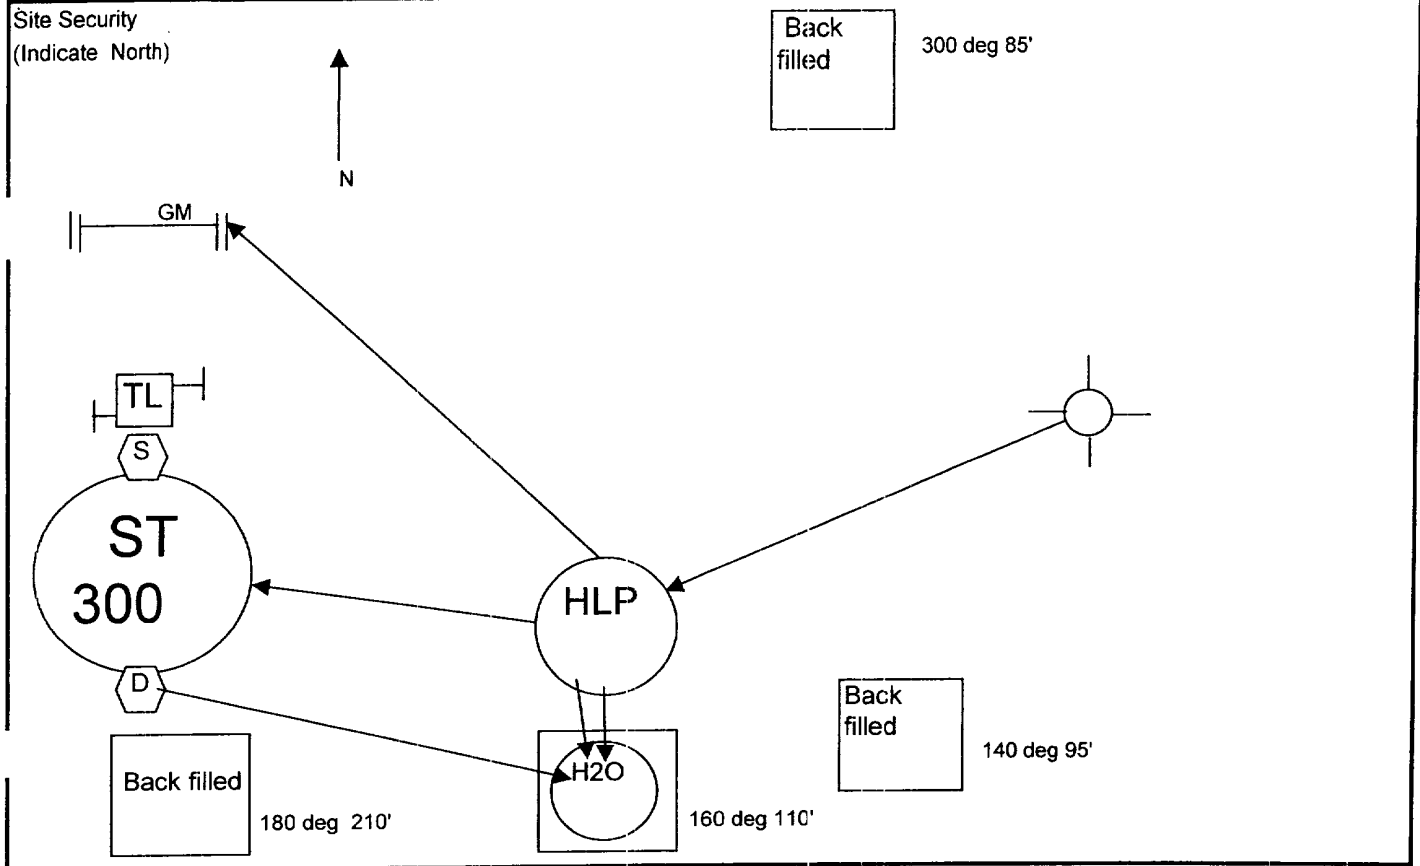
Site Security  
(Indicate North)

Load line valves :  
Sealed during Production

Drain line valves :  
Sealed during Production

Production Line valve:  
Sealed during sales
