Meter Number: 72843  
Location Name: SAN JUAN 27-5 #49 MV  
Location: TN-27 RG-05  
SC-18 UL-A  
4 - Fee  
NMOCD Zone: OUTSIDE  
Hazard Ranking Score: 00

**RATIONALE FOR RISK-BASED CLOSURE OF PRODUCTION PITS  
LOCATED OUTSIDE OF THE VULNERABLE ZONE  
IN THE SAN JUAN BASIN**

**FIELD PIT SITE ASSESSMENT FORM**

# FIELD PIT REMEDIATION/CLOSURE FORM

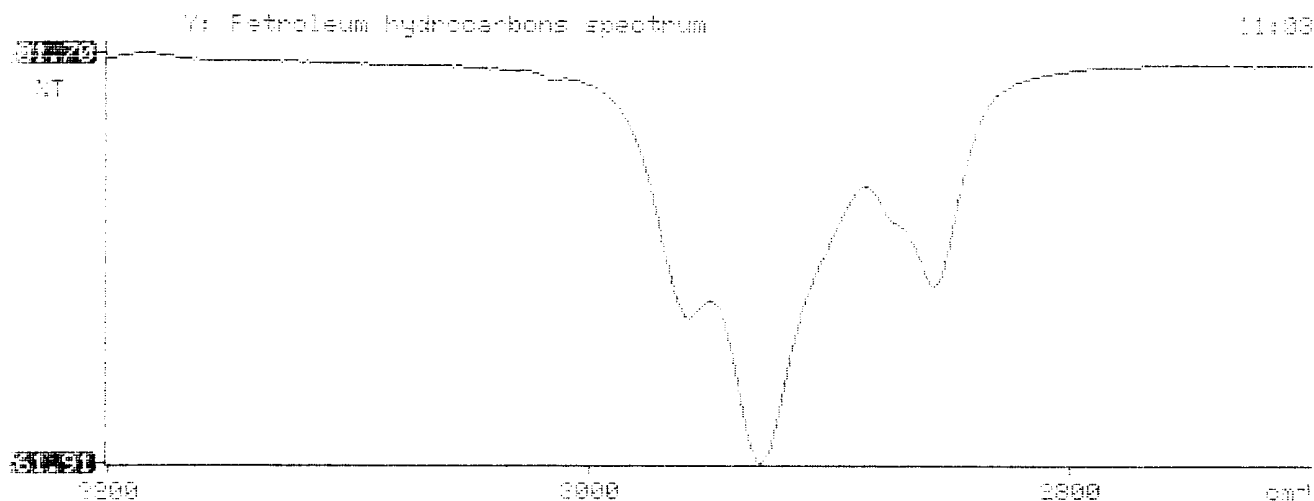
\*\*\*\*\*  
Test Method for  
Oil and Grease and Petroleum Hydrocarbons  
in Water and Soil  
Perkin-Elmer Model 1600 FT-IR  
Analysis Report  
\*\*\*\*\*

Sample identification  
246753

Petroleum hydrocarbons, ppm  
3302.021

Net absorbance of hydrocarbons (2930 cm<sup>-1</sup>)  
0.012
