ANNUAL PACKER LEAKAGE TEST

El Paso Natural Gas

San Juan 27-5 No. 26 (PM)

# San Juan 27-5 Unit #26 (PM) Annual Packer Leakage Test 1958

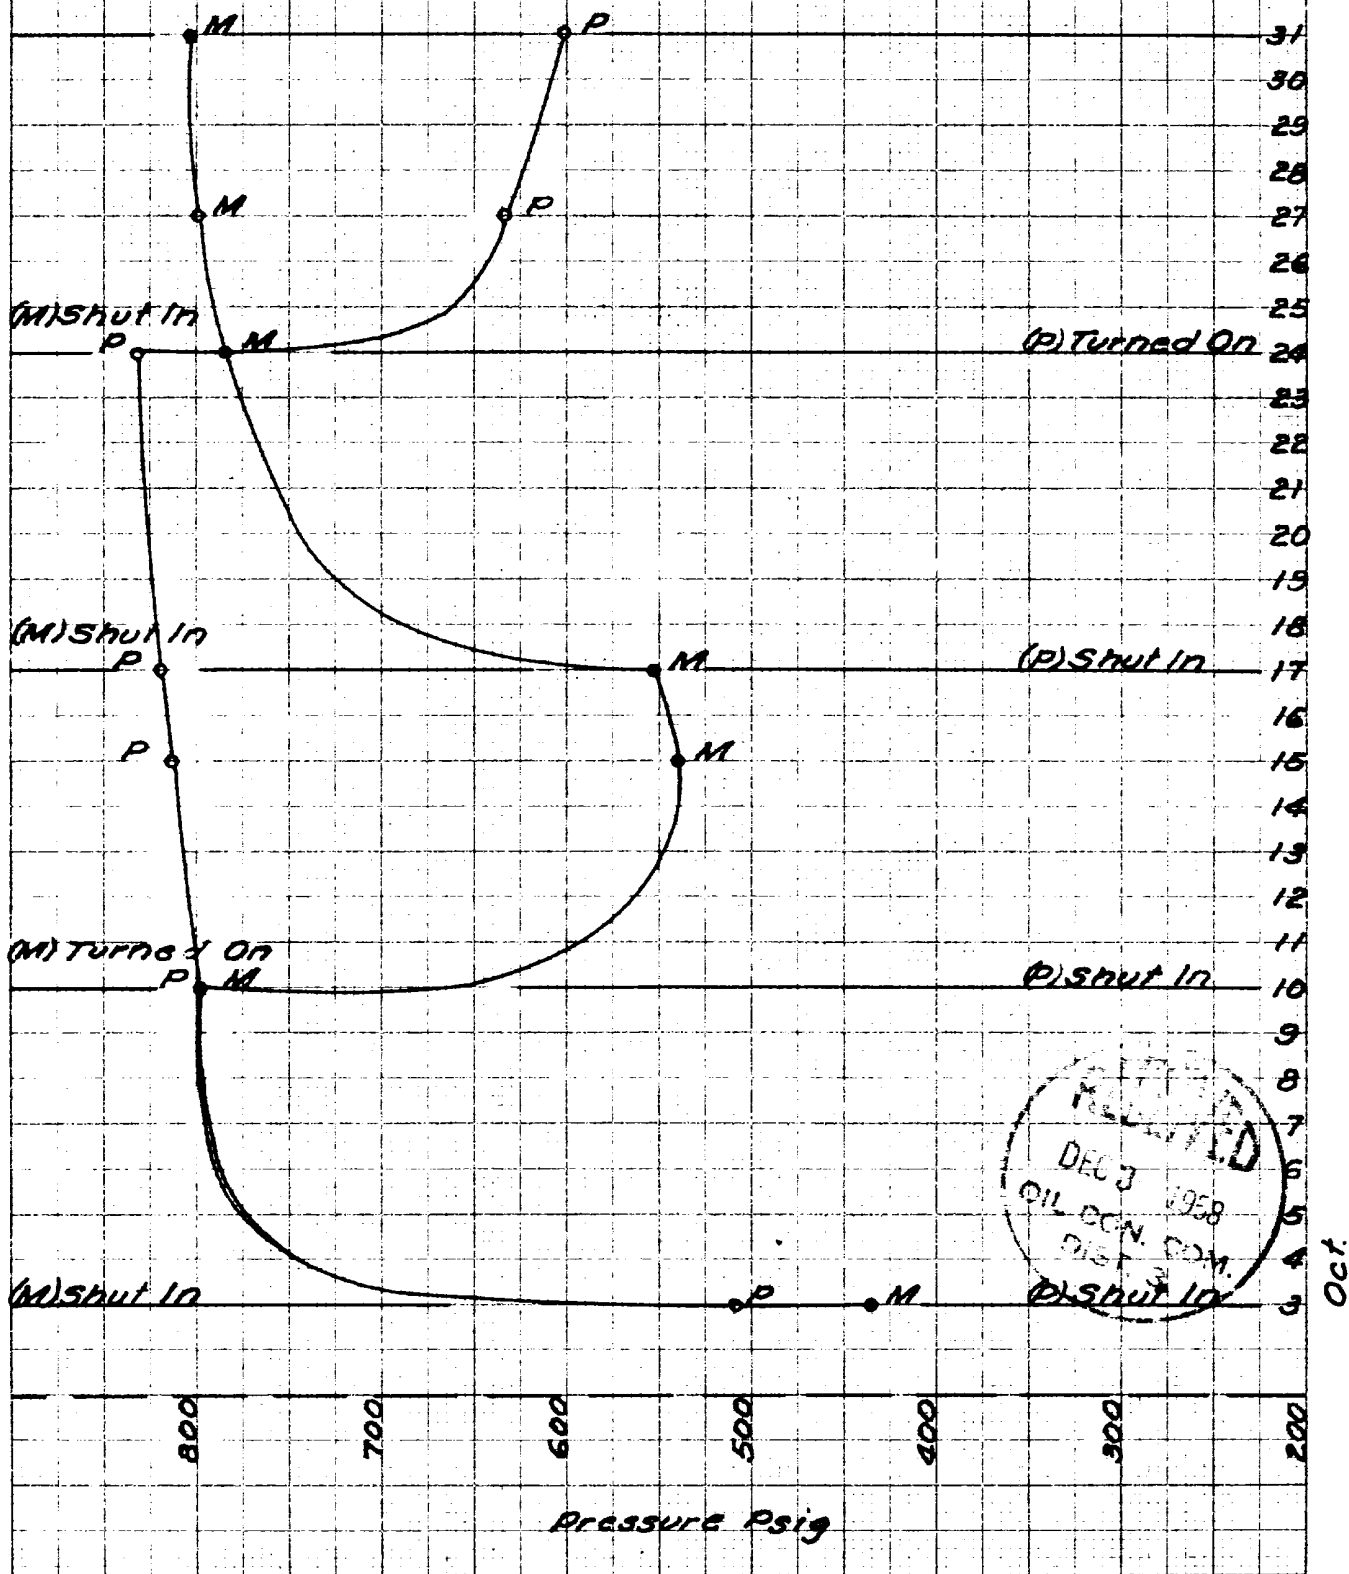
All pressures were taken with a dead weight gauge. A diagram is attached, showing pressures of each zone plotted against time.

The results of this test indicate

No Packer Leakage  
Packer Leakage

in this well.
