## PIT REMEDIATION AND CLOSURE REPORT

Operator: \_\_\_\_\_ Conoco, Inc. \_\_\_\_\_ Telephone: \_\_\_\_\_

Facility Or: \_\_\_\_\_ San Juan 28-7 #44 \_\_\_\_\_  
Well Name

Location: Unit or Qtr/Qtr Sec \_\_\_\_\_ A \_\_\_\_\_ Sec \_\_\_\_\_ 2 \_\_\_\_\_ T \_\_\_\_\_ 7N \_\_\_\_\_ R \_\_\_\_\_ 7W \_\_\_\_\_ County \_\_\_\_\_ Rio Arriba \_\_\_\_\_

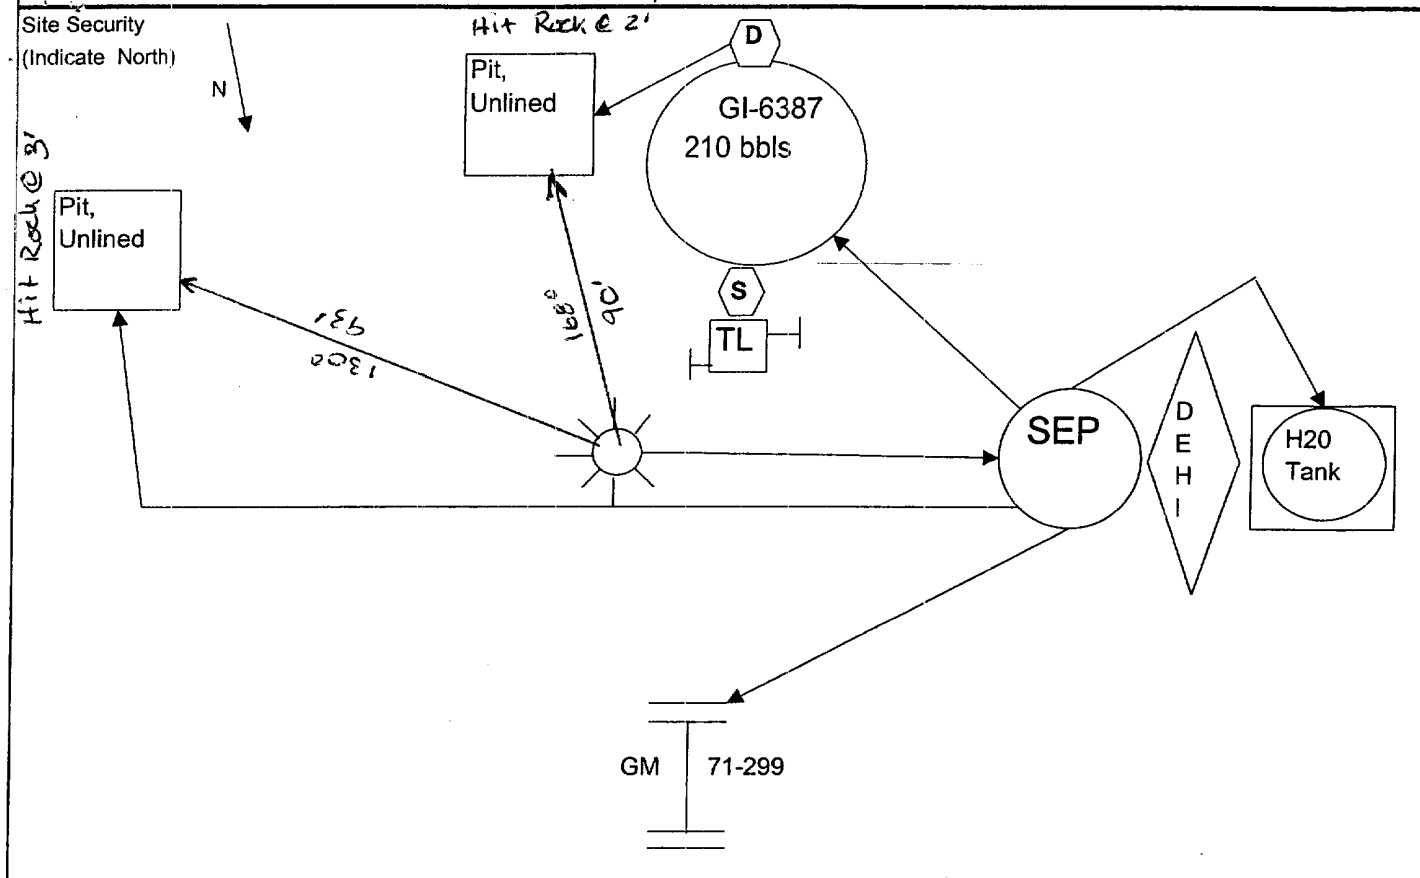
Lease Name: San Juan 28-7 #44 MV

Load line valves :  
Sealed during Production

Drain line valves :  
Sealed during Production

Production Line valve:  
Sealed during sales
