# San Juan 28-7 #196

South Blanco Pictured Cliffs

SE Section 10, T-27-N, R-7-W, Rio Arriba County, NM

## Proposed P&A

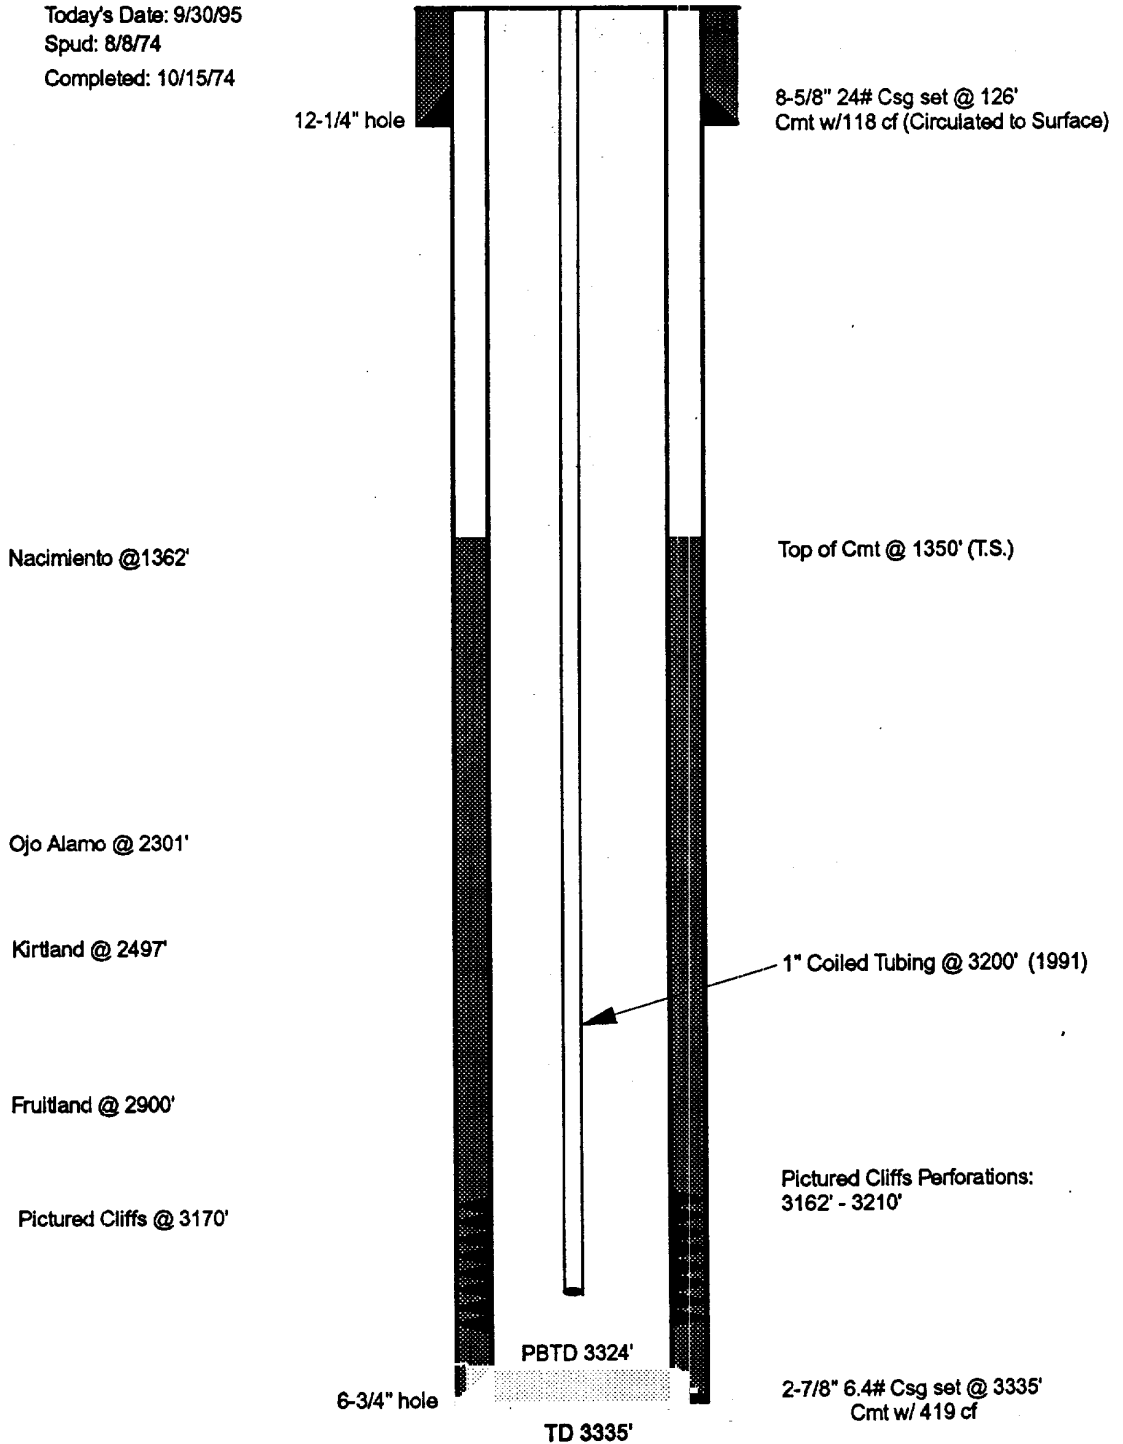
Current

Today's Date: 9/30/95

Spud: 8/8/74

Completed: 10/15/74
