## FIELD REPORT: CLOSURE VERIFICATION

PAGE No: 1 of 1STATION NAME: NICKSONWELL # 11PIT: NADATE STARTED: 3/25/99QUAD/UNIT: L SEC 11 TWP: 26N RNG: 8W PM: NM CNTY: ST NM

Comments: **Nickson #11 - Tank Bottom Location.**

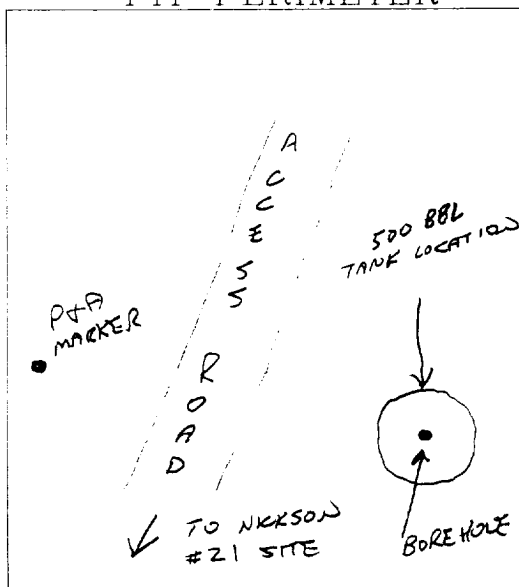
## PIT PROFILE

GRAVEL OBSERVED ON GROUND SURFACE WHERE TANK WAS LOCATED, SOIL CONSISTED OF DR. YELL. ORANGE SAND, NON COHESIVE, SLIGHTLY MOIST, FIAM, NO APPARENT DISCOLORATION OR HC ODOOR OBSERVED/DETECTED W/IN ENTIRE BORING, NO APPARENT HC ODOOR DETECTED W/IN OVM SAMPLE.

Tank Pad - for record  
not pit

CLOSED
