FIELD PIT SITE ASSESSMENT FORM

# FIELD PIT REMEDIATION/CLOSURE FORM

FIELD SERVICES LABORATORY  
ANALYTICAL REPORT

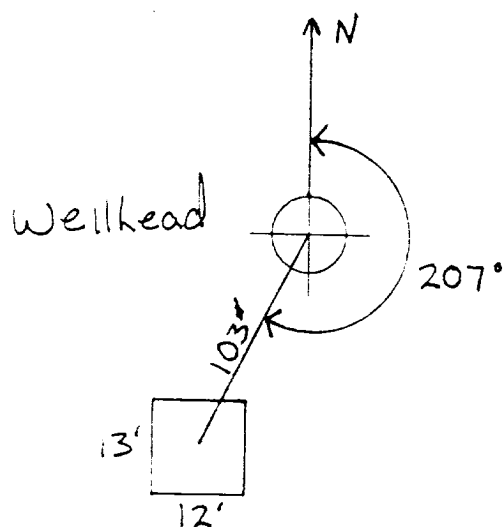
ORIGINAL PIT LOCATION

Original Pit : a) Degrees from North 207 Footage from Wellhead 103  
b) Length : 13 Width : 12 Depth : 3
