El Paso Natural Gas Company

San Juan 28-7 No. 91 (PM)

Pictured Cliffs and Mesa Verde

Dual Completion

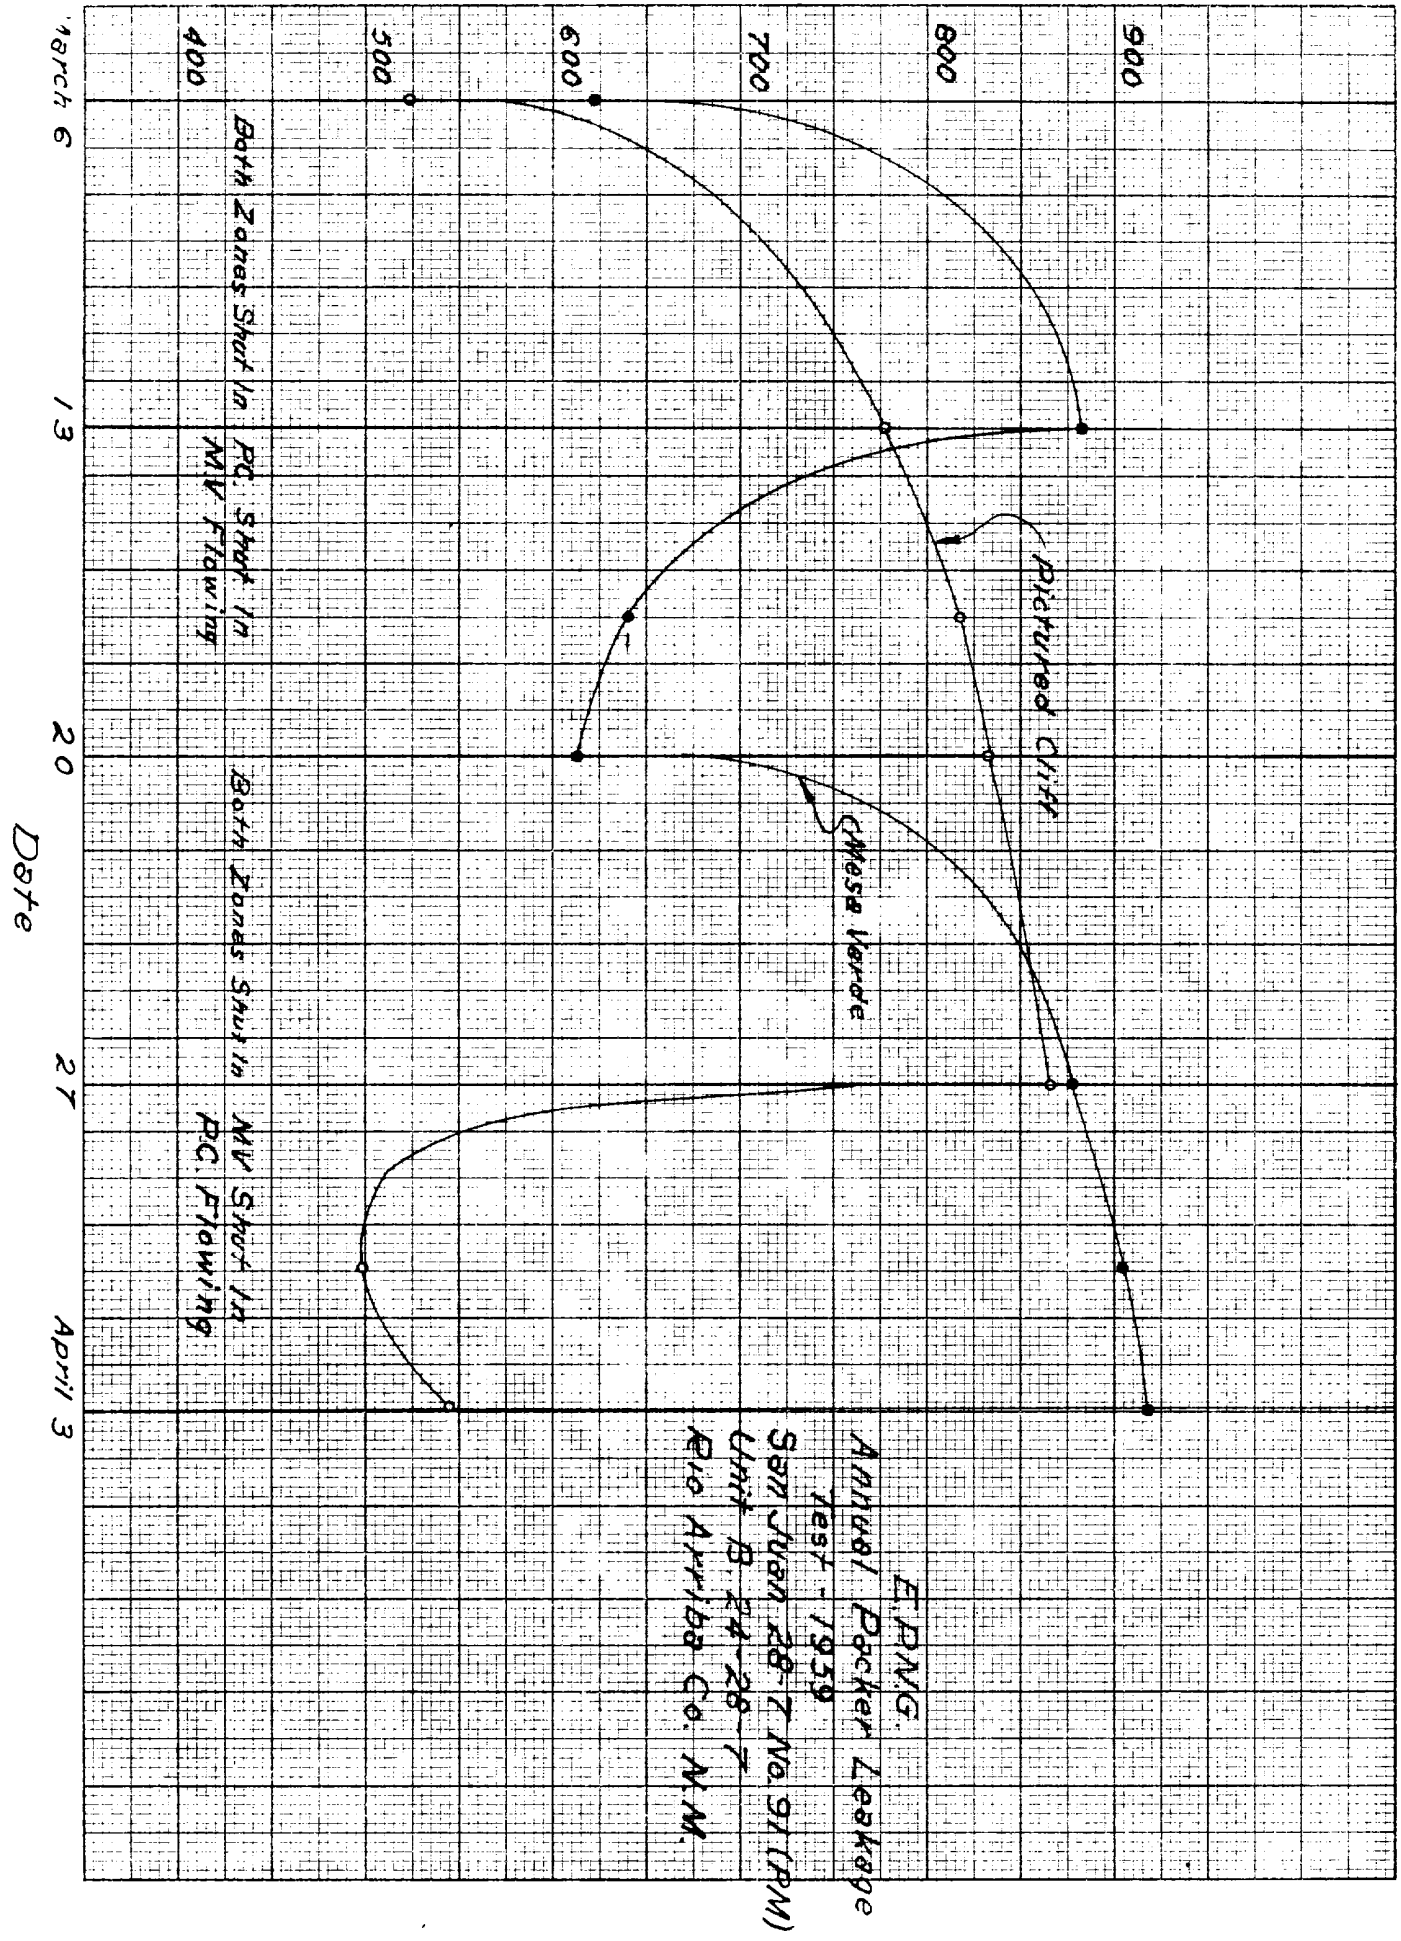
Pressure was plotted against time showing pressures of each zone plotted against time.

Pressure PSIG.
