EL PASO FIELD SERVICES

## FIELD PIT SITE ASSESSMENT FORM

Meter: 74885 Location: Huerfano unit No. 59-23  
 Operator #: 2999 Operator Name: Merran P/L District: Ballard  
 Coordinates: Letter: E Section 23 Township: 27 Range: 9W  
 Or Latitude \_\_\_\_\_ Longitude \_\_\_\_\_  
 Pit Type: Dehydrator \_\_\_\_\_ Location Drip: ☒ Line Drip: \_\_\_\_\_ Other: \_\_\_\_\_  
 Site Assessment Date: 6-15-94 Area: 11 Run: 71

# FIELD PIT REMEDIATION/CLOSURE FORM

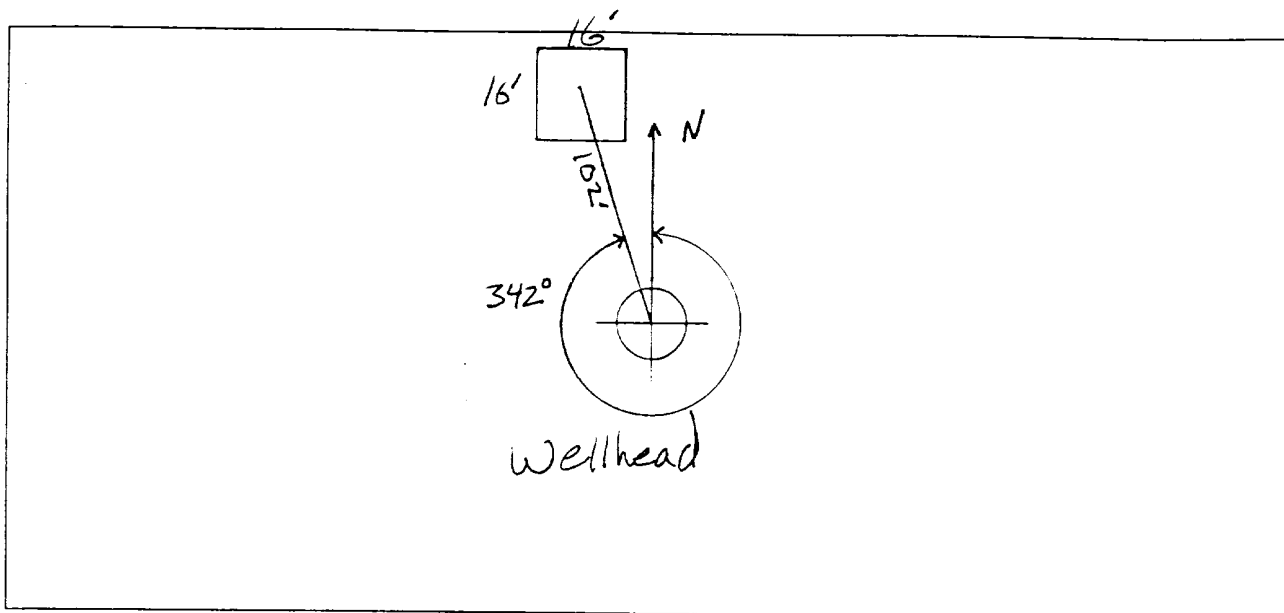
# ORIGINAL PIT LOCATION

Original Pit : a) Degrees from North 342 Footage from Wellhead 102  
 b) Length : 16 Width : 16 -Depth : 3
