PIT REMEDIATION AND CLOSURE REPORTOperator: Phillips Petroleum Company Telephone: (505) 599-3400Address: 5525 Hwy. 64, NBU 3004, Farmington, NM 87401Facility Or: San Juan 29-6 Unit #9  
Well NameLocation: Unit or Qtr/Qtr Sec SW SW Sec 36 T 29N R 6W County Rio ArribaPit Type: Separator ☒ Dehydrator ☐ Other Condensate TankLand Type: BLM ☐ State ☒ Fee ☐ Other ☐Pit Location: Pit dimensions: Length 25', width 25', depth 4'  
(Attach diagram) Reference: wellhead ☒ other ☐  
Footage from reference: 25  
Direction from reference: 0 Degrees ☒ East North ☐  
West South ☐Depth to Ground Water: 80'  
(vertical distance from  
contaminants to seasonal  
highwater elevation of  
ground water)  
☒ Less than 50 feet (20 points)  
☐ 50 ft to 99 feet (10 points)  
☐ Greater than 100 feet (0 points) 10Wellhead Protection Area:  
(less than 200 feet from a private  
domestic water source, or: less than  
1000 feet from all other water sources).

PHILLIPS PETROLEUM PIT ASSESSMENT SUMMARY  
REVISED DATE SEPTEMBER 09, 1993

# FIELD REPORT: SITE ASSESSMENT

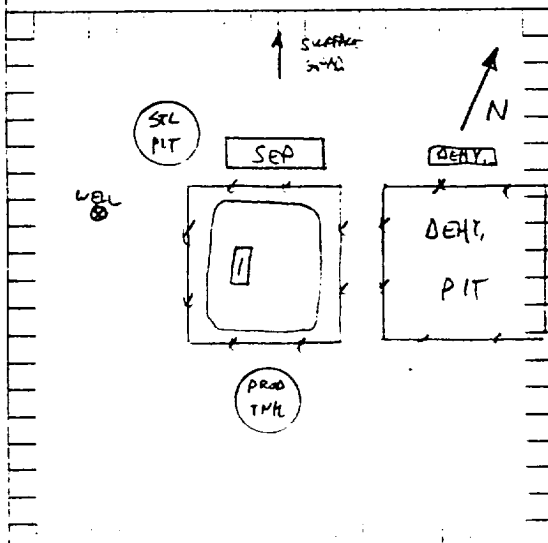
# SITE DIAGRAM

SURFACE CONDITIONS: EARTHEN PIT - NO STAINING

FIELD NOTES & REMARKS: PIT IS LOCATED APPROXIMATELY 25 FEET EAST OF WELLHEAD.

T1: Brown, moist, organic silty clay, med. plastic.

NO ODOR OR STAIN.

PIT IS APPROX 25' x 25'
