Location Name:SAN JUAN 29-6 #14-7

**RATIONALE FOR RISK-BASED CLOSURE OF PRODUCTION PITS
LOCATED OUTSIDE OF THE VULNERABLE ZONE
IN THE SAN JUAN BASIN**

FIELD PIT SITE ASSESSMENT FORM

FIELD PIT REMEDIATION/CLOSURE FORM

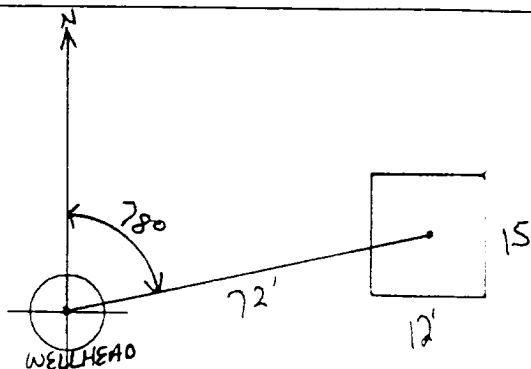
ORIGINAL PIT LOCATION

REMARKS	<p>Remarks : <u>ONLY PIT ON LOCATION. PIT IS DRY. PIT HAS TANK NEXT TO IT.</u></p> <p><u>LOCATION IS ON TOP OF SMITH PASS. REDLINE AND TOPO CONFIRMED LOCATION</u></p> <p><u>IS OUTSIDE V.2.</u></p>

Original Pit : a) Degrees from North 78° Footage from Wellhead 72'
b) Length : 15' Width : 12' Depth : 2'
