PIT REMEDIATION AND CLOSURE REPORT

Facility Or: San Juan 29-6 Unit #104

Location: Unit or Qtr/Qtr Sec SE SW N sec 14 T 29N R 6W County Rio Arriba

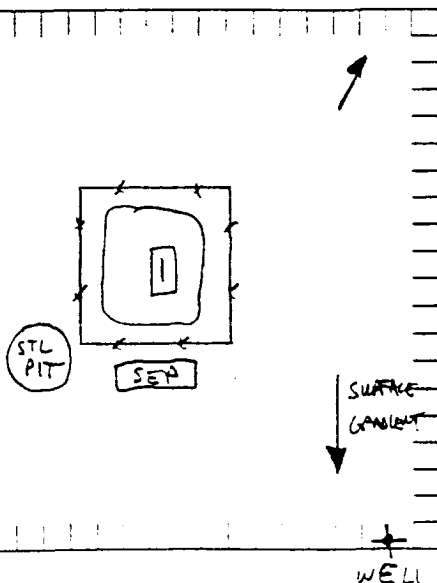
# SITE DIAGRAM

Initial assessment of pit showed soils to be clean  
at the surface and at three feet below pit bottom.

FIELD NOTES & REMARKS: PIT IS LOCATED APPROXIMATELY 60 FEET WEST OF WELLHEAD.  
CLOSURE STD: 1000 PPM TPH T1: MOIST, BROWN, SILTY CLAY - NO OOR,  
RANKING SCORE: 10
