**RATIONALE FOR RISK-BASED CLOSURE OF PRODUCTION PITS  
LOCATED OUTSIDE OF THE VULNERABLE ZONE  
IN THE SAN JUAN BASIN**

# FIELD PIT SITE ASSESSMENT FORM

Meter: 90304 Location: Hardie LS 3A  
 Operator #: 0203 Operator Name: AMCO P/L District: Blanco  
 Coordinates: Letter: I Section 25 Township: 29N Range: 8W  
 Or Latitude \_\_\_\_\_ Longitude \_\_\_\_\_  
 Pit Type: Dehydrator ☒ Location Drip: \_\_\_\_\_ Line Drip: \_\_\_\_\_ Other: \_\_\_\_\_  
 Site Assessment Date: 6-7-94 Area: 03 Run: 43

# FIELD PIT REMEDIATION/CLOSURE FORM

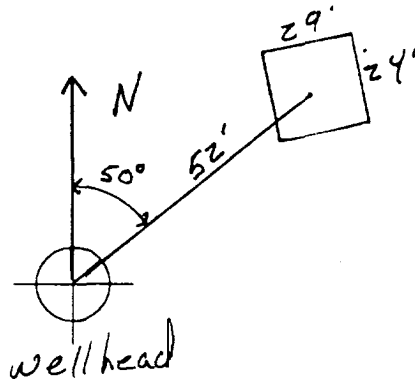
ORIGINAL PIT LOCATION

Original Pit : a) Degrees from North 50 Footage from Wellhead 52  
 b) Length : 29 Width : 24 Depth : 5
