P.O. Box 2088  
Santa Fe, New Mexico 87504-2088SUBMIT 1 COPY TO  
APPROPRIATE  
DISTRICT OFFICE  
AND 1 COPY TO  
SANTA FE OFFICEPIT REMEDIATION AND CLOSURE REPORT

Facility Or: FLORANCE #30  
Well Name

## FIELD REPORT: CLOSURE VERIFICATION

PAGE NO: 1 of 1LOCATION: NAME: FLORANCEWELL #: 30 PIT: ABD. FLAREQUAD/UNIT M SEC: 1 TWP: 29N RNG: 8W PM: NM CNTY: SJ ST: NMDATE STARTED: 8-28-00DATE FINISHED: 9-1-00QTR/FOOTAGE: SW/4 SW/4 <sup>870' 5'</sup> <sub>830' 5'</sub> CONTRACTOR: FLINTENVIRONMENTAL SPECIALIST: BLAGG

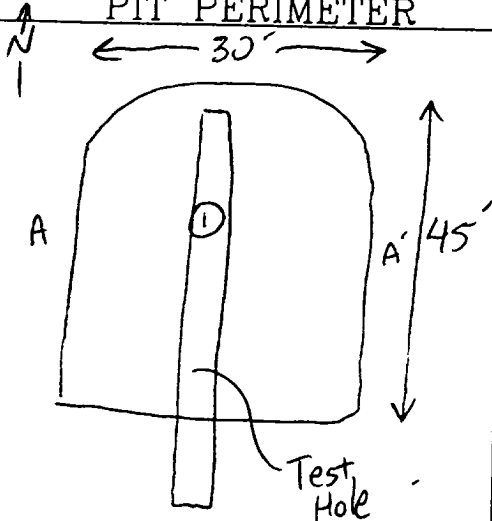
## PIT PERIMETER

~~PIT~~  
EXCAVATION APPROX. 45' FT. x 30' FT. x 8' FT. DEEP. CUBIC YARDAGE: 0  
DISPOSAL FACILITY: N/A <sup>ON-SITE</sup> REMEDIATION METHOD: N/A <sup>CLOSE AS IS</sup>  
LAND USE: RANGE LEASE: SF 078596-A FORMATION: OK/MU

PIT LOCATED APPROXIMATELY 132 FT. N10°W FROM WELLHEADDEPTH TO GROUNDWATER: >100 NEAREST WATER SOURCE: >1000 NEAREST SURFACE WATER: >1000NMDCD RANKING SCORE: 0 NMDCD TPH CLOSURE STD: 5000 PPM

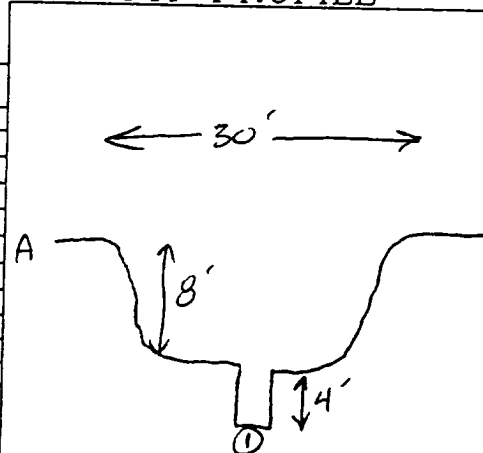
## PIT PROFILE

PIT LOCATED IN SAND/SILT CLAY MIX, yellow orange, moist, Non Cohesive.  
No HC ODOR or staining in PIT. Thin layer, 2", of Cement on PIT Surface.

Test hole dug to 4' Below PIT Base w/ Backhoe. - SAME LITHOLOGY,  
No HC ODOR or staining.

CLOSED

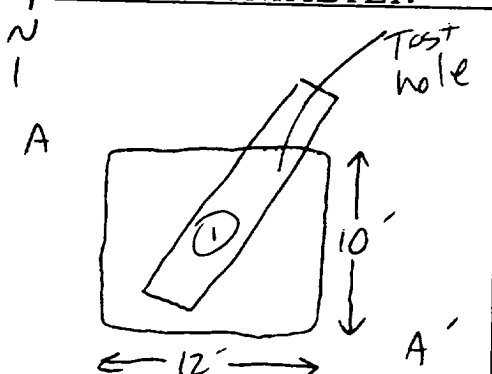
PIT PERIMETER

PAGE No: 1 of 1LOCATION: NAME: FLORANCE WELL #: 30 PIT: ABD. TANK.QUAD/UNIT: M SEC: 1 TWP: 29N RNG: 8W PM: NM CNTY ST: NMQTR/FOOTAGE: SW 1/4 SW 1/4 CONTRACTOR: FLINTDATE STARTED 8-28-00DATE FINISHED 9-1-00ENVIRONMENTAL SPECIALIST: BLAGGPIT EXCAVATION APPROX. 12 FT. x 10 FT. x 3 FT. DEEP. CUBIC YARDAGE 0  
DISPOSAL FACILITY: ATA ON-SITE REMEDIATION METHOD: ATA CLOSE AS IS  
LAND USE: RANGE LEASE: SF 078596 A FORMATION: OR/MVFIELD NOTES & REMARKS: PIT LOCATED APPROXIMATELY 110 FT. S 12° E FROM WELL-HEAD  
DEPTH TO GROUNDWATER: >100 NEAREST WATER SOURCE: >1000 NEAREST SURFACE WATER: >1000NMOC RANKING SCORE: 0 NMOC TPH CLOSURE STD: 5000 PPM

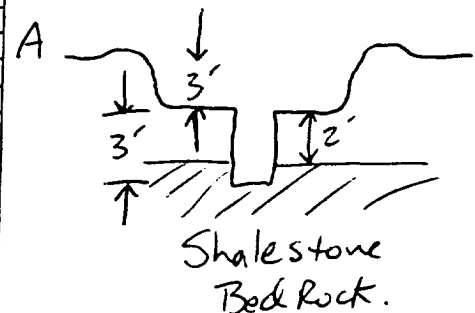
## PIT PROFILE

☒ PIT ABANDONED☐ STEEL TANK INSTALLED☐ FIBERGLASS TANK INSTALLEDPIT LOCATED IN SAND/SILT/CLAY MIX, yellow orange, Dry, Non Cohesive.  
No HC ODOOR OR STAIN.DUG Test Pit with Backhoe in Base of Pit. Found Shalestone  
Bedrock @ 2' Below Pit Bottom. No HC ODOOR OR STAIN  
in Test hole.BEDROCK  
BOTTOM

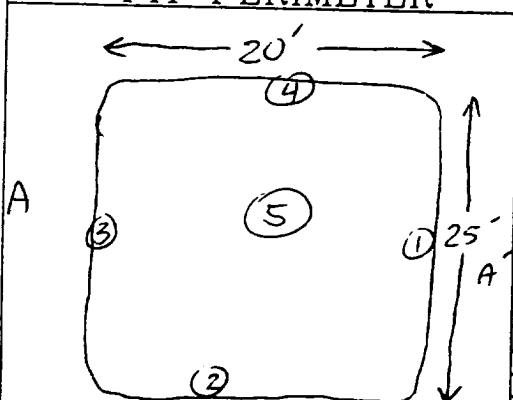
## PIT PERIMETER

PAGE No: 1 of 1LOCATION: NAME: FLORANCE WELL #: 30 PIT: ABD SEP  
QUAD/UNIT: M SEC: 1 TWP: 29N RNG: 8W PM: NM CNTY: SJ ST: NM  
QTR/FOOTAGE: SW/4 SW/4 CONTRACTOR: FLINTDATE STARTED: 8-28-00  
DATE FINISHED: 9-1-00ENVIRONMENTAL  
SPECIALIST: BLAGGEXCAVATION APPROX. 25 FT. x 20 FT. x 11 FT. DEEP. CUBIC YARDAGE: 175  
DISPOSAL FACILITY: NYE GC B/E (E7-79-9) REMEDIATION METHOD: LF/COMPOST  
LAND USE: RANGE LEASE: SF 07596A FORMATION: OR/LNVFIELD NOTES & REMARKS: PIT LOCATED APPROXIMATELY 95 FT. S57°E FROM WELL HEAD  
DEPTH TO GROUNDWATER: >100 NEAREST WATER SOURCE: >1000 NEAREST SURFACE WATER: >1000NMCD RANKING SCORE: 0 NMCD TPH CLOSURE STD: 5000 PPM

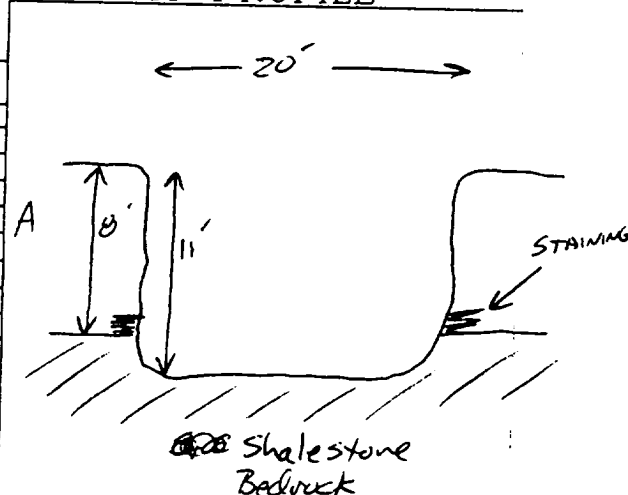
## PIT PROFILE

SAND/SILT/CLAY MIX FROM 0'-8'. ORANGE-YELLOW, Dry to moist, cohesive.  
NO HC ODOR OR STAIN 0'-7'. MINOR STAIN FROM 8'-9'.  
FROM 9'-11', Shalestone Bedrock, MINOR HC ODOR & STAIN.

| SAMPLE I.D. | FIELD HEADSPACE PID (ppm) |
| 1 @ 8' | 104 |
| 2 @ 9' | 255 |
| 3 @ 10' | 177 |
| 4 @ 11' | 28 |
| 5 @ 11' | 169 |

CLOSED
