Meter Number: 94676 Location Name: HUGHES A #1E Location:TN-29 RG-08

RATIONALE FOR RISK-BASED CLOSURE OF PRODUCTION PITS LOCATED OUTSIDE OF THE VULNERABLE ZONE IN THE SAN JUAN BASIN

FIELD PIT SITE ASSESSMENT FORM

FIELD PIT REMEDIATION/CLOSURE FORM

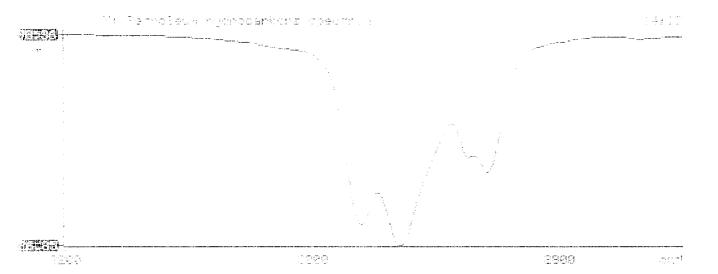
> Perkin-Elmer Model 1600 FT-IR Analysis Report

Petroleum hydrocarbons, ppm 180-879

Med absorbanca of hydrocarbons (29%) ca-11. TSR
