**RATIONALE FOR RISK-BASED CLOSURE OF PRODUCTION PITS  
LOCATED OUTSIDE OF THE VULNERABLE ZONE  
IN THE SAN JUAN BASIN**

FIELD PIT SITE ASSESSMENT FORM

## FIELD PIT REMEDIATION/CLOSURE FORM

**FIELD SERVICES LABORATORY  
ANALYTICAL REPORT  
PIT CLOSURE PROJECT - Soil**

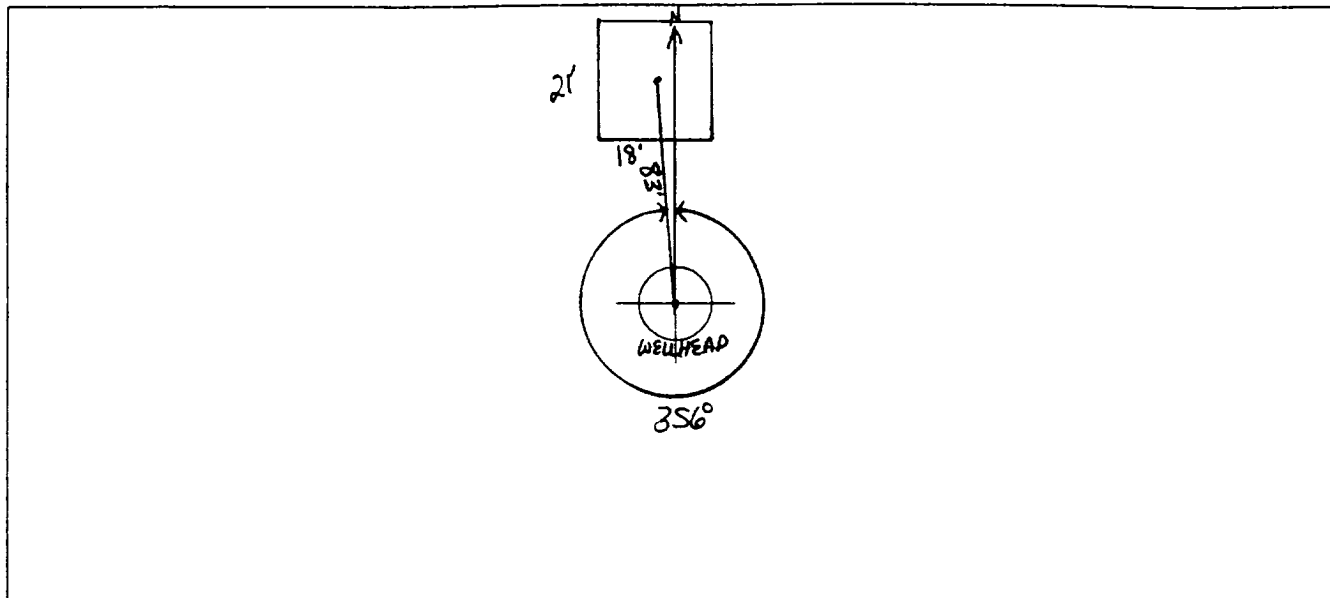
ORIGINAL PIT LOCATION

Original Pit : a) Degrees from North 356° Footage from Wellhead 83'  
b) Length : 21' Width : 18' Depth : 2'

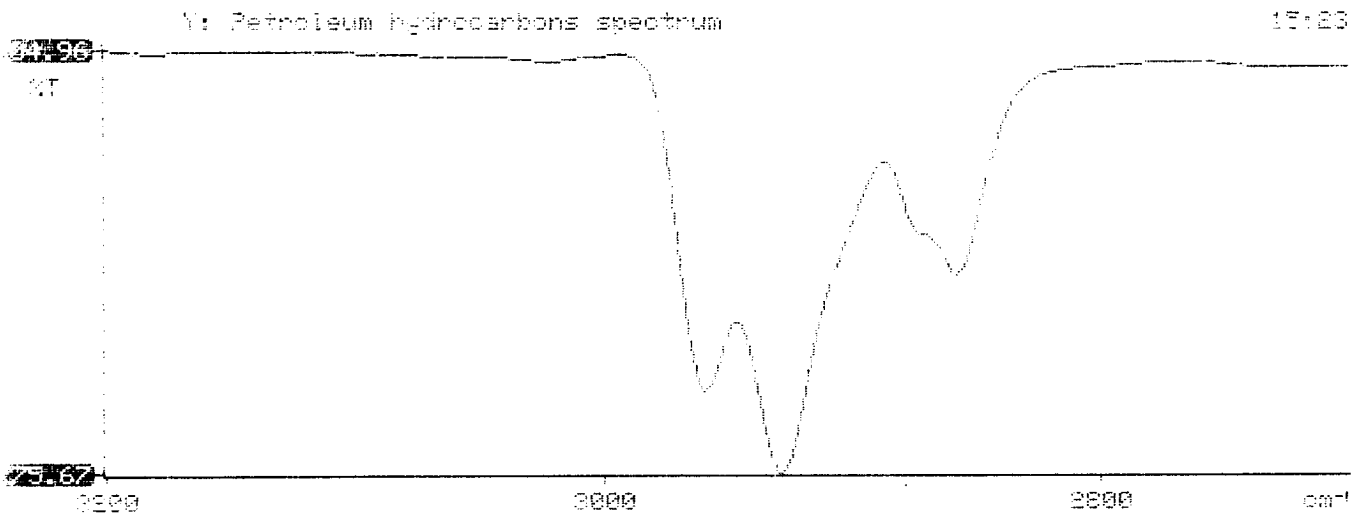
\*\*\*\*\*  
Test Method for  
Oil and Grease and Petroleum Hydrocarbons  
in Water and Soil  
Perkin-Elmer Model 1600 FT-IR  
Analysis Report  
\*\*\*\*\*

Petroleum hydrocarbons, ppm  
092.226

Net absorbance of hydrocarbons (2930 cm<sup>-1</sup>)  
1.137
