# PIT REMEDIATION AND CLOSURE REPORT

**Facility Or:** San Juan 32-8 Unit #30

ENVIROTECH, INC.

# SITE DIAGRAM

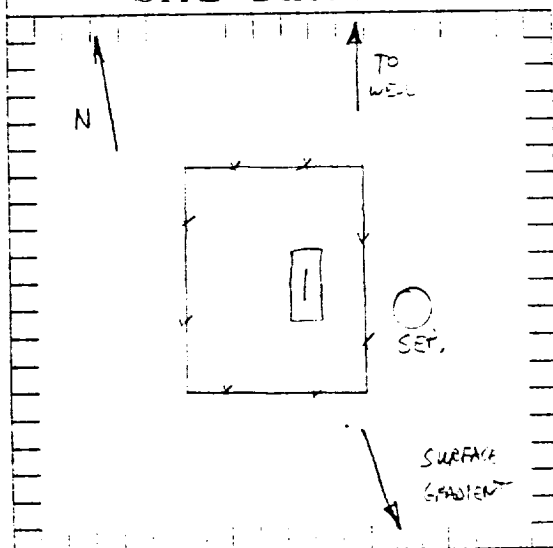
FIELD NOTES & REMARKS: PIT IS LOCATED APPROXIMATELY 85 FEET S.30°W. OF WELLHEAD.  
CLOSURE STD: — WELL CLOSED-IN IN 1985.

T1: MOIST, BROWN, SAND, NO CLAY.  
SILT

15' x 19'
