Finley & Johansen      Nore #1  
C - 22.29N-11W

COUNTY San Juan STATE NEW MEXICO  
SEC. 22 T. 29N R. 11W  
ELD OR AREA LOCATION 175'/N. 1570'/W  
CASE Hare WELL NO. 1  
COMPANY Finley & Johansen SPD. 7-25-34 COMPLETED 2-14-35  
LEV. 5480' T. D. 722' P. B.  
SING 10" @ 87' 8" @ 390' 6" @ 624'  
BT OR ACID  
F.  
P.  
PRODUCING FORM.  
PRODUCTIVE DEPTH OR INTERVAL

30-045-08166

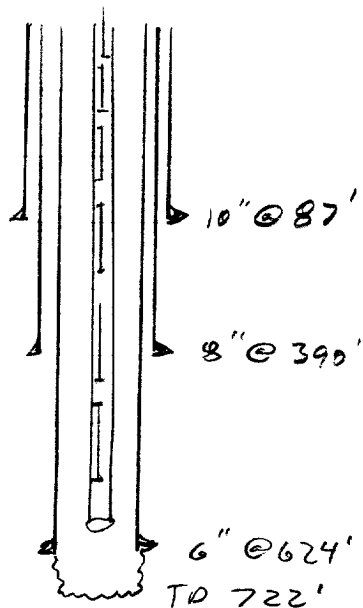
This photograph was taken by Mr. Charles  
Johnson, Oil Conservation Division Field Representative,  
on April 4, 1978. This well is located in an  
abandoned refinery yard in Bloomfield.

1. Open lines are potential sources of pollution.
2. Within 100 feet of residences.
3. Threat of pollution to other strata

2" tbg. @ unknown depth  
rods in tbg. @ surface

Notified Don Ferguson of Plateau, Inc.  
by phone 5-23-78.
