Release Notification and Corrective Action

Name of Company	Mark L. Shilder, Inc.	Contact	G. B. Gregson
Address	1313 Campbell Rd., Bldg. D, Houston, Texas 77055	Telephone No.	(713) 481-6487
Facility Name:	State 1-30	Facility Type	Tank Battery and Wellhead
Surface Owner:	Phillip Frier	Mineral Owner:	State of New Mexico
		API No.:	30-025-08441

MARK L. SHIDLER, INC.
NM State No. 1-30
Lea Co., NM

Dec. 8, 2014 Release Area (Around Wellhead)

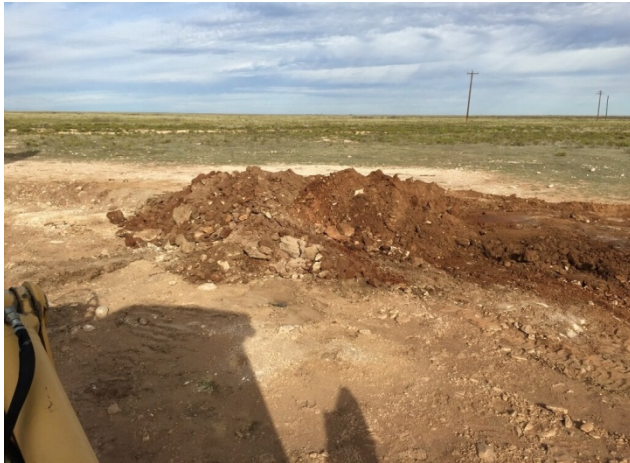
Northside

Further delineation of oil saturated soils north and south of Wellhead
occurring on Oct. 28 and 29, 2015

Describe Area Affected and Cleanup Action Taken.* Approx. 25-acres of ranch land affected by wet gas release. 0.33 acre area outside firewall and a 0.20 acre area surrounding the wellhead were affected by crude oil. Both release sites were initially delineated using onsite visual reconnaissance and soil sample collection by an independent environmental contractor, Viper Products & Services. Soil sample analysis was conducted by Cardinal Labs. Those lands outside the immediate release areas 25-acres, +/-, operator coordinated with the landowner and took corrective action promote growth on native grasses on nearby pasture land (conducted & completed w/landowner's satisfaction). Jan. 2015 contaminated soils were removed by Liberty Maintenance Services to an authorized land farm, Gandy Marley, Inc. and replaced with caliche and top soil. Acquired/installed replacement separation vessels. Additional soil samples collection and analysis was conducted and further soil removal was undertaken, replacement with caliche and top soil followed. Remediation completed in Dec. 2105. Periodic reports were provided to Messrs. Oberding and Keyes.
