Phillips Lea North & South Battery

(Phillips Lea #002)

CLOSURE REQUEST

NMOCD Case #: 1R-4075

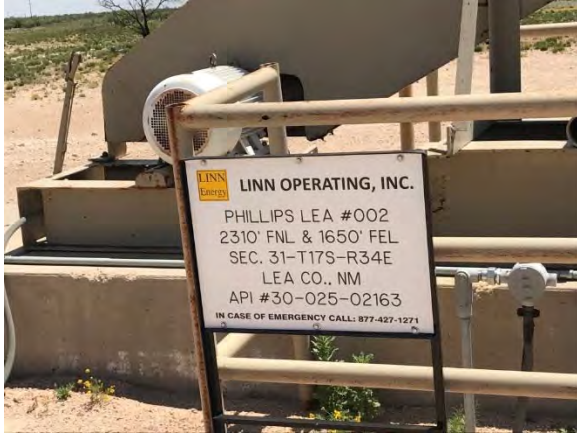
Current photo documentation 5/8/2017

The impacted soils were excavated to a depth of 1' bgs and properly disposed of at an approved facility. The excavation was backfilled with clean, imported caliche to ground surface and contoured to the surrounding area. Current site photo documentation is provided (Appendix II). Additional remediation will occur at time of site abandonment.

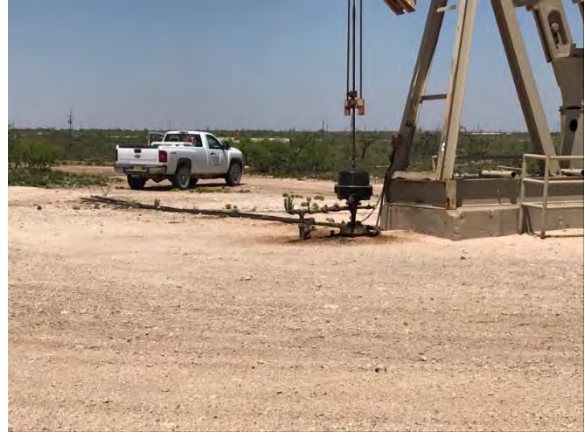
Current photo documentation 5/8/2017

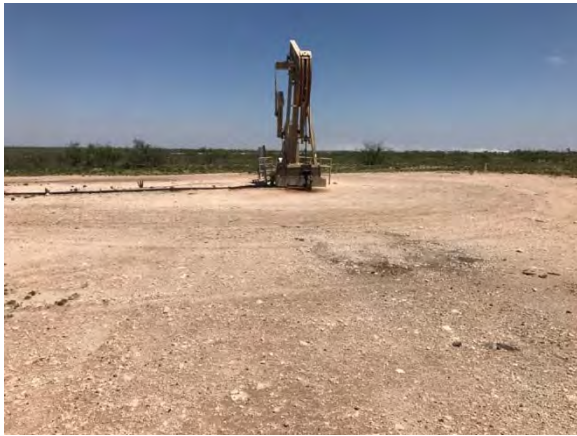
Current photo documentation 5/8/2017

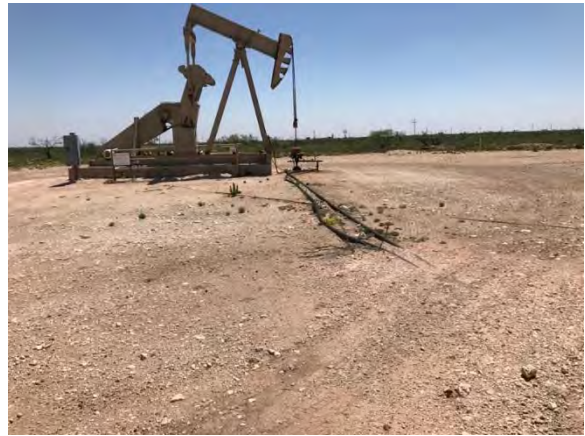
Current photo documentation 5/8/2017
