**RE: 1RP-4867 - Submittal of Proposed WorkPlan for Soil Delineation at the Trionyx Frac Pond T-25-S, R-31-E, Eddy County, New Mexico**

TETRA Technologies Inc. (TETRA), a contractor to Devon Energy Production Co, LP (6137) (Devon) wishes to submit this Proposed Delineation Workplan (Workplan) to the New Mexico Oil Conservation Division (NMOCD) to address the release at the Trionyx Frac Pond on October 24, 2017. The purpose of this Workplan is to describe proposed methodologies and activities to carry out the delineation to assess the horizontal and vertical extent of impact to soils at the release site. The legal description of the Release Site is Unit Letter "P", Section 2, Township 25 South, Range 31 East, in Eddy County, New Mexico. The site location is shown in Figure 1.

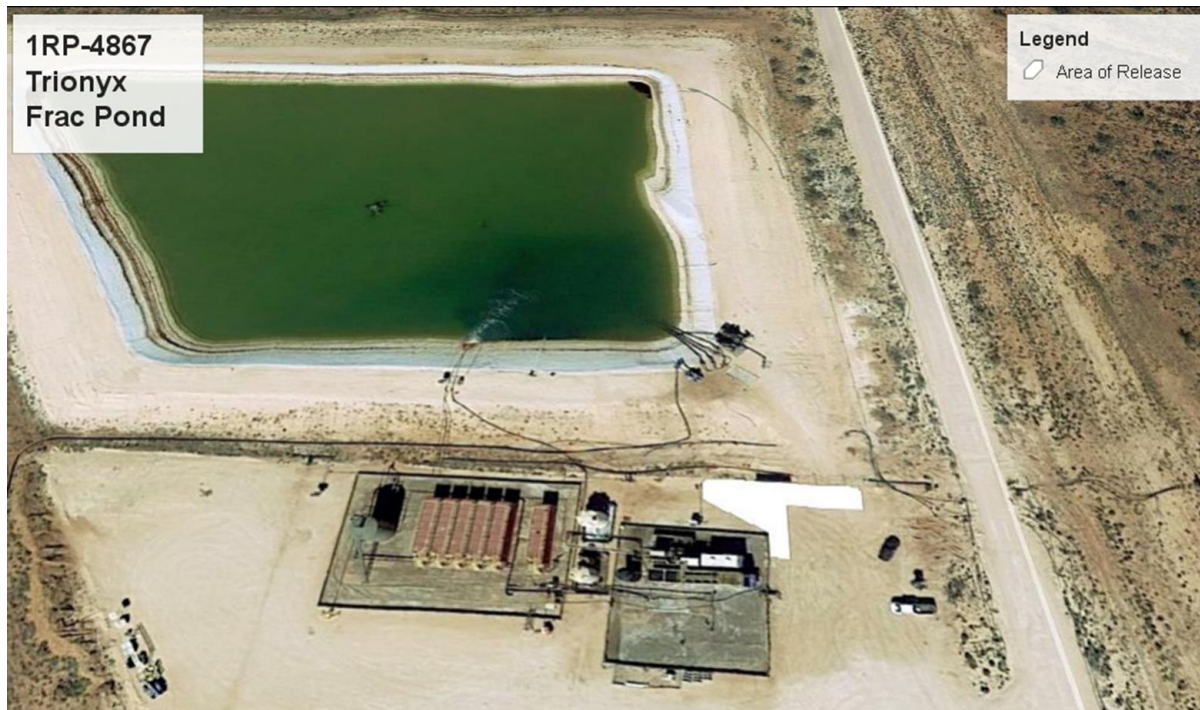
Figure 2: Area of Release at Trionyx Frac Pond – 50 bbls with 40 bbls recovered.

On October 24, 2017 at 2:14 PM MST, TETRA, under contract to Devon was pigging a line from the Arabian 30-19 Fed Com 1H to the Trionyx pond. TETRA had completed the line from the location to the booster pump. After rigging up to pig from the booster pump to the Trionyx pond, air in the line caused the line to come out of the pond and fluid was released to the ground. TETRA then shut down operations and notified Devon. Approximately 50bbls of produced water ran off the side of the pond onto the Trionyx facility. A vacuum truck was dispatched and recovered 40 bbls of treated produced water. The release affected approximately 25,000 square feet running south from the release point. The location of the release area is shown in Figure 2.
