## Release Notification and Corrective Action

Name of Company Marathon Oil Permian LLC	Contact Callie Karrigan
Address 5555 San Felipe Street, Houston, Texas 77056	Telephone No. 405-202-1028 (cell) 575-297-0956 (office)
Facility Name: Angell B No. 2	Facility Type Oil and gas production facilities

**1RP-5142**

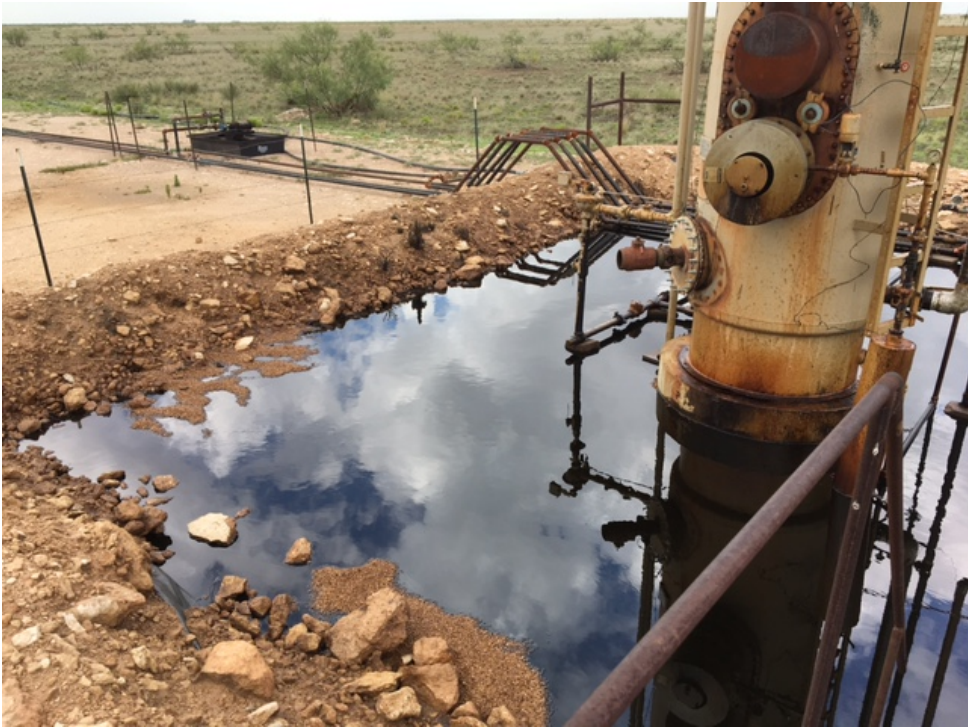
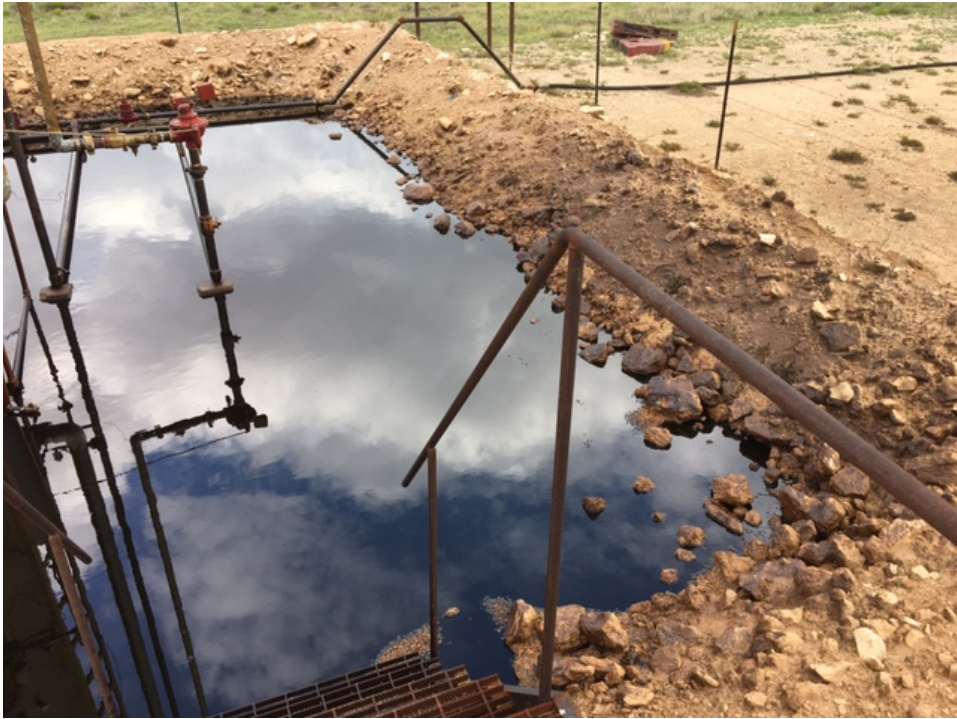
At 9:00 am, Operator reported standing fluids in containment due to a fire tube leak. The release was contained in lined containment, affecting a 30x30 ft area.

Standing fluids were recovered via vac truck. Caliche and rock material were removed from containment for disposal. Liner will be assessed for integrity.

Title: HES Professional	Approval Date: <b>8/2/2018</b>	Expiration Date:
E-mail Address: cnkarrigan@marathonoil.com	Conditions of Approval:	Attached <input type="checkbox"/>
Date: 07/26/18 Phone: 405-02-1028(cell) 575-297-0956 (office)	Please inspect liner in question. Provide NMOCD with a concise report of the inspection with affirmation the liner has and will continue to contain liquids.
