Re: Form C-147 with accompanying documentation
Hearns Reuse Water Facility and Containment Pit

Recycling Facility and/or Recycling Containment

Hearns Reuse Water Recycling Facility and Containment Pit

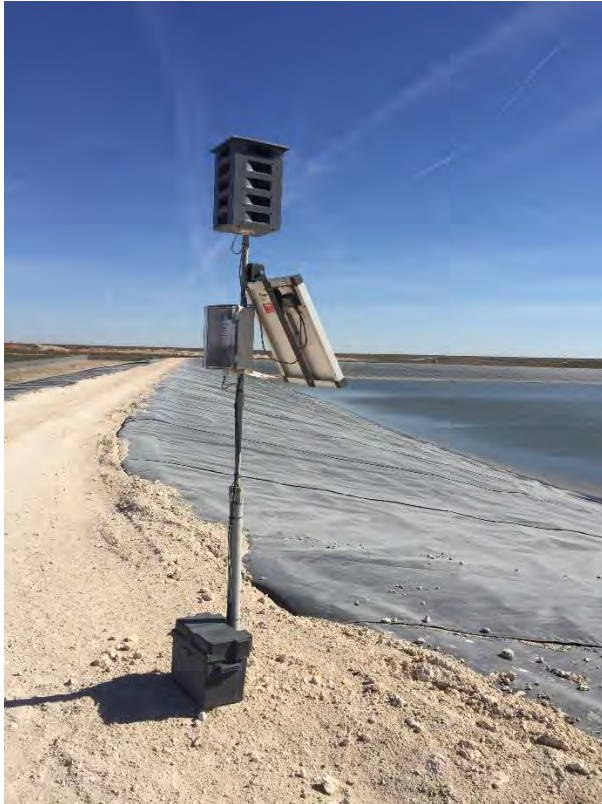
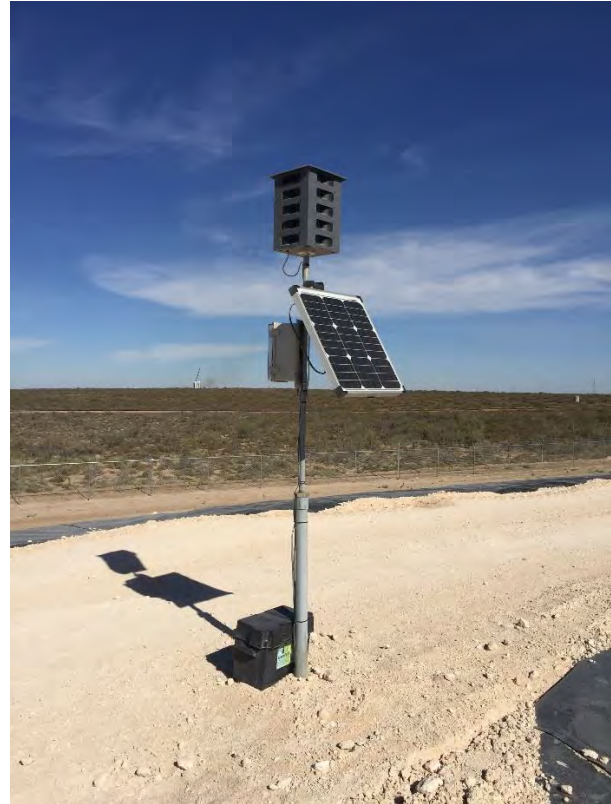
This is the typical configuration EOG Resources is currently utilizing at the Southern Red Hills Water Recycling Facility and Containment Pit.

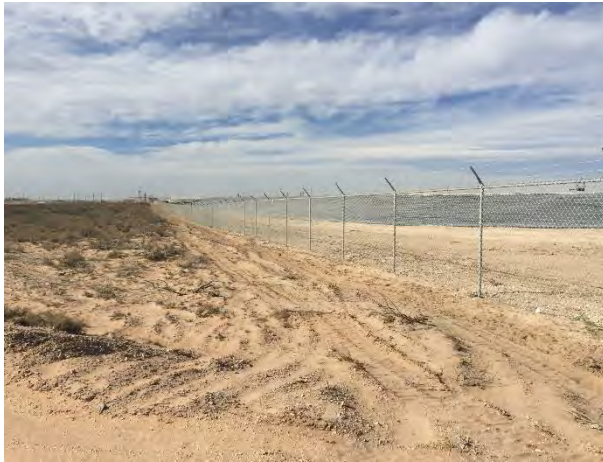
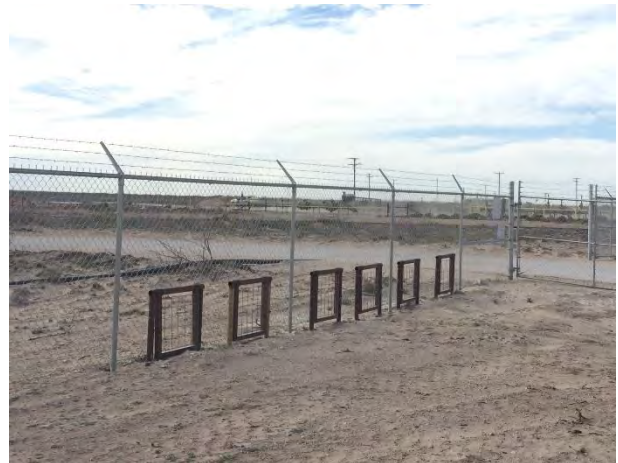
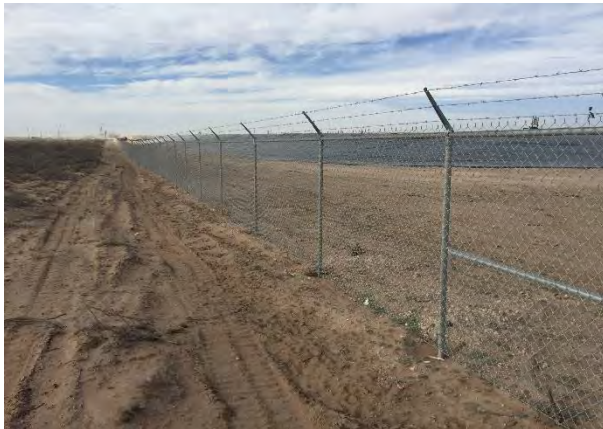
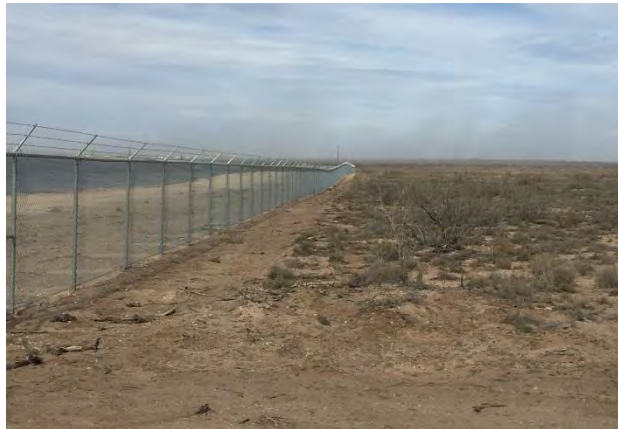
Variance Request for Fencing

This is the typical configuration EOG Resources is currently utilizing at the Southern Red Hills Water Recycling Facility and Containment Pit.

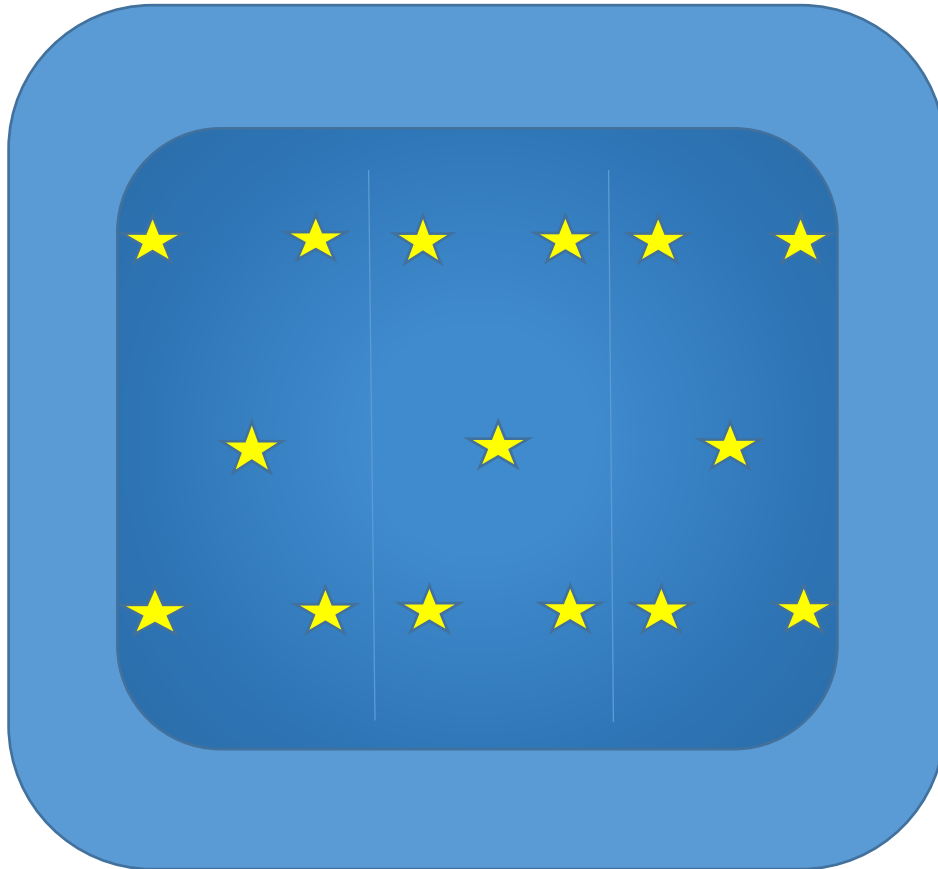
- Sampling Diagram

- If all sample concentrations are less than or equal to the parameters listed in Table 1 in 19.15.34.14 NMAC, then closure can proceed, backfilling with non-waste containing, uncontaminated, earthen material
