## **Casing Assumptions and Load Cases**

DEVON ENERGY PRODUCTION COMPANY, L.P. GAUCHO 21 FED 5H

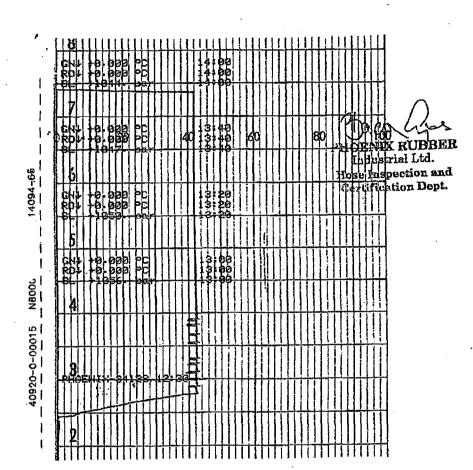
QUAI INSPECTION	LITY CONTR I AND TEST		\TE		CERT. N	lo:	552	
PURCHASER:	Phoenix Bear	tie Co.			P.O. Nº	1519	FA-871	
PHOENIX RUBBER order N°	170466	HOSE TYPE:	3"	ID	Cho	ke and Kill	Hose	
HOSE SERIAL Nº	34128	NOMINAL / AC	TUAL LE	NGTH:		11,43 m		
W.P. 68,96 MPa	10000 psi	T.P. 103,4	MPa	1500	) psi	Duration:	60	min.
Pressure test with water at ambient temperature			*.

•	See att	achment. (1	page)					3.18
			age opposite the second		·			A. B. S. A.
↑ 10 mm = 10 Min → 10 mm = 25 MP				•				_ ಬಳಕ್ಕಾ .ಮ
Туре	·	COUPLIN	ves		Ouelite		11410	
3" coupling with	72	Serial N° 		-	Quality SI 4130		Heat N° C7626	
4 1/16" Flange end	l l			•	SI 4130		47357	
					:			
All metal parts are flawless			API Sp Tempe		C e rate:"E	3"	· • • • • • • • • • • • • • • • • • • •	
WE CERTIFY THAT THE ABOV PRESSURE TESTED AS ABOVE	E HOSE HAS BEEN WITH SATISFACT	I MANUFACTURE ORY RESULT.	ED IN ACC	ORDAN	ICE WITH	THE TERMS C	F THE ORDE	R AND
Date:	Inspector	·	Quality	y Contro
