**C-144 Permit Package
Cotton Draw Grizzly 3 10 FED & 34 27 FED, Temporary
Pit
Section 3 of T25S, R32E, and
Section 34 of T24S, R32E, Lea County**

CO Grizzly 34 27 Fed Com #407H
CO Grizzly 34 27 Fed Com #408H
CO Grizzly 34 27 Fed Com #409H
CO Grizzly 3 10 Fed #416H
CO Grizzly 3 10 Fed #417H
CO Grizzly 3 10 Fed #418H

RE: Chevron USA Incorporated Temporary Pit Application

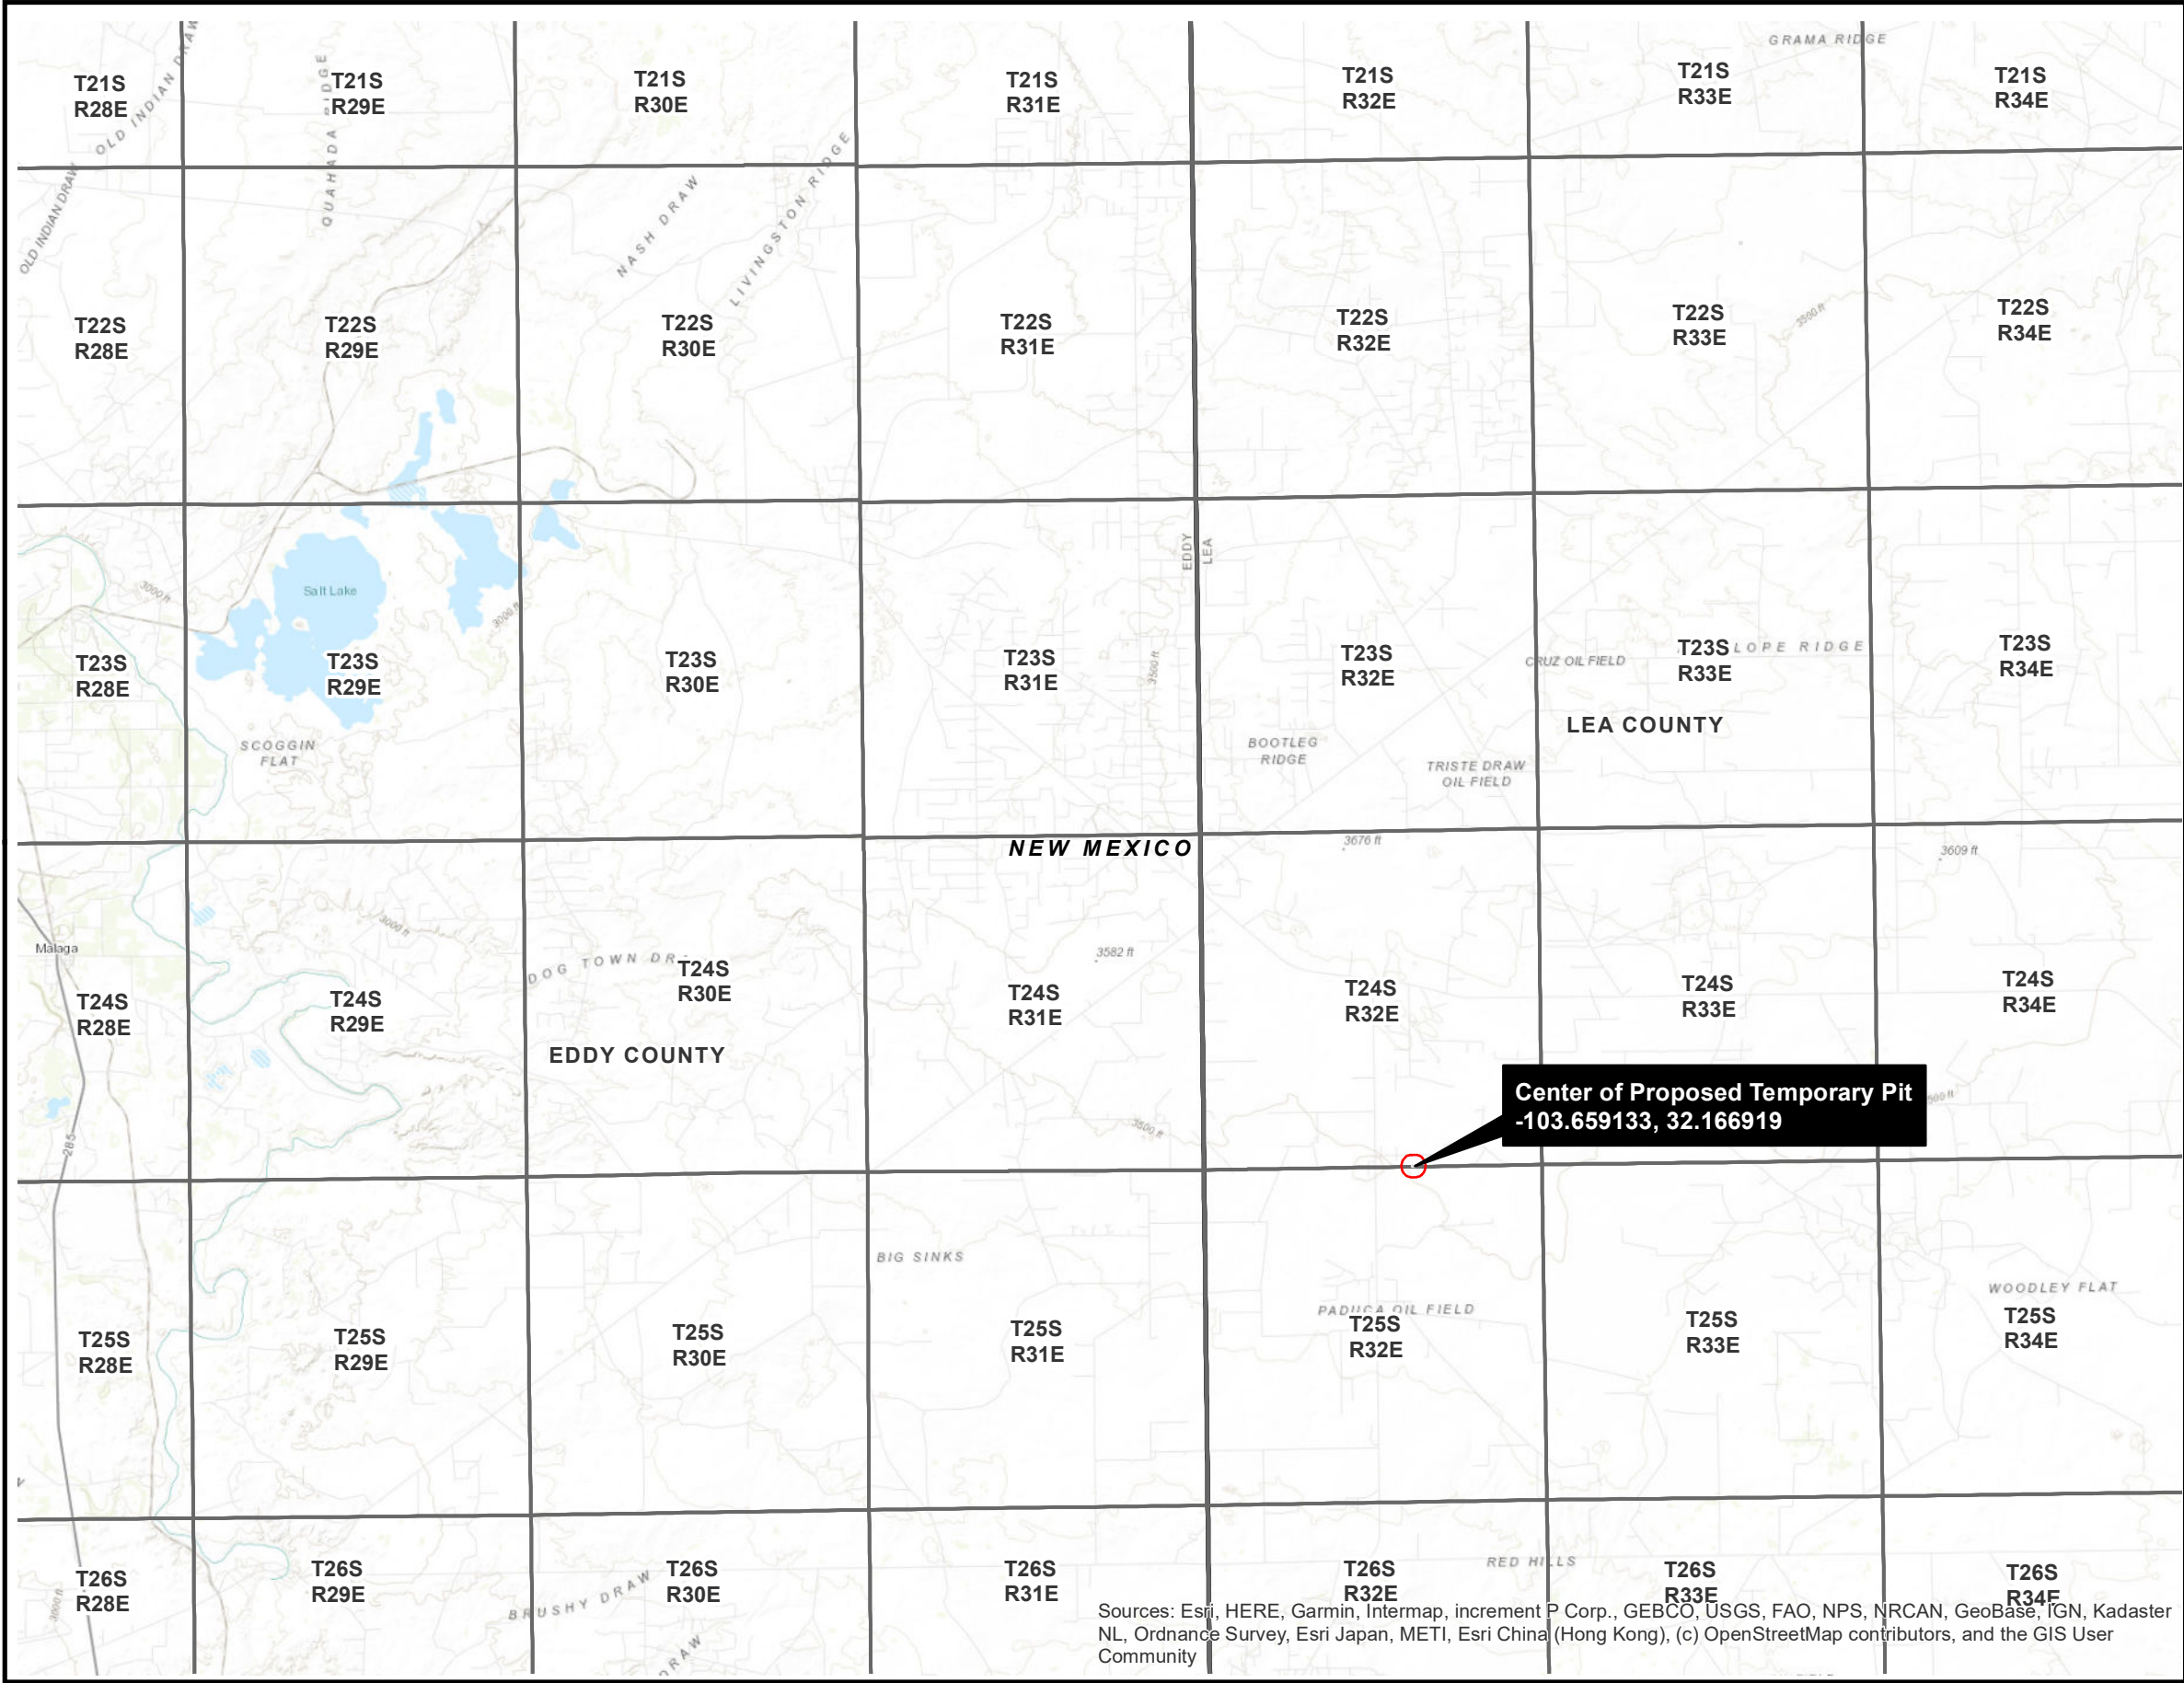
FIGURE
1

Figure 1 demonstrates that the location is not within incorporated municipal boundaries or defined municipal fresh water well fields covered under a municipal ordinance adopted pursuant to NMSA 1978, Section 3-27-3, as amended.

VICINITY MAP

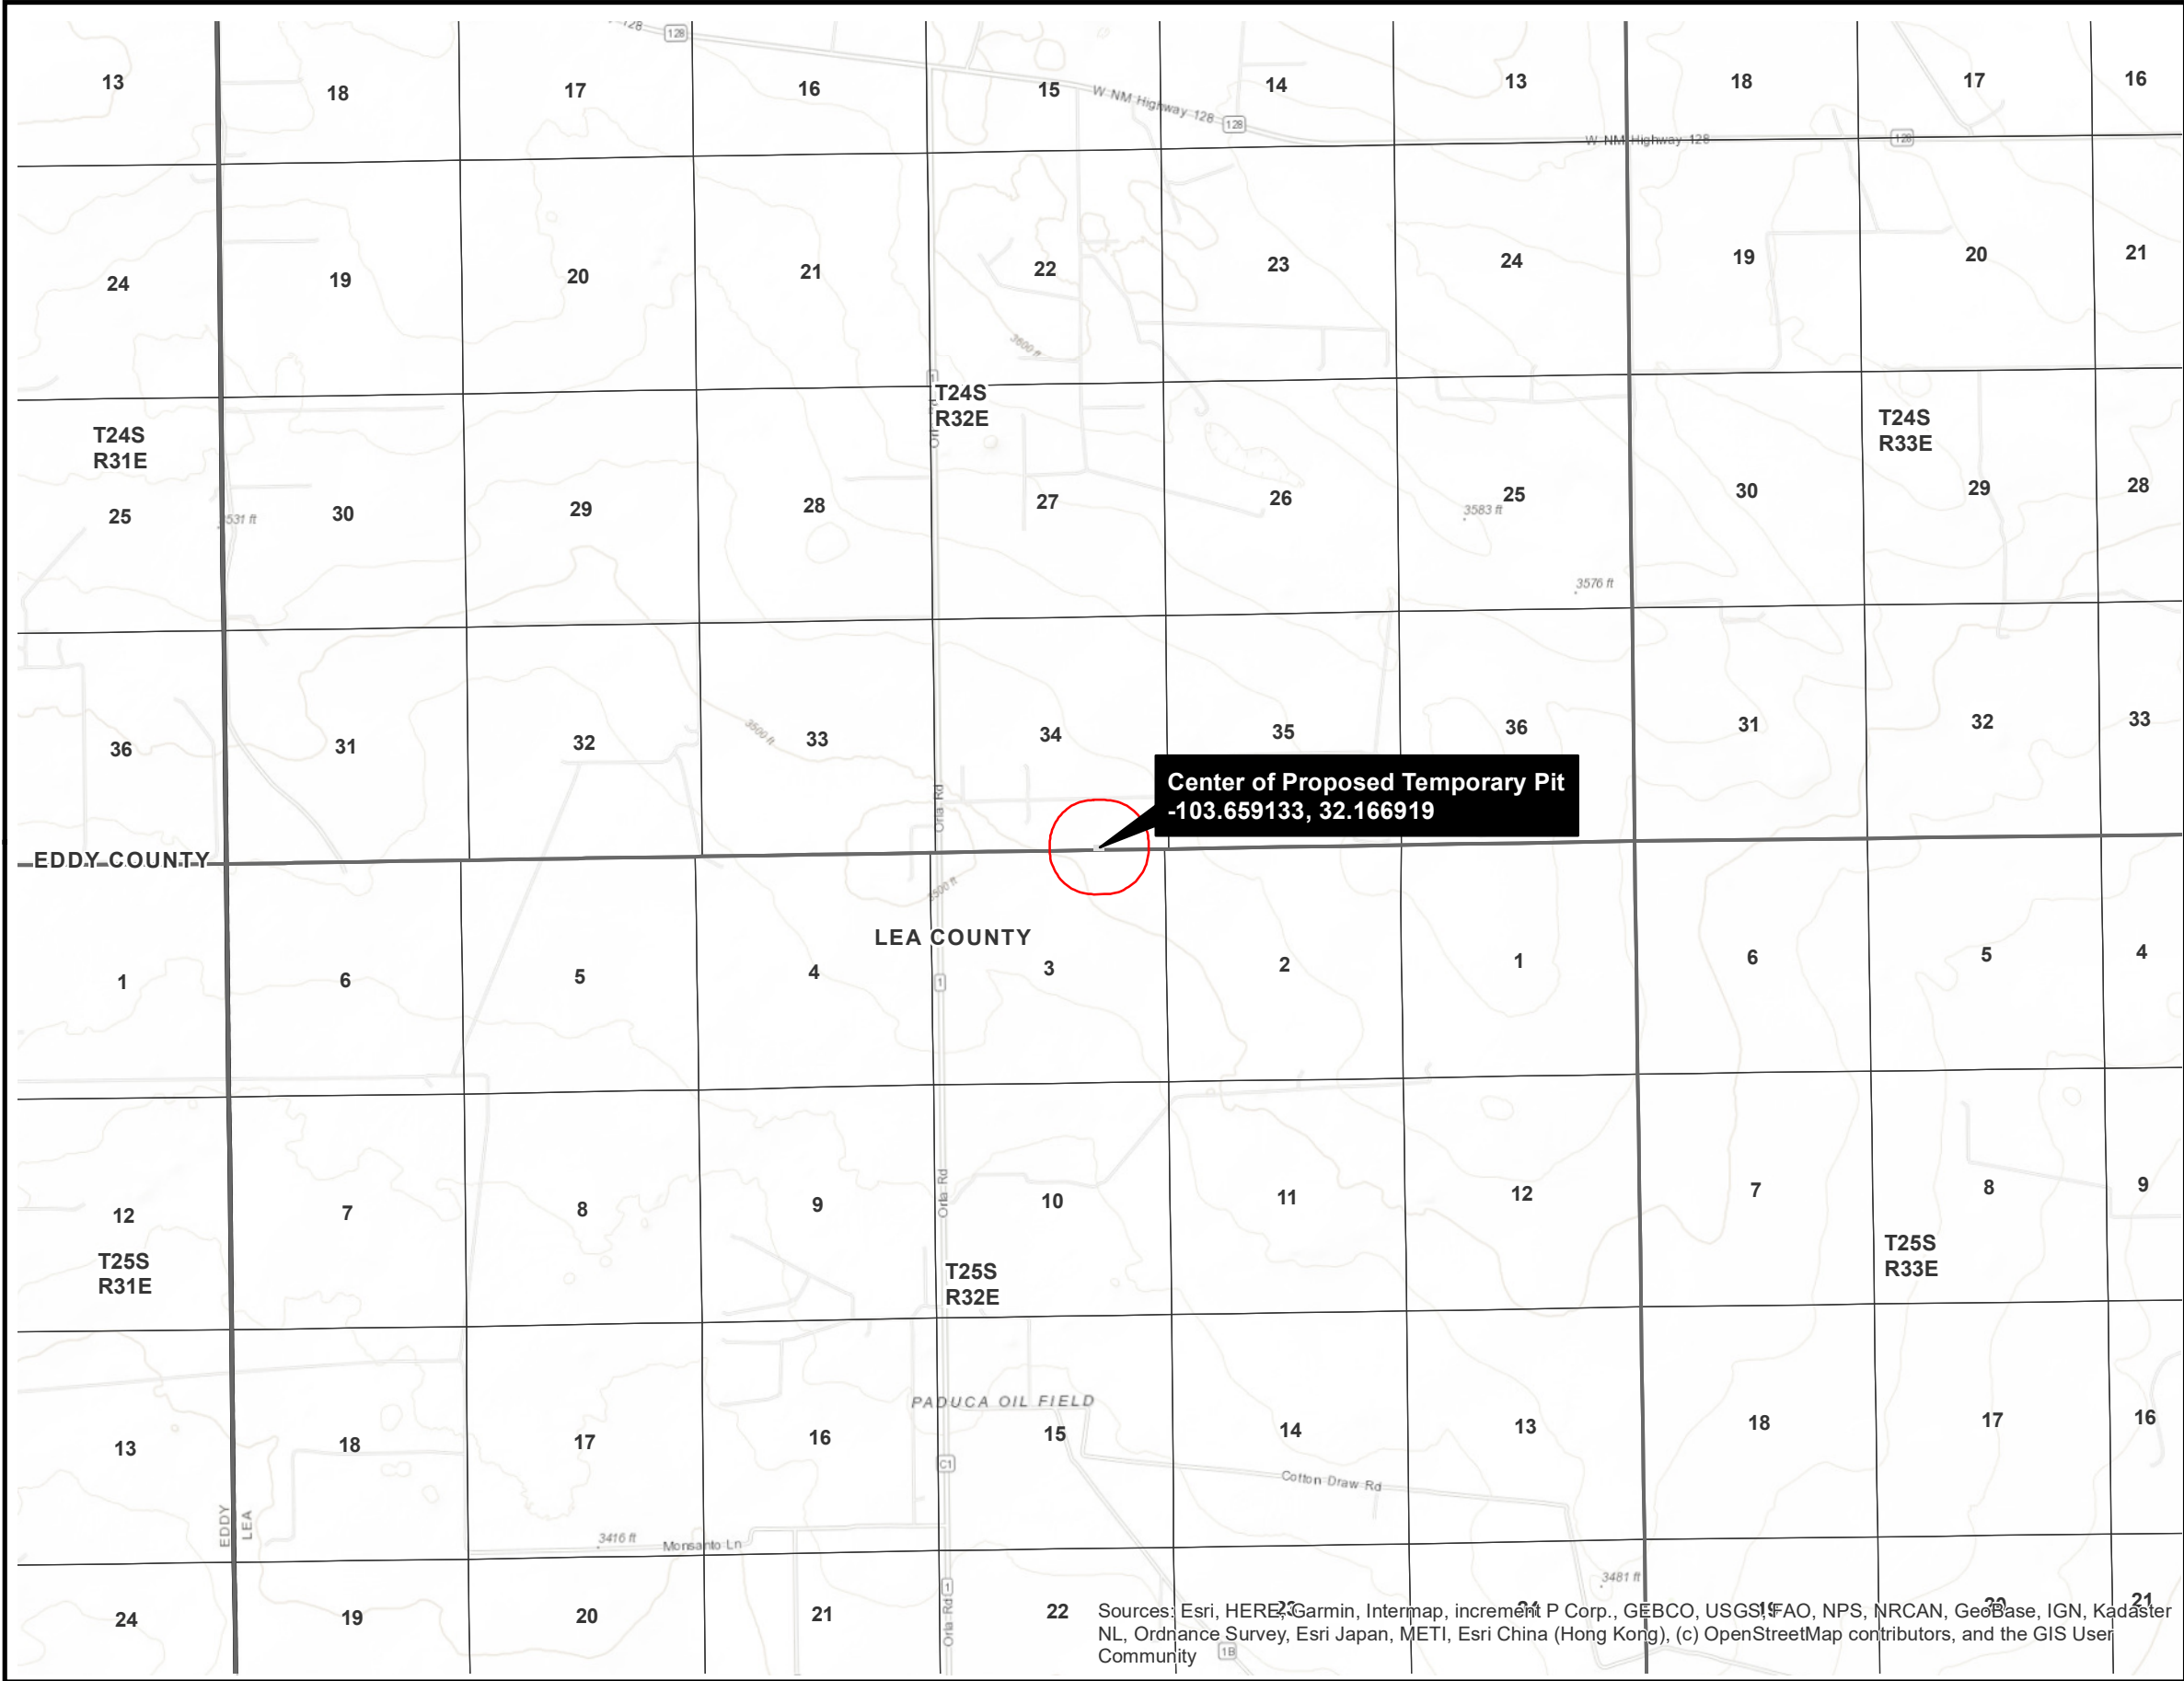
FLOODPLAIN MAP

NOTE:
1. FLOODPLAIN DATA IS NOT AVAILAIBE IN THIS MAP EXTENT.

The location is within an area that has not yet been mapped by the Federal Emergency Management Agency with respect to the Flood Insurance Rate 100-Year Floodplain (**Figure 3**). In lieu of FEMA data, **Figure 10** visualizes the USDA – SSURGO Soils data for dominant flooding frequency condition. The location is not located within an area with any indication of flooding. The nearest area determined to have “Rare” flooding frequency is in excess of 1 mile away. As defined by the USDA, “*Rare*’ means that flooding is unlikely but possible under unusual weather conditions. The chance of flooding is 1 to 5 percent in any year”.

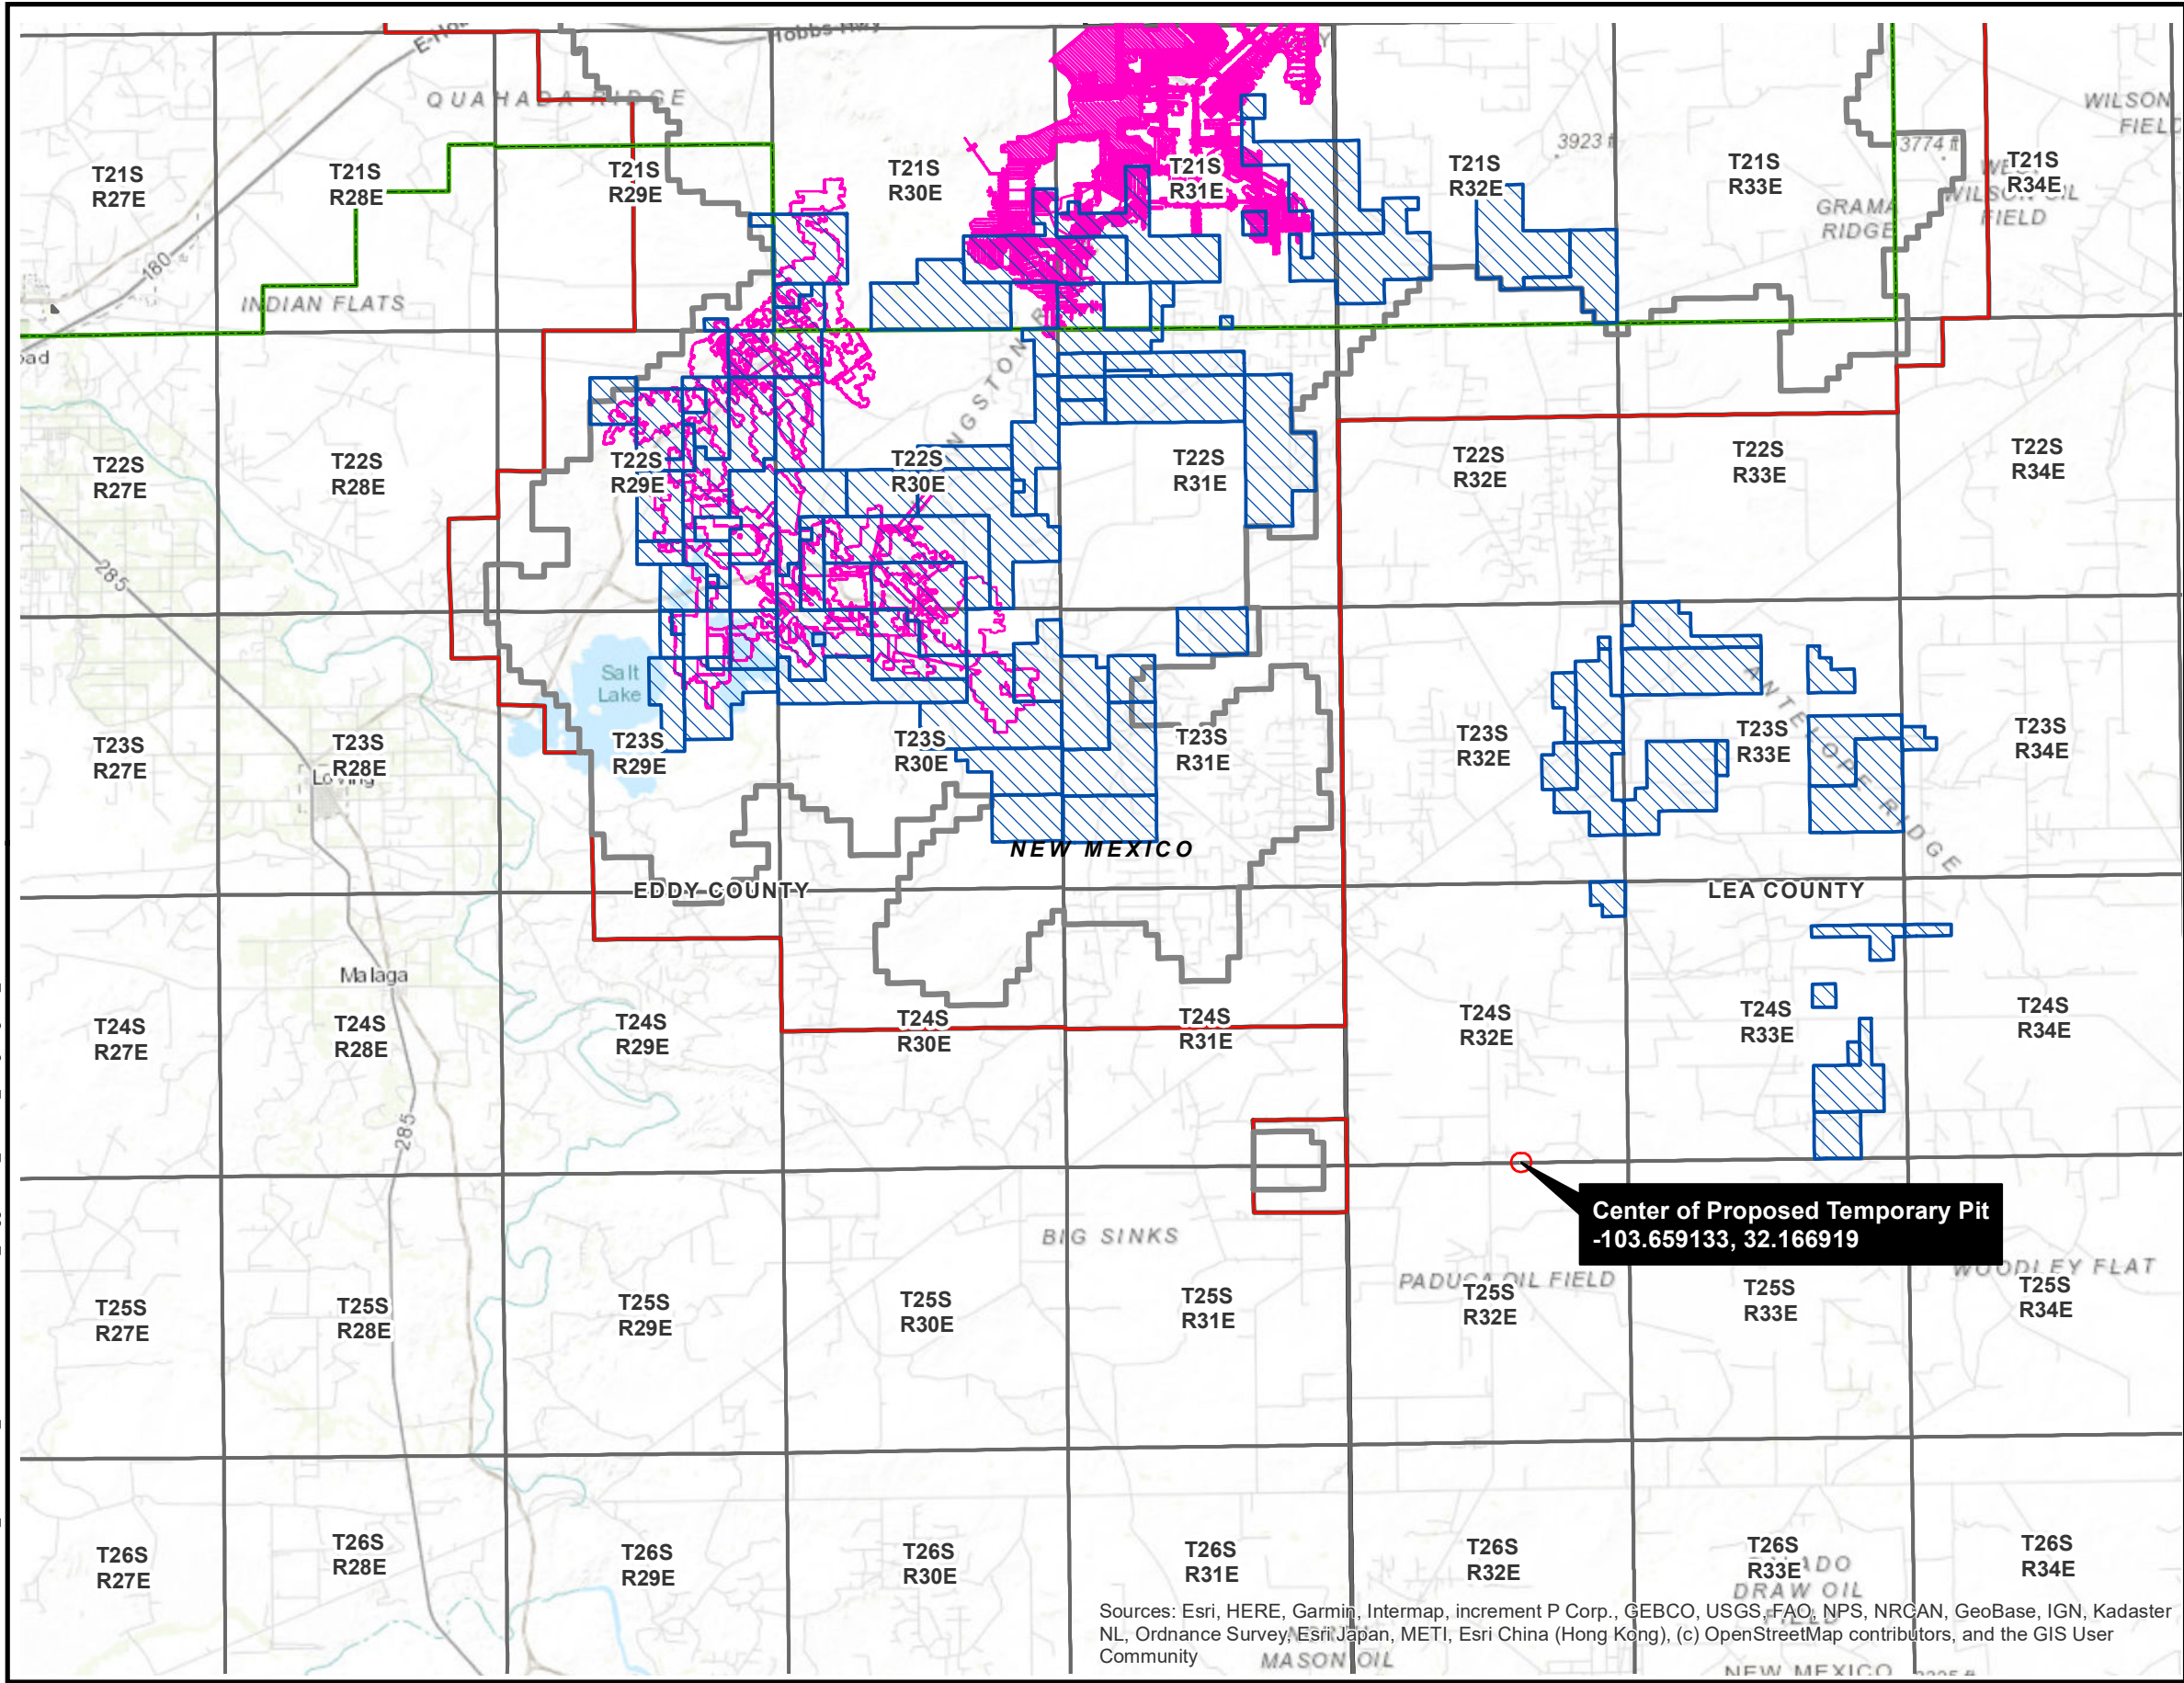
FIGURE
4

Analysis of aerial imagery in the vicinity of the proposed temporary pit show that the nearest mines are all surficial caliche pits. There are no subsurface mines in the area as indicated in **Figure 4**.

SUBSURFACE MINES - POTASH

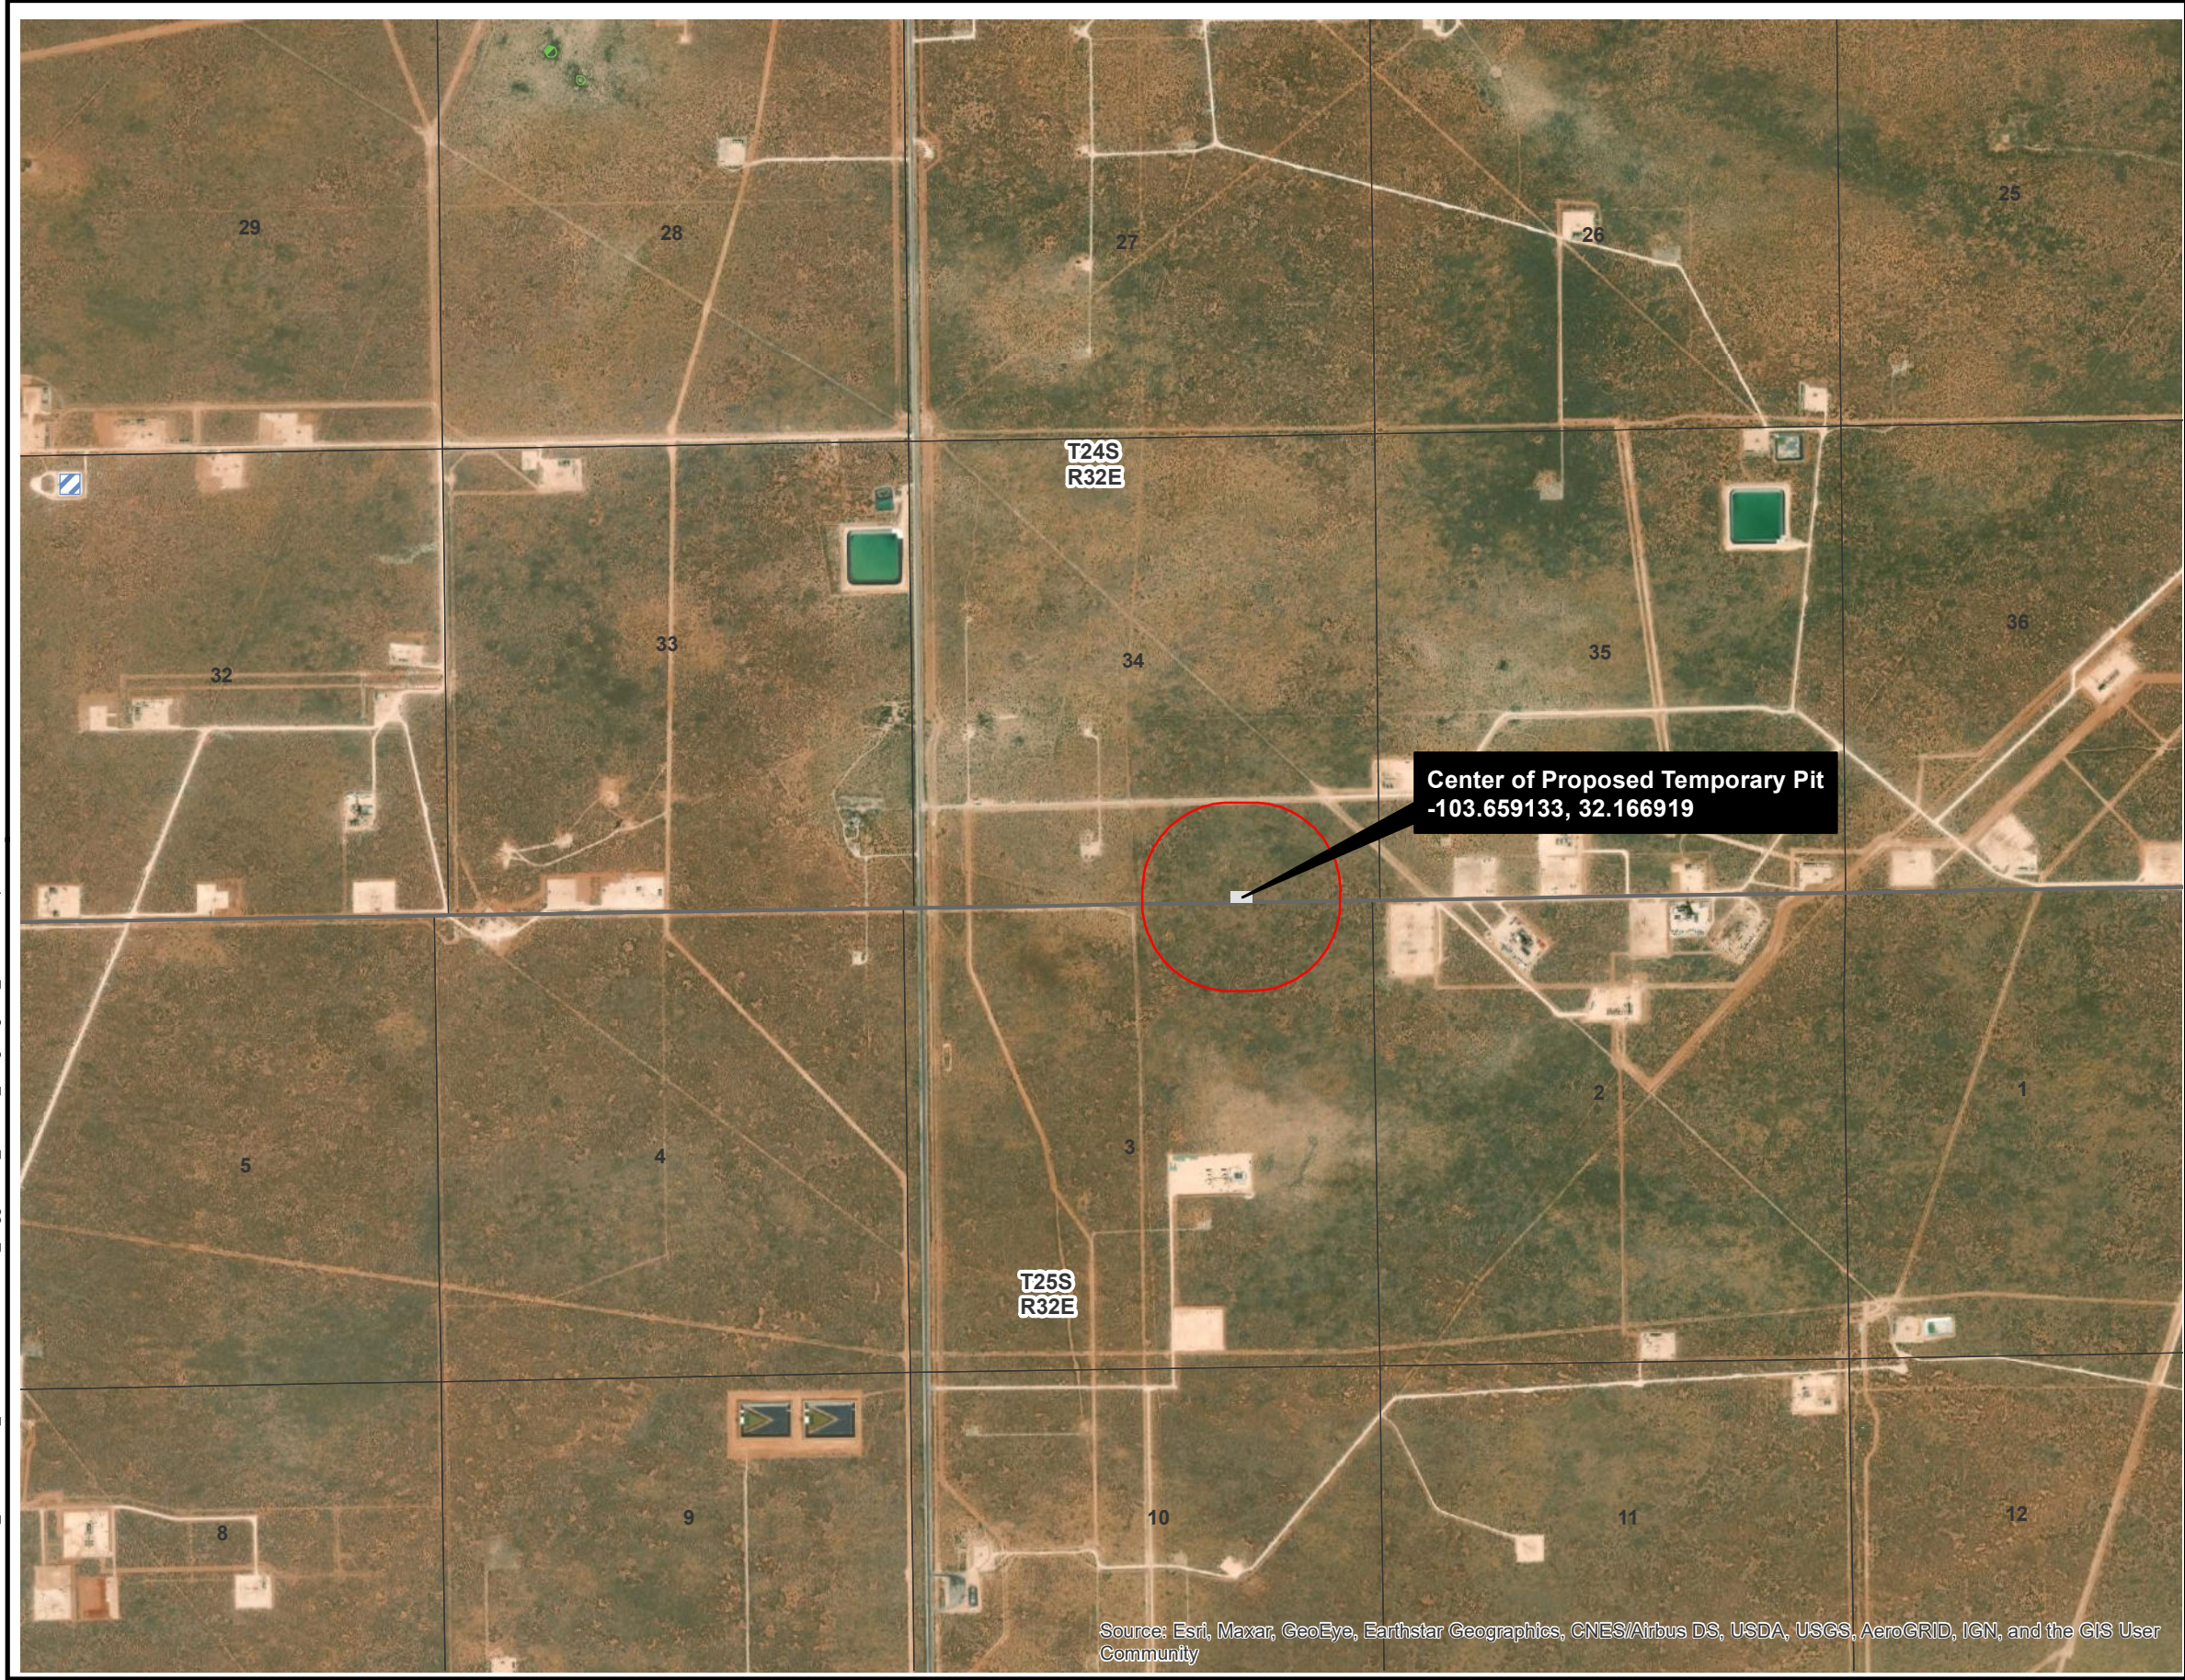
FIGURE
5

Utilizing USFWS wetland data, **Figure 5** demonstrates that the proposed location is not located within 300 feet of a wetland.

WETLANDS MAP

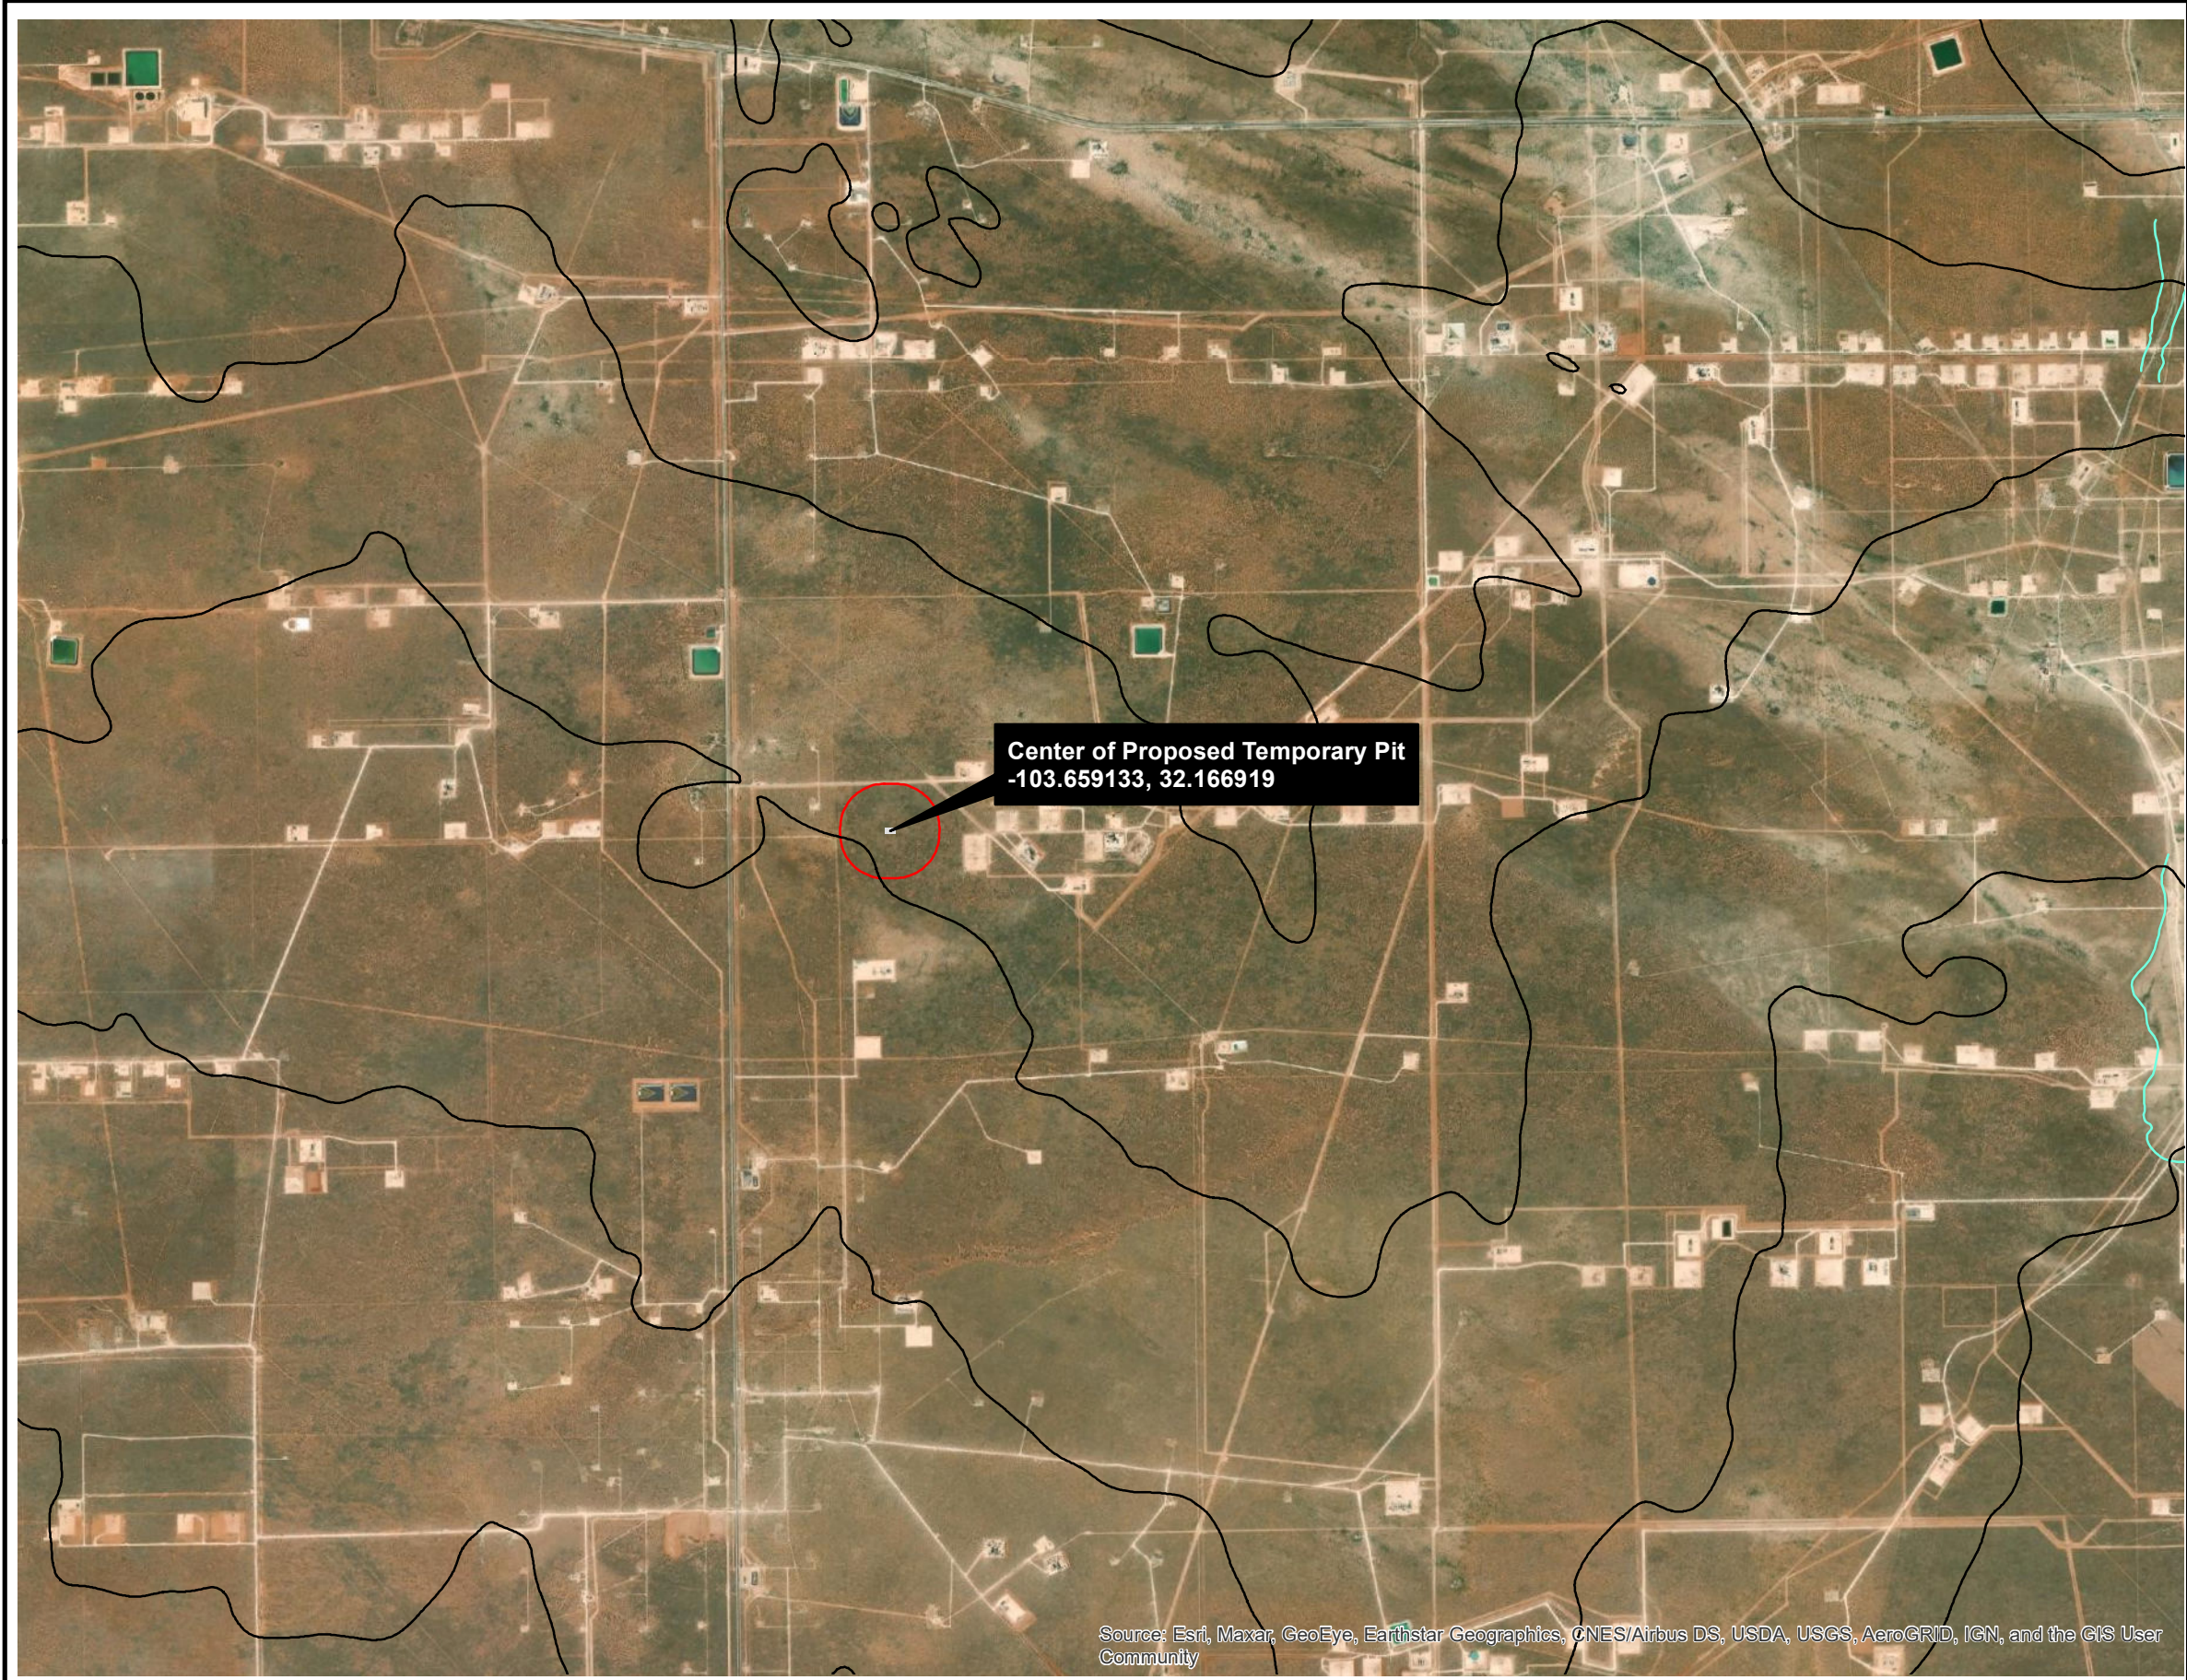
FIGURE
6

Figure 6 visualizes USGS contour lines and the USGS National Hydrography Dataset. The map demonstrates that the location is not within 1,000 feet of a continuously flowing waterway course, any other significant watercourse or lakebed, sinkhole, or playa lake.

ELEVATION CONTOUR & NHD MAP
