**C-144 Permit Package
Cotton Draw Grizzly 3 10 FED & 34 27 FED, Temporary
Pit
Section 3 of T25S, R32E, and
Section 34 of T24S, R32E, Lea County**

CO Grizzly 34 27 Fed Com #407H
CO Grizzly 34 27 Fed Com #408H
CO Grizzly 34 27 Fed Com #409H
CO Grizzly 3 10 Fed #416H
CO Grizzly 3 10 Fed #417H
CO Grizzly 3 10 Fed #418H

RE: Chevron USA Incorporated Temporary Pit Application

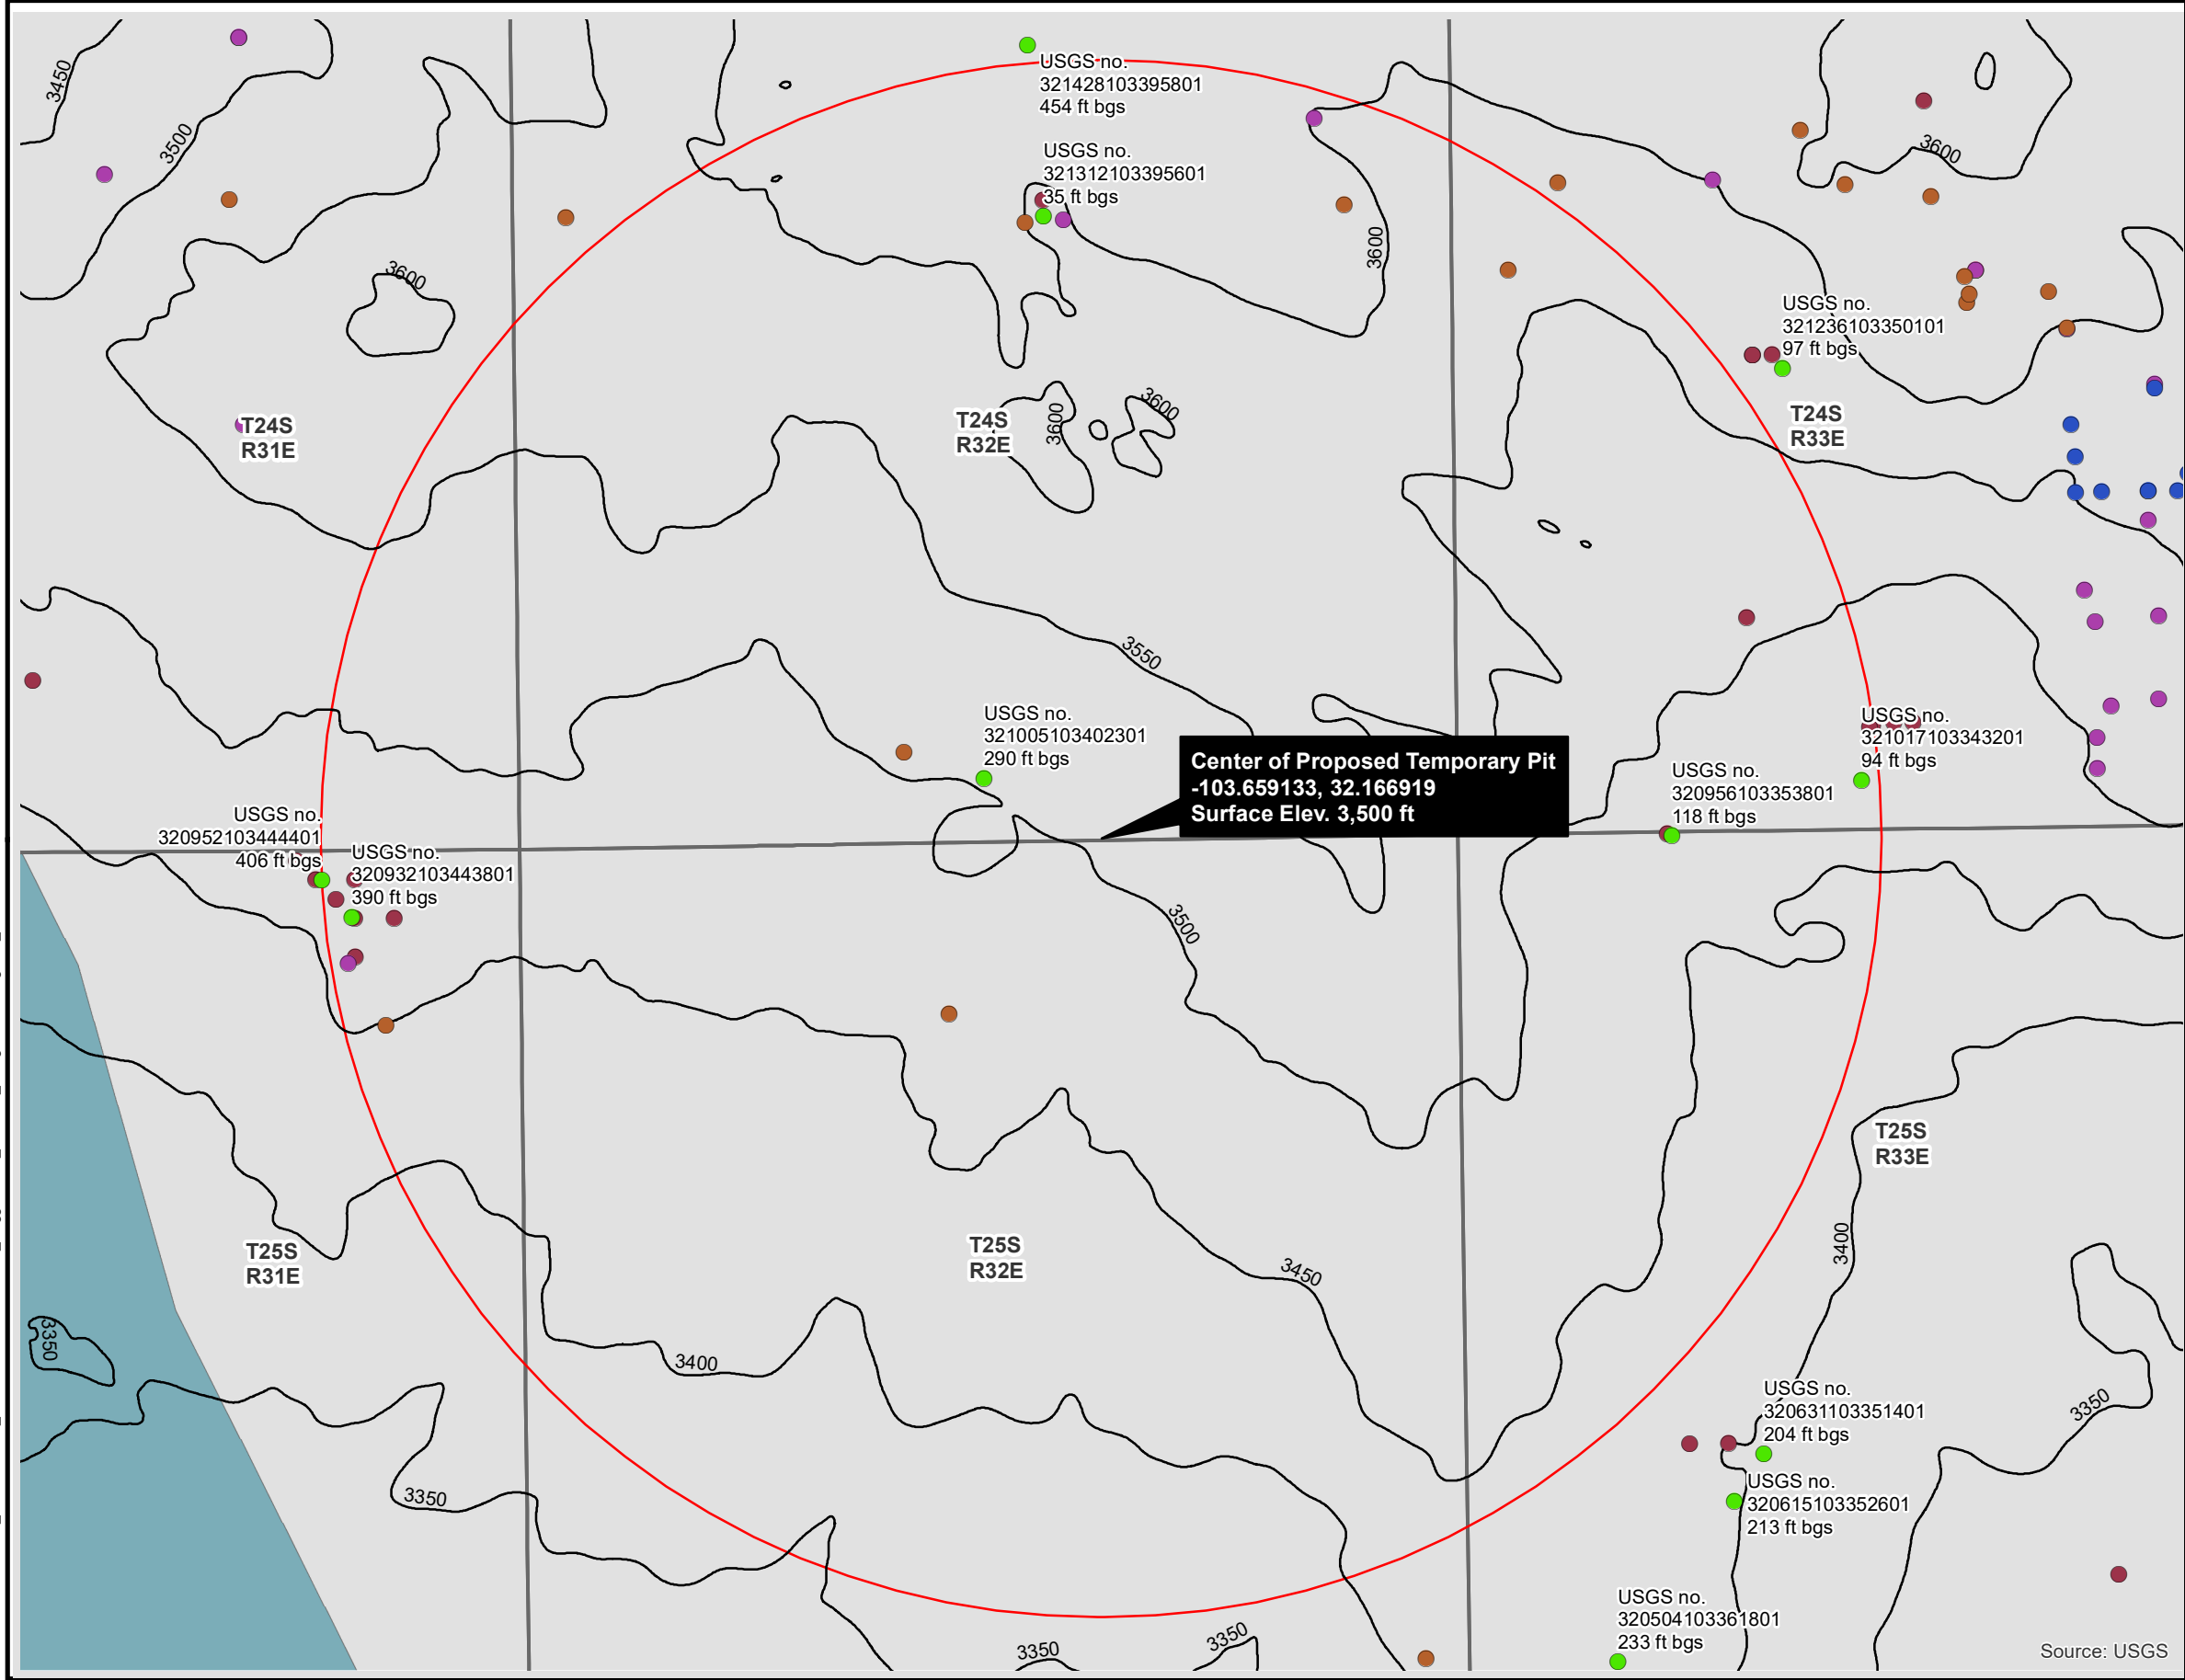
FIGURE
7

Figure 7, Appendices A & B, and the discussion presented below demonstrate that the groundwater within the broader area of the proposed site ranges from 60 to 1,016 feet near the Temporary Pit.

Figure 7 depicts the location of the pit relative to the locations of water wells within 5 miles of the pit for which water level data are available. Depth to water for the most recent, reliable measurement and the well identification number are shown adjacent to each well on **Figure 7**. The approximate boundary of the Pecos River Basin alluvial aquifer is located ~6.5 miles to the west of the Temporary Pit (**Figure 7**). Water well data, including gauging dates, are detailed in **Appendix A** (USGS) and **Appendix B** (NMOSE).

USGS AND NMOSE
GROUNDWATER WELLS

The location of the proposed temporary pit is in southwestern Lea County, New Mexico between the Mescalero Ridge and the Pecos River in the Pecos Valley section of the Great Plains physiographic province. The pit lies at an elevation of 3,500 ft above sea level and the general area in the vicinity of the pit is characterized by bluffs surrounded by relatively flat to gentle sloping terrain (**Figure 7**). The land surface slopes gently to the southwest at approximately 25 feet per mile.

In the vicinity of the proposed pit, the Rustler Formation, Dockum Group and the Alluvium / Ogallala have the potential to provide small quantities of water to water supply wells. However, no water wells were found at in the immediate vicinity of the proposed site (**Figure 7**). Several water wells have been identified within 2 to 5 miles of the site) which are used primarily to support domestic, livestock and / or oil and gas exploration and development water needs. The depths of the wells indicate that some are completed in the Alluvium/Ogallala, some in the Dockup and one may be completed in the lower part of the Triassic Dockum or the Rustler Formation.

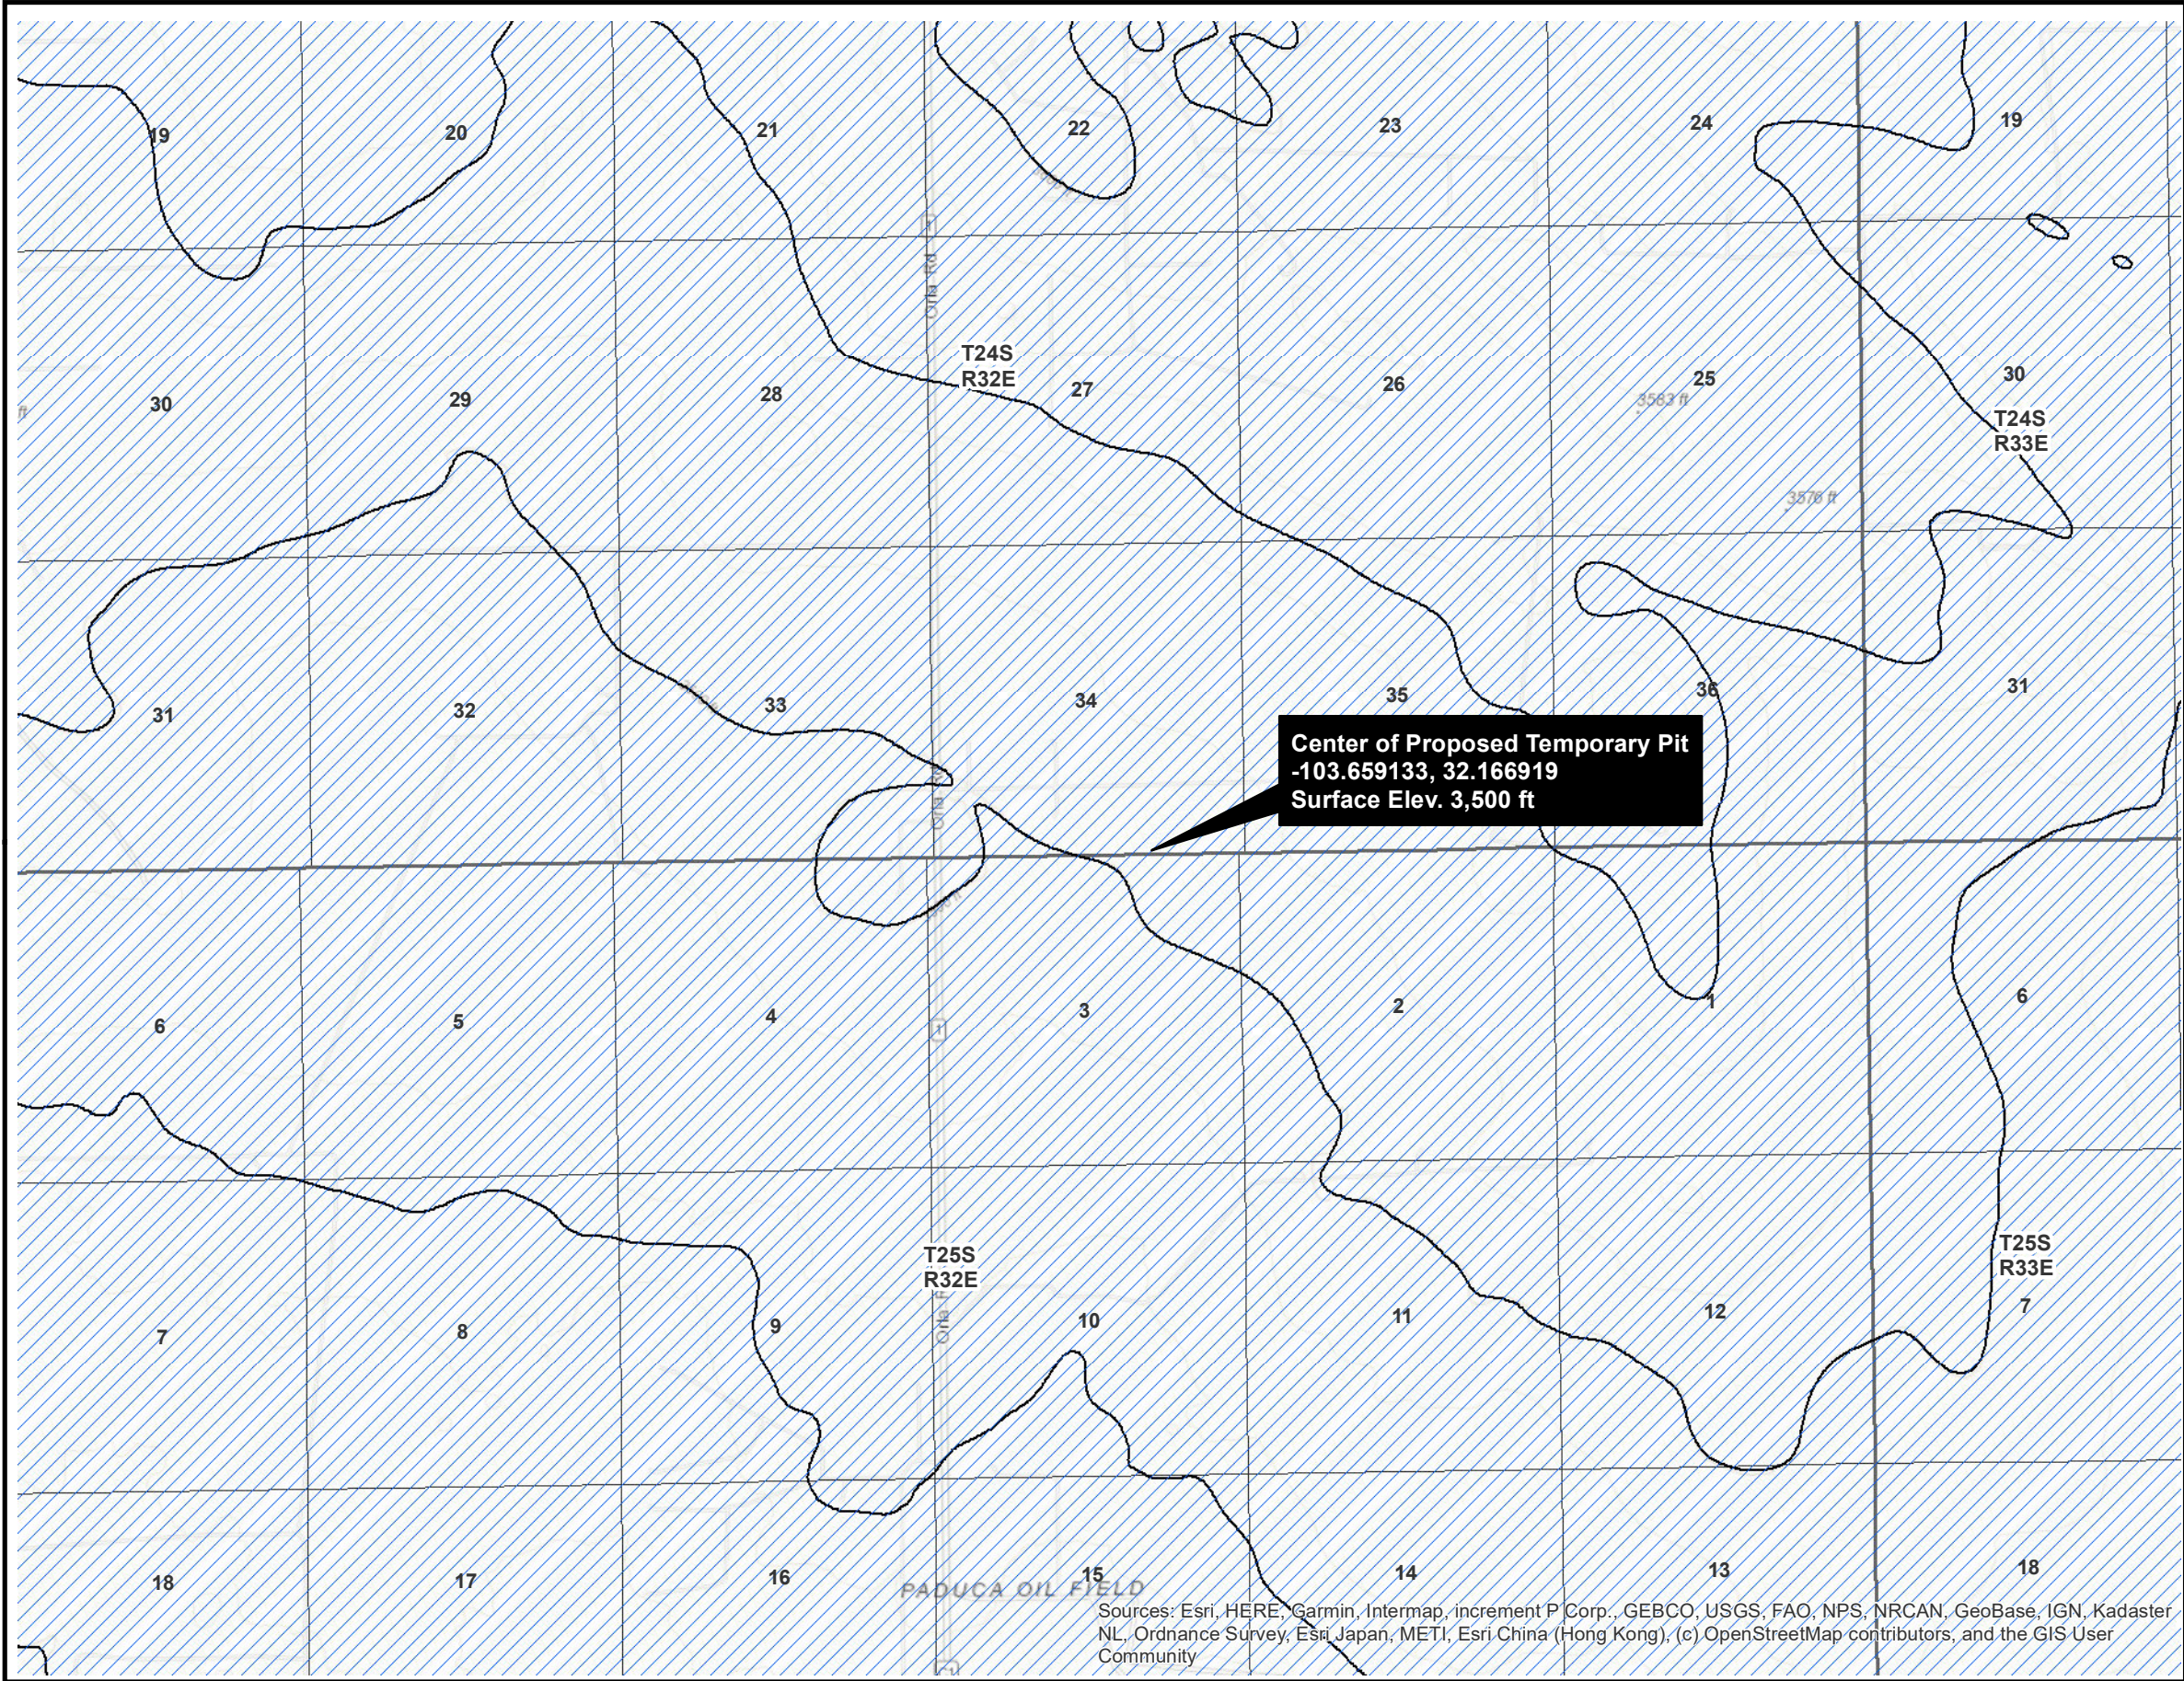
FIGURE
8

KARST POTENTIAL

Figure 8 identifies the location of the proposed temporary pit with respect to BLM Karst areas. The proposed Temporary Pit is mapped in a “Low Potential” karst area. The area lies near the western end of the Delaware Basin, and is situated north of the Gypsum Plain (Hill 1996²). Bedrock cropping out beneath the proposed project area is comprised of the Rustler Formation, a roughly 50-meter-thick sequence of limestone, siltstone, and sandstone with interbedded clay and gypsum (Land and Veni 2014³). There are, however, no indications that voids or other karst features are present or are likely to form in the vicinity of the proposed location. Therefore, local karst potential is likely to be low. An Evaluation of Unstable Conditions is presented in Appendix G that details several lines of evidence in support of this position. In summary:

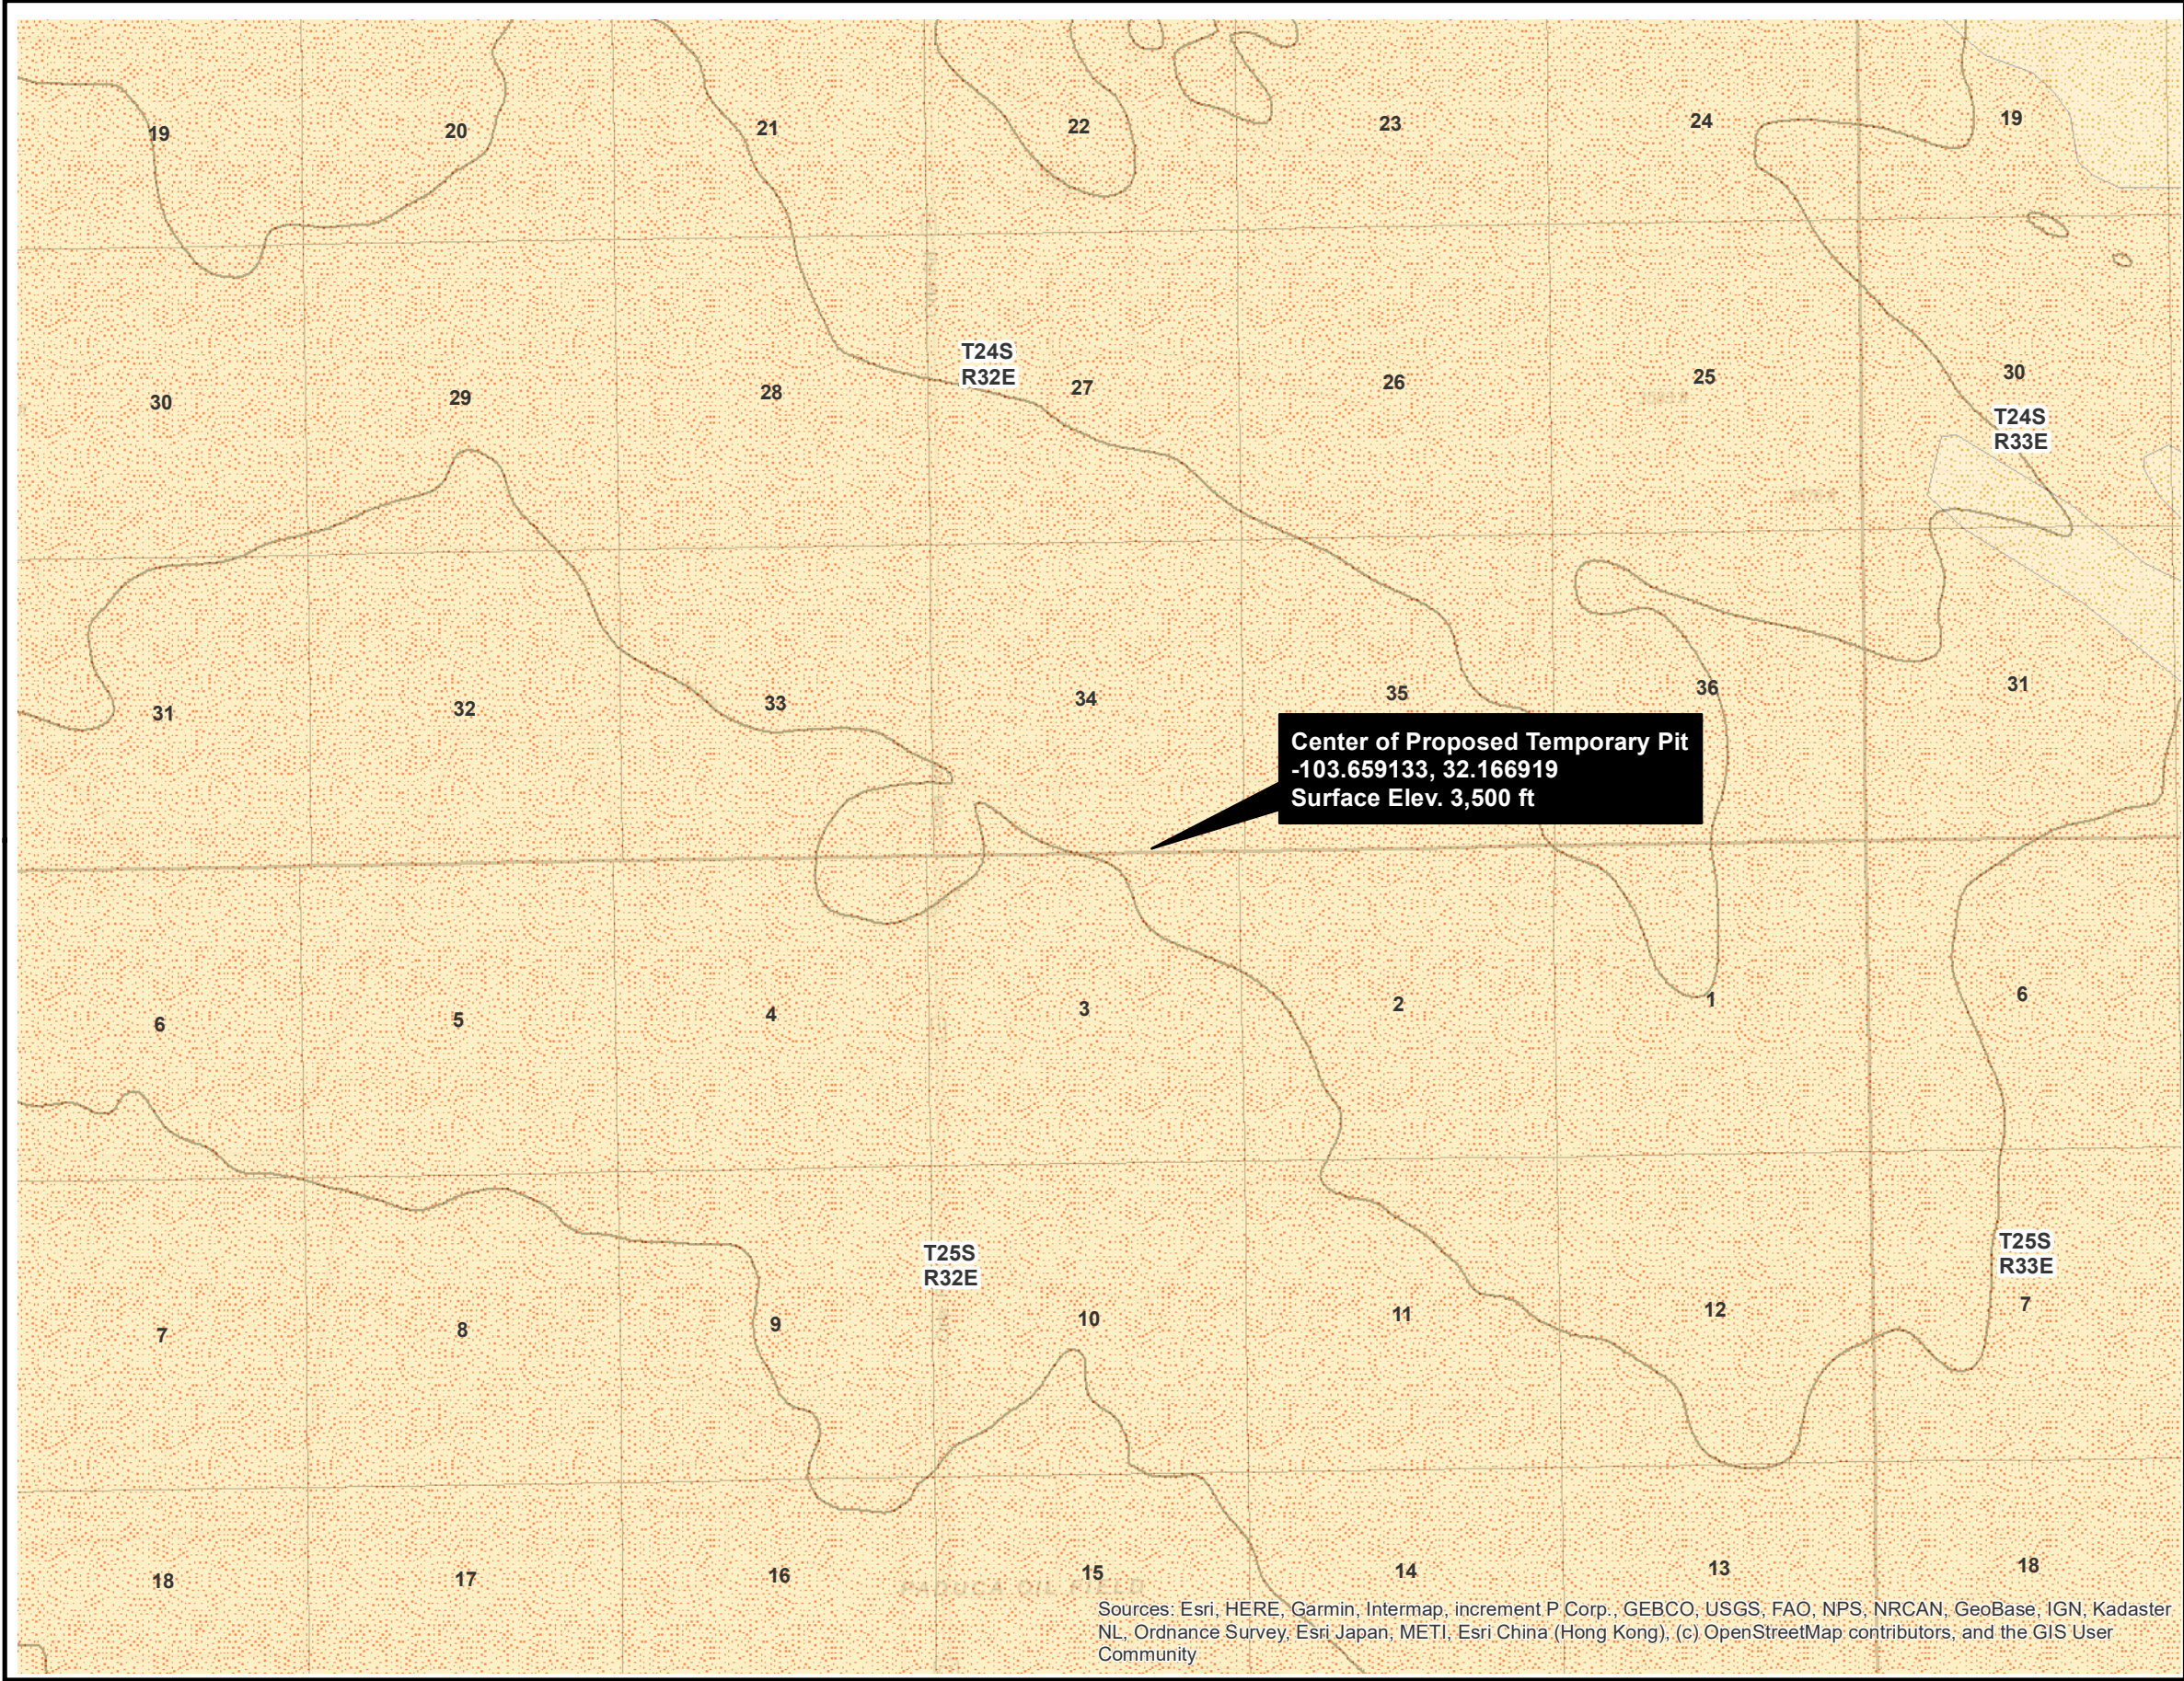
FIGURE
9

Qe: Quaternary Eolian Deposits

Qp: Quaternary Piedmont Deposits

LOCAL GEOLOGY

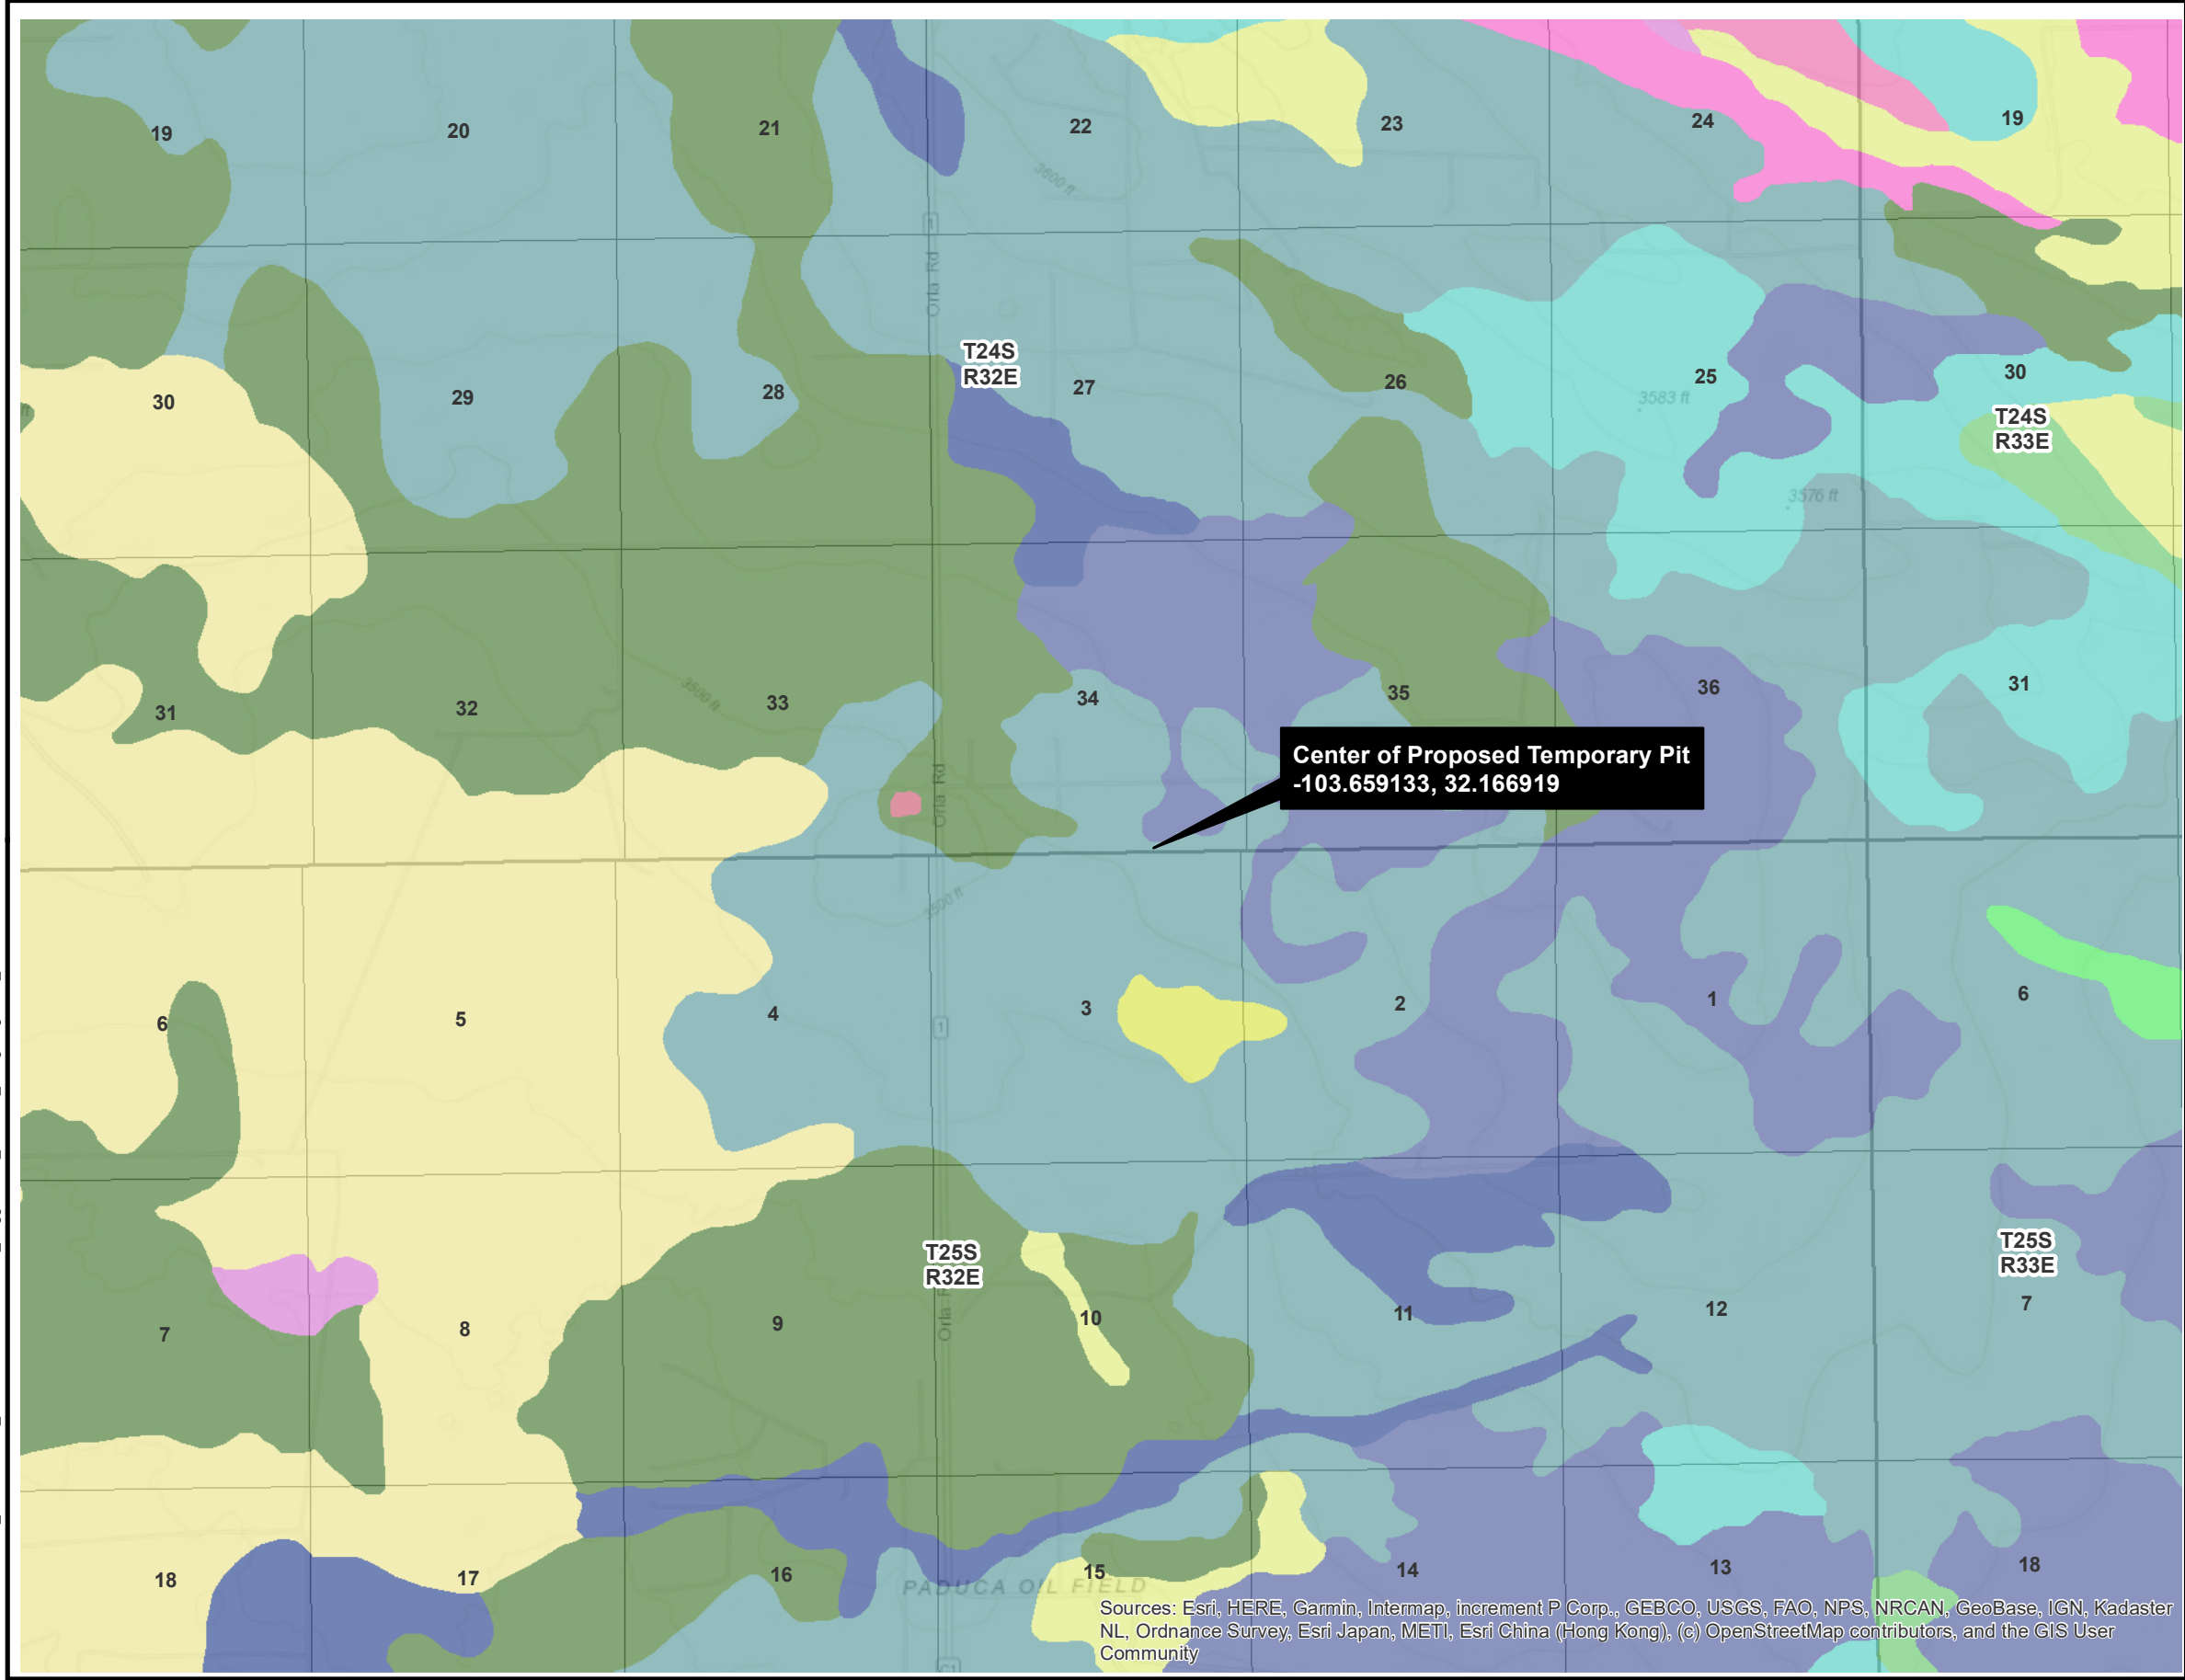
FIGURE
10

- BE: Berino-Cacique loamy fine sands association
- BF: Berino-Cacique fine sandy loams association
- CLP: Caliche pit
- KD: Kermit-Palomas fine sands, 0 to 12 percent slopes
- MF: Maljamar and palomas fine sands, 0 to 3 percent slopes
- MN: Midessa and wink fine sandy loams
- PT: Pyote loamy fine sand
- PU: Pyote and maljamar fine sands
- PY: Pyote soils and dune land
- SE: Simona fine sandy loam, 0 to 3 percent slopes
- SR: Simona-Upton association
- TF: Tonuco loamy fine sand
- WF: Wink fine sand
- WK: Wink loamy fine sand

SOILS

The location is within an area that has not yet been mapped by the Federal Emergency Management Agency with respect to the Flood Insurance Rate 100-Year Floodplain (**Figure 3**). In lieu of FEMA data, **Figure 10** visualizes the USDA – SSURGO Soils data for dominant flooding frequency condition. The location is not located within an area with any indication of flooding. The nearest area determined to have “Rare” flooding frequency is in excess of 1 mile away. As defined by the USDA, “*Rare*’ means that flooding is unlikely but possible under unusual weather conditions. The chance of flooding is 1 to 5 percent in any year”.

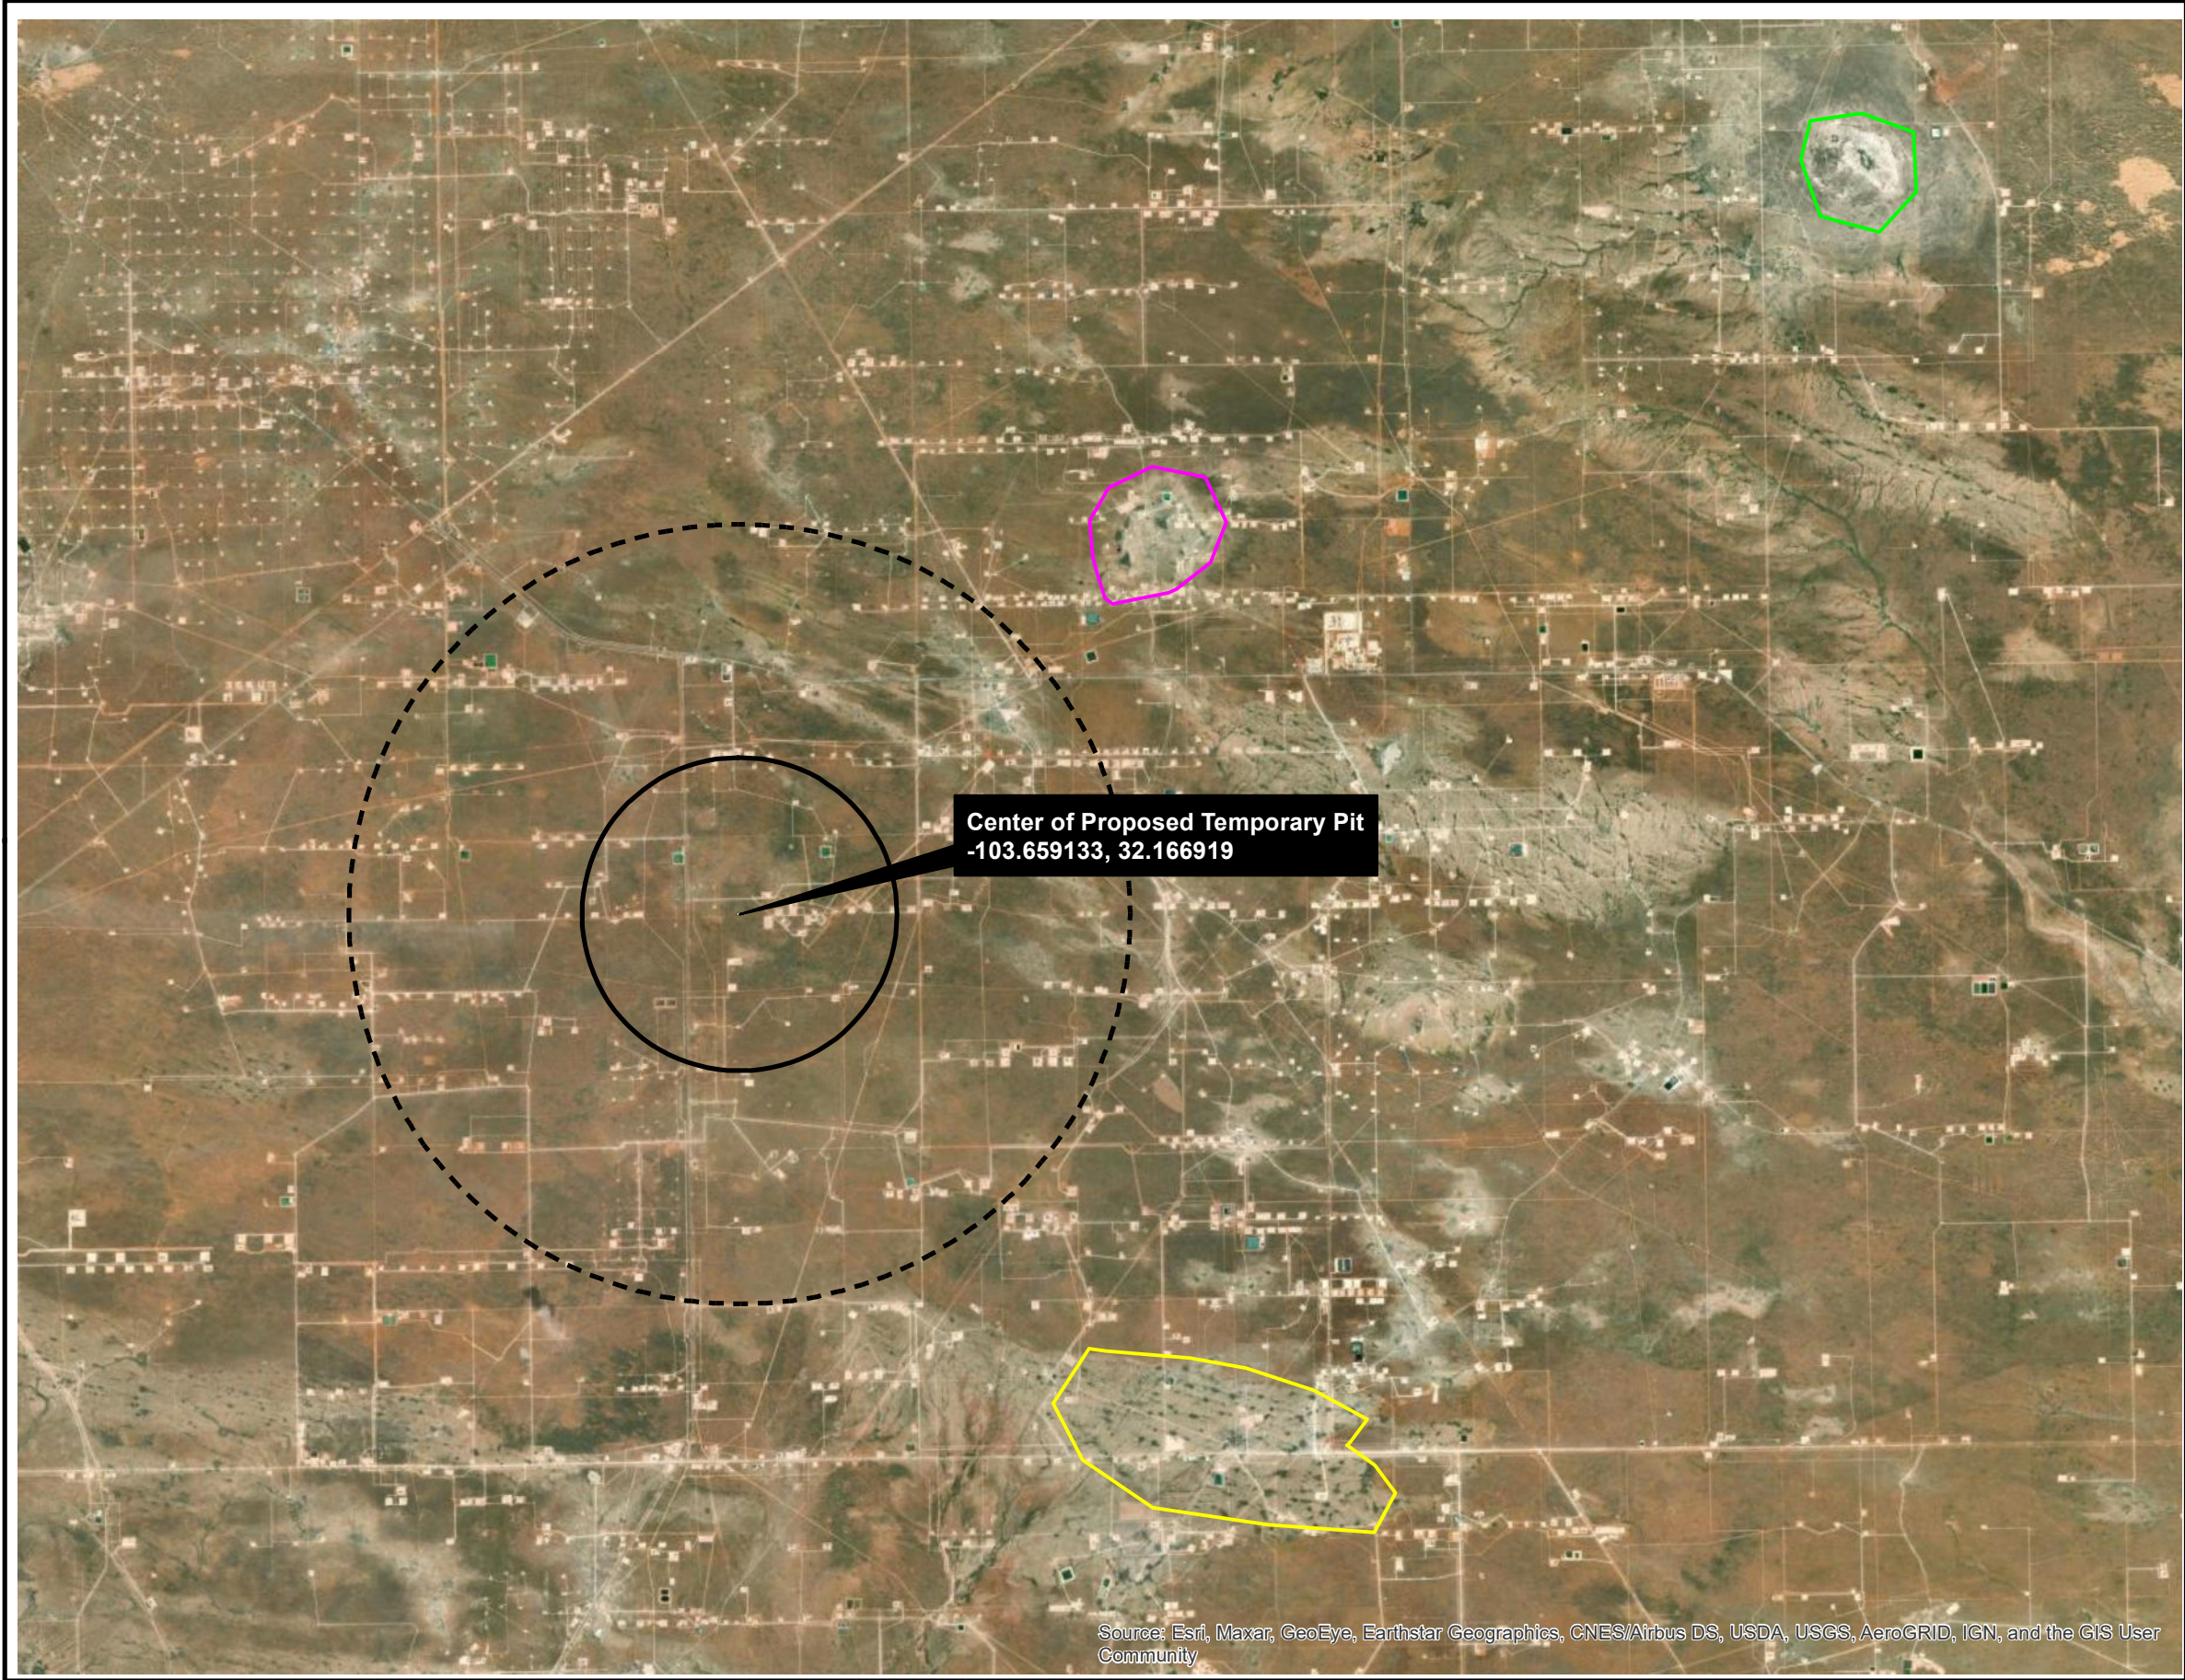
AERIAL IMAGERY OF DISSOLUTION FEATURES

- Proposed Temporary Pit
- San Simon Sink
- Bell Lake Sink
- Area with Multiple Small Depressions
- 2 Mile Buffer
- 5 Mile Buffer

Note: Boundaries of sink and depression features area approximate.
