**C-144 Permit Package
Cotton Draw Grizzly 3 10 FED & 34 27 FED, Temporary
Pit
Section 3 of T25S, R32E, and
Section 34 of T24S, R32E, Lea County**

CO Grizzly 34 27 Fed Com #407H
CO Grizzly 34 27 Fed Com #408H
CO Grizzly 34 27 Fed Com #409H
CO Grizzly 3 10 Fed #416H
CO Grizzly 3 10 Fed #417H
CO Grizzly 3 10 Fed #418H

RE: Chevron USA Incorporated Temporary Pit Application

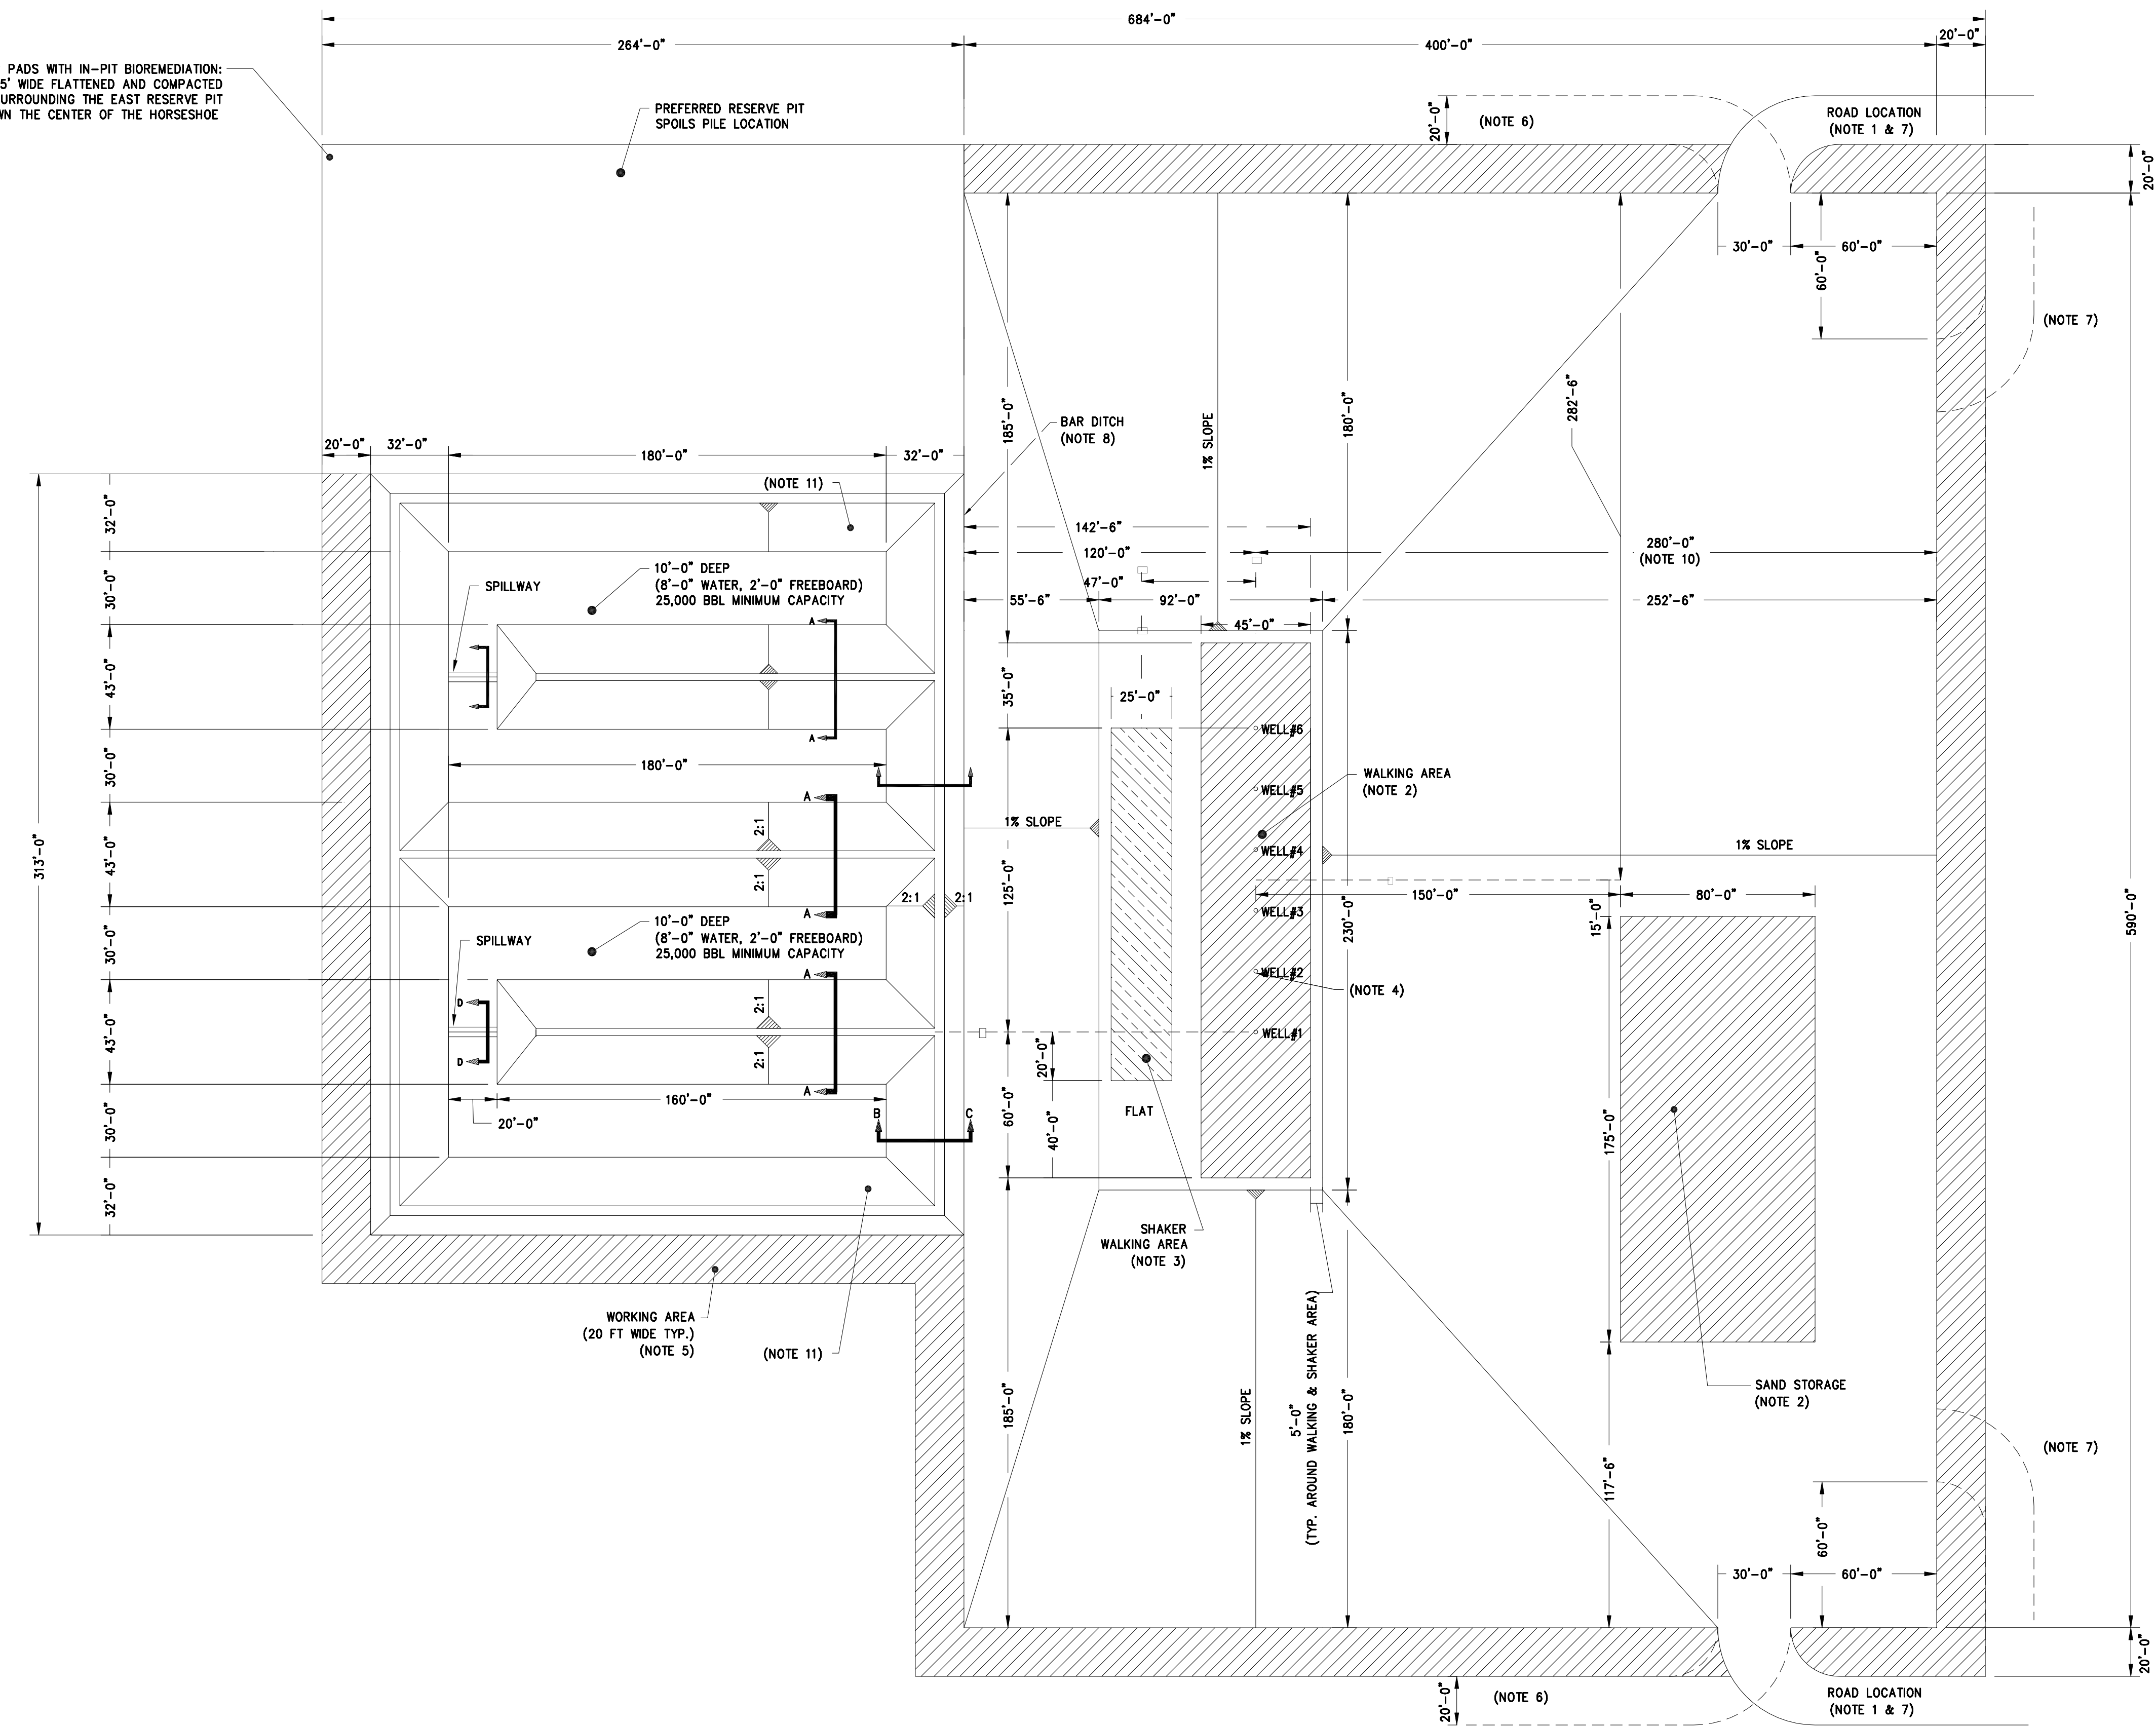
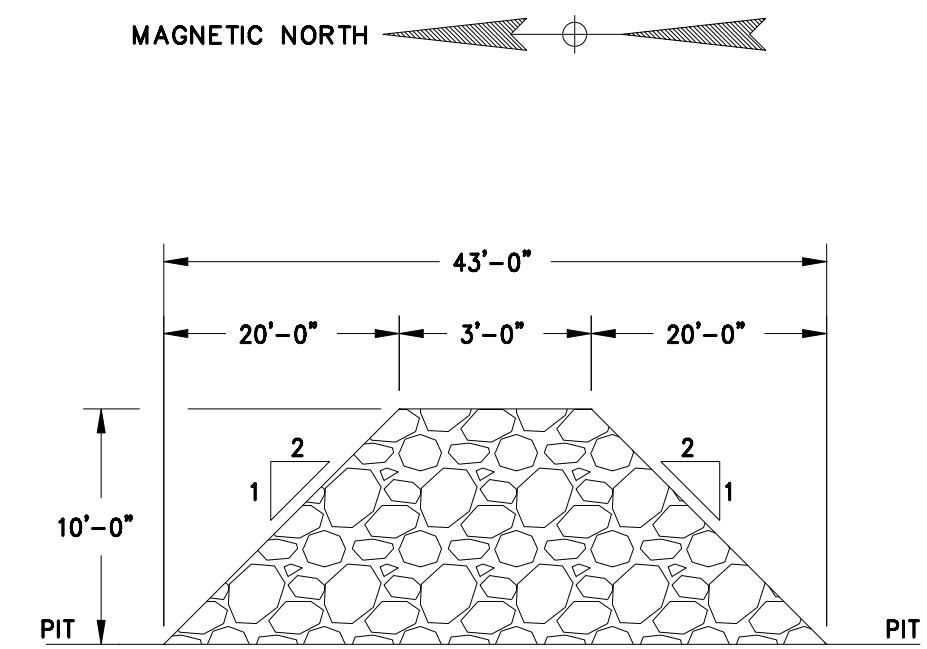
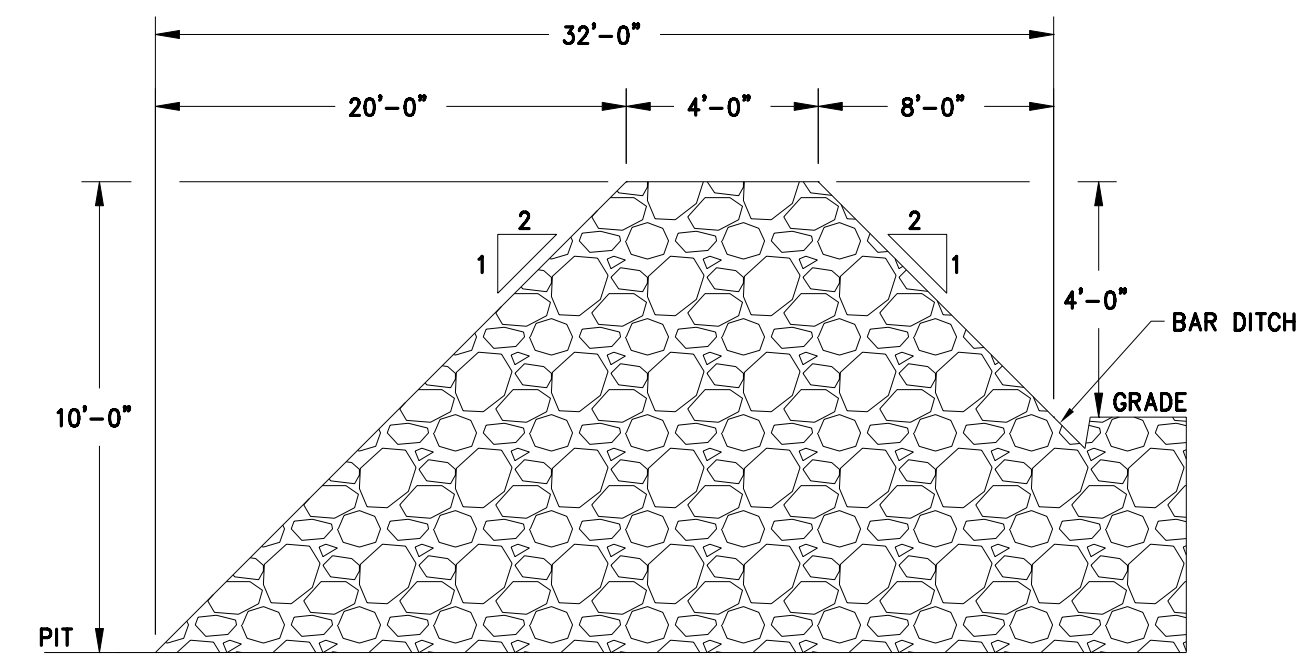
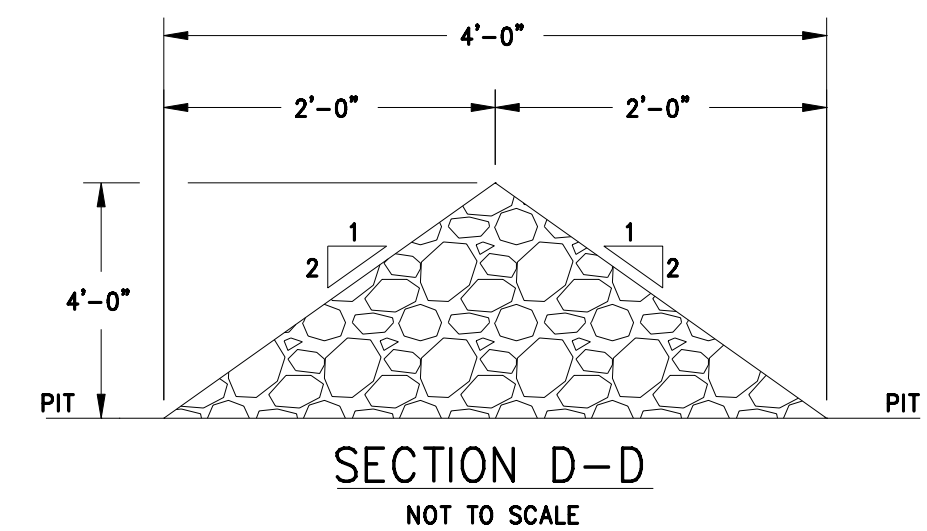
FACTSTD-6WPADOPN-CIV-PVD-MCB-0001-01

FOR PADS WITH IN-PIT BIOREMEDIATION:
ADD A 15' WIDE FLATTENED AND COMPACTED
AREA SURROUNDING THE EAST RESERVE PIT
AND DOWN THE CENTER OF THE HORSESHOE

- NOTES:
1. PRIMARY PAD ENTRANCE MUST BE ON WEST OR EAST SIDE OF PAD FOR DRILLING LAYOUT.
 2. SEE GEO-TECHNICAL INVESTIGATION REPORT FOR COMPACTION RECOMMENDATION. SEE DRILLING MAT LAYOUT FOR DETAILS.

3. SHAKER WALKING AREA IS REQUIRED WHEN USING NABORS M800 SERIES DRILLING RIG.
 4. FOR COMPLETIONS GRAVEL LOCATIONS, SEE DWG. FACTSTD-COMGRVL-CIV-PVD-MCB-0001-01.

- Clear and complete subgrade for 590'x380' pad according to the drawings including the 6" caliche cap.
- Construct drilling reserve pit according to standard drawing attached.
- Walking areas specified in drawings shall be brought to compaction per geotechnical recommendations.
- Silo area to be compacted to the same compaction requirements as the walking area.
- Caliche shall be watered and compacted to obtain a smooth surface that will drain rainwater without ponding.

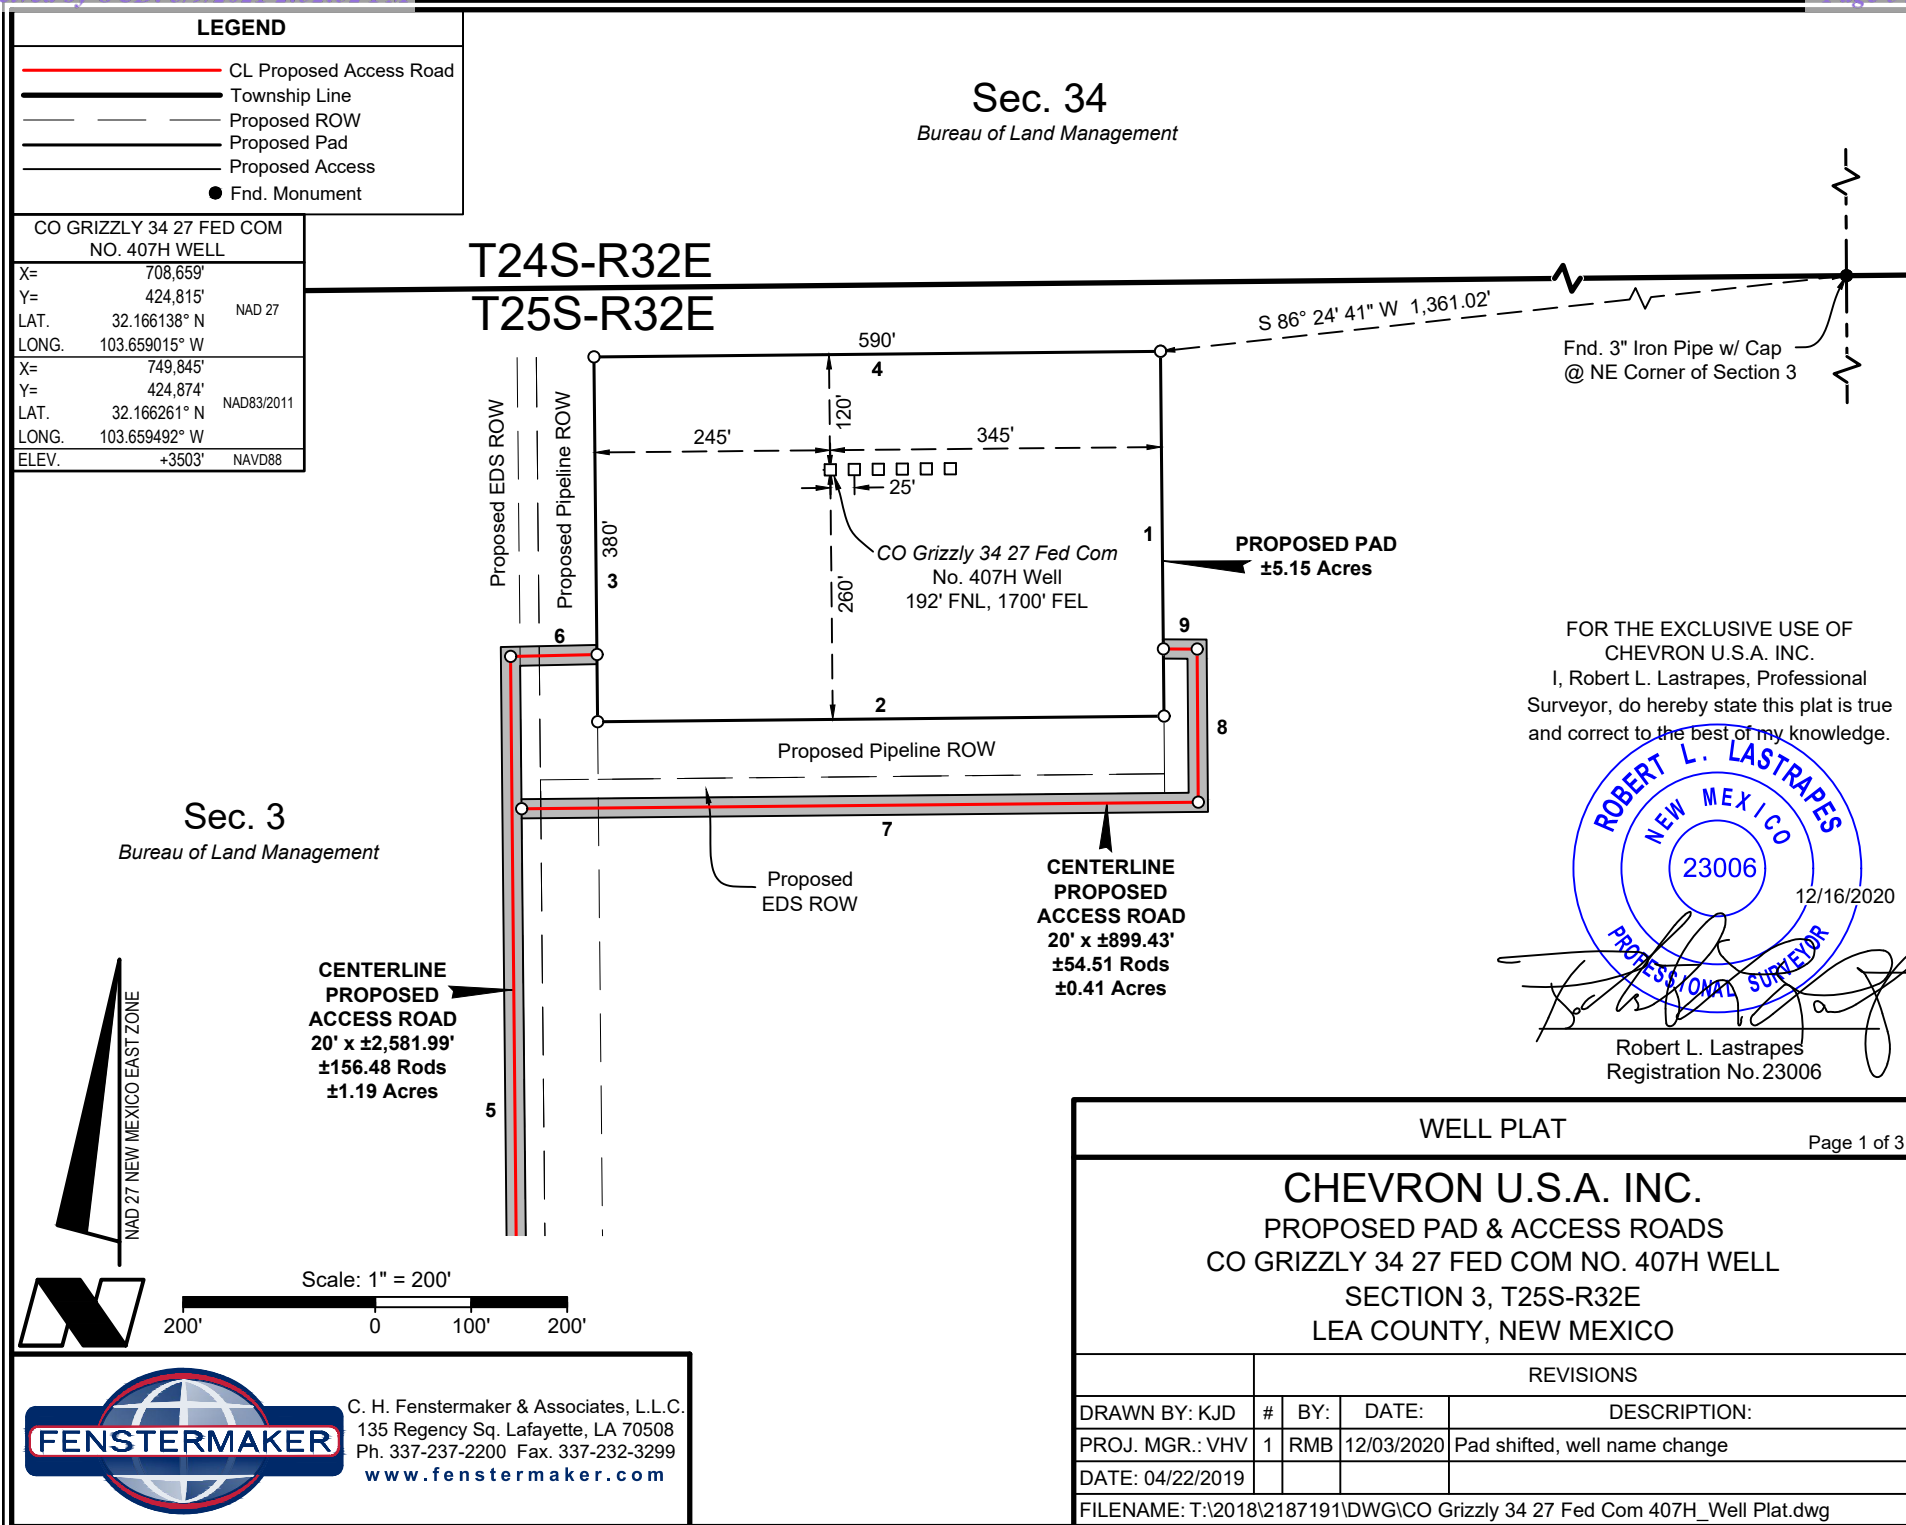
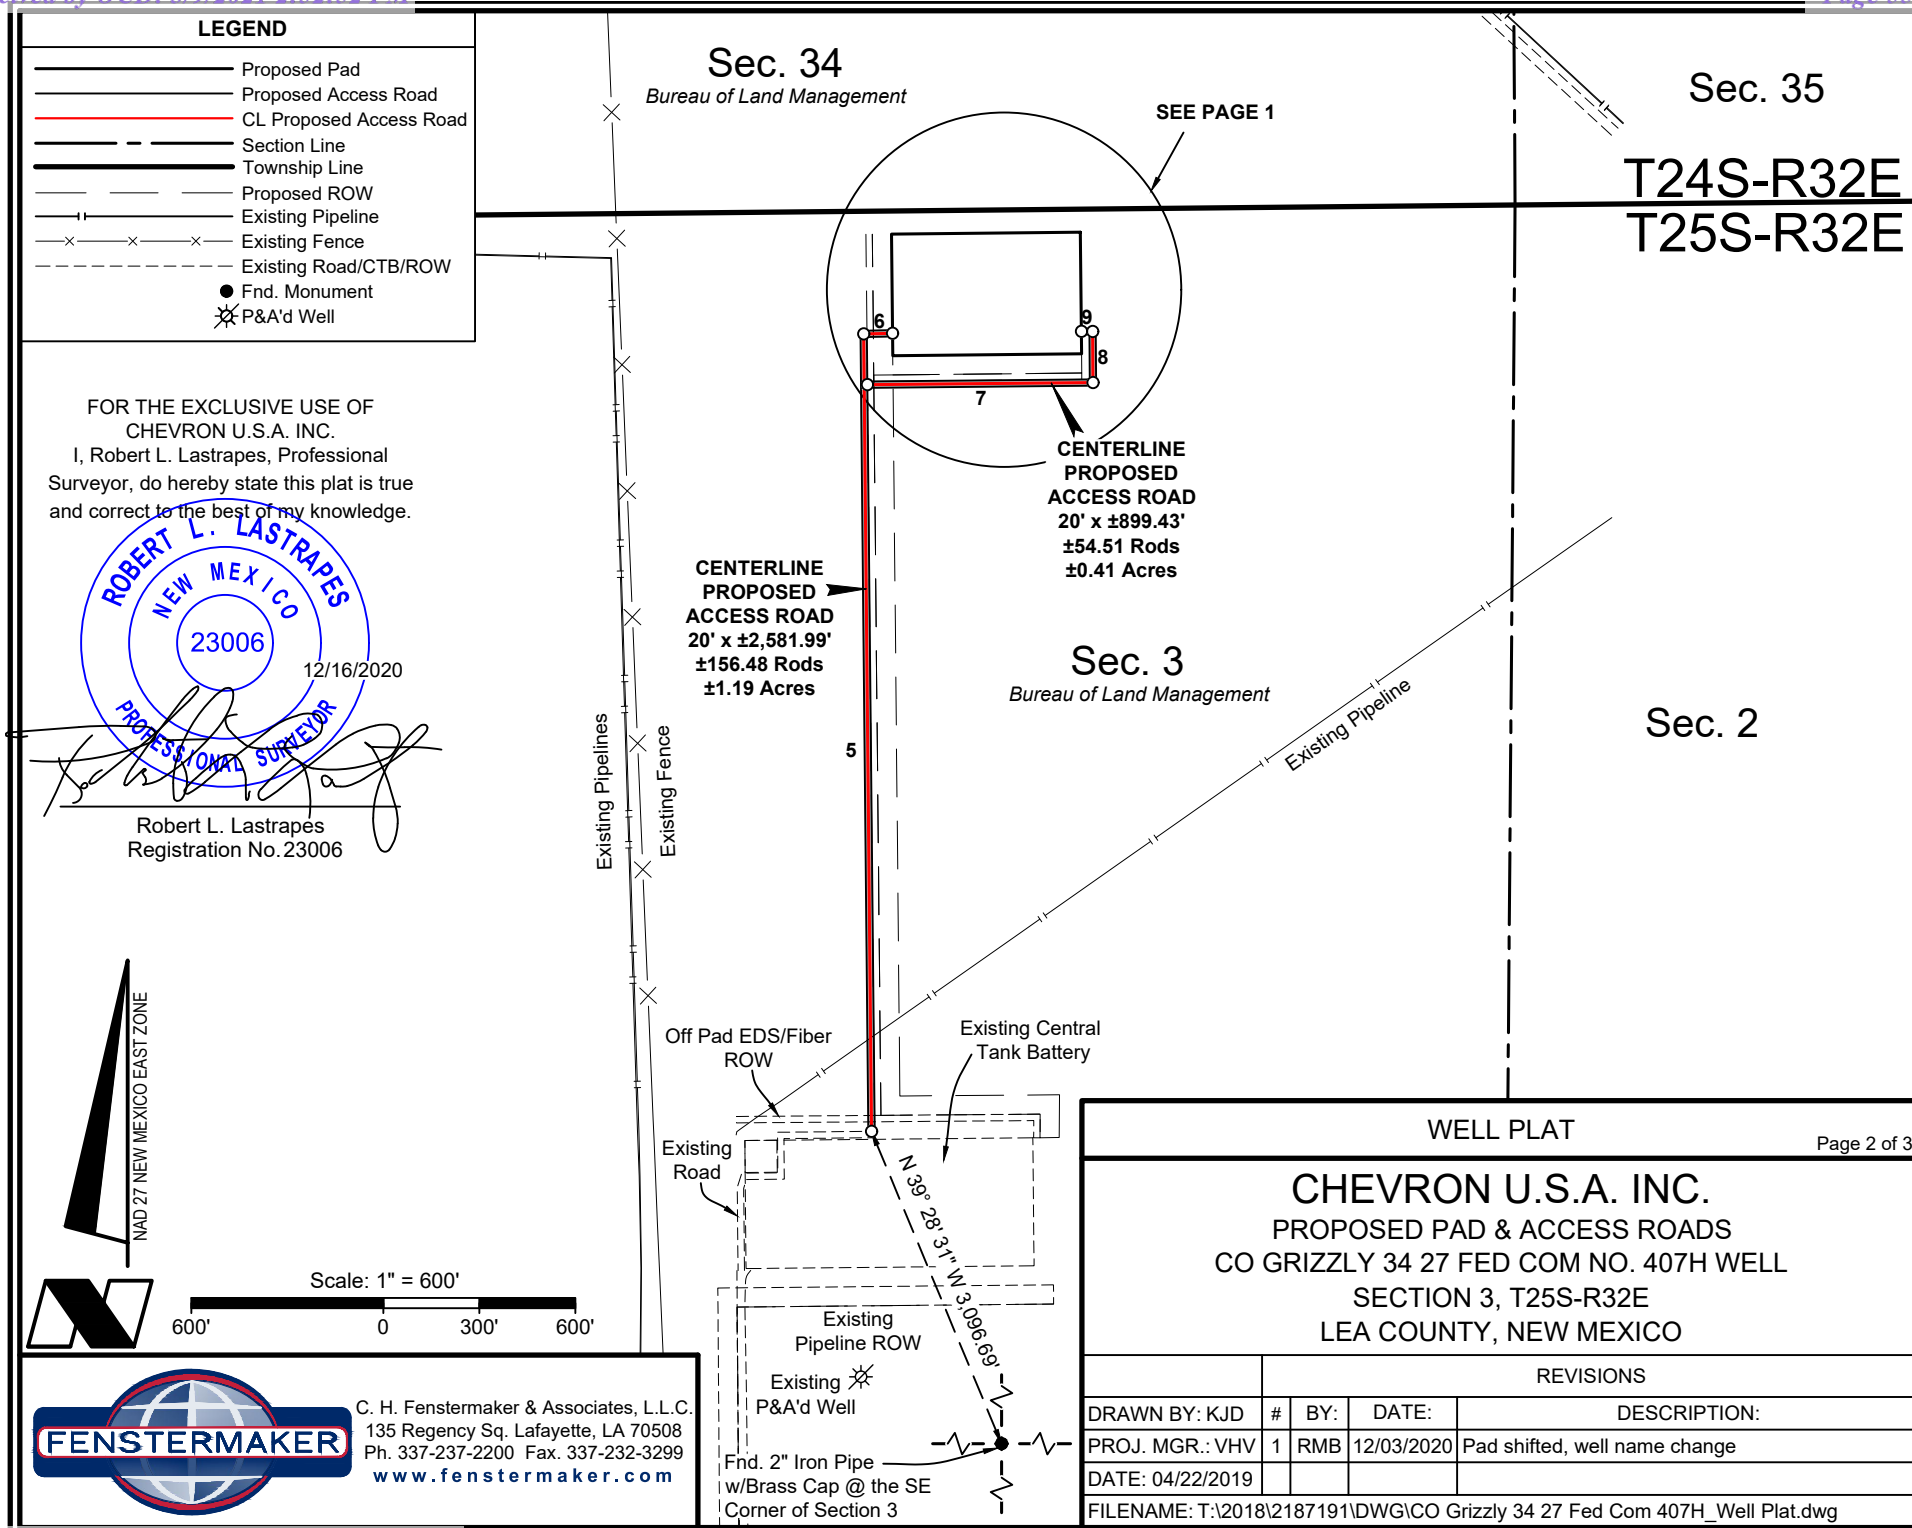
PROPOSED PAD		
COURSE	BEARING	DISTANCE
1	S 00° 33' 20" E	380.00'
2	S 89° 26' 40" W	590.00'
3	N 00° 33' 20" W	380.00'
4	N 89° 26' 40" E	590.00'

CENTERLINE PROPOSED ACCESS ROAD		
COURSE	BEARING	DISTANCE
5	N 00° 33' 18" W	2491.86'
6	N 88° 43' 46" E	90.13'

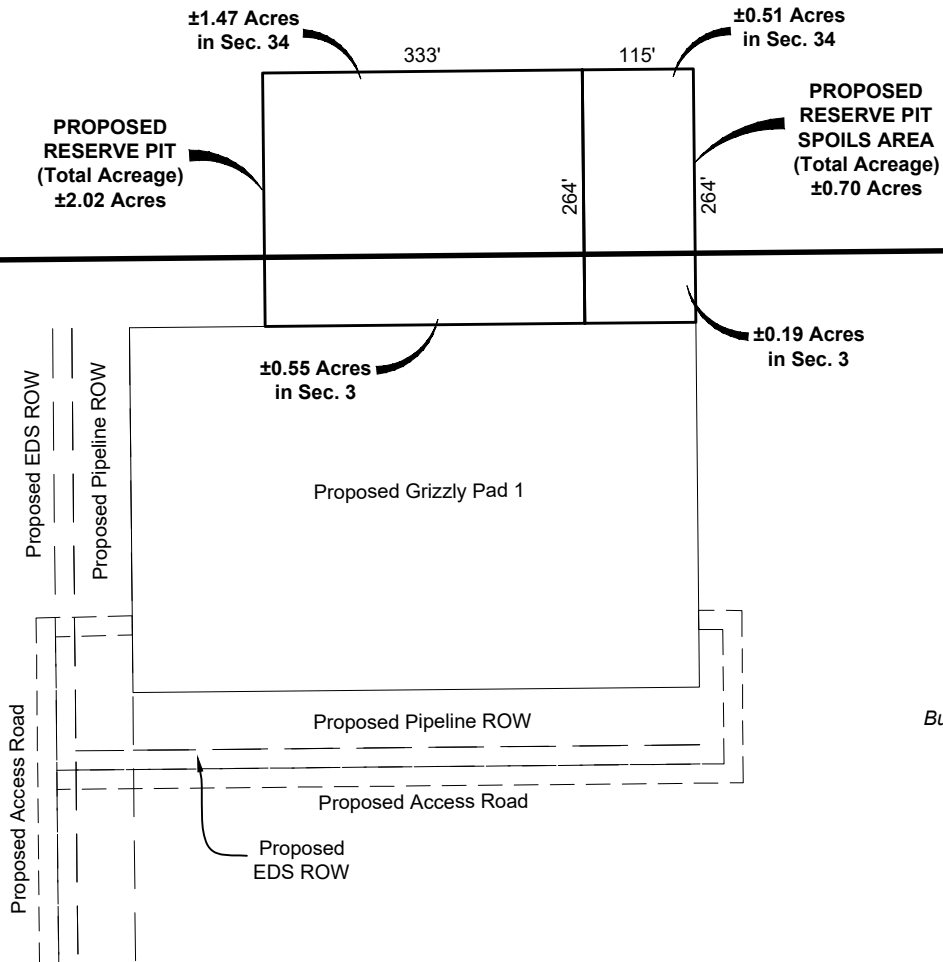
LEGEND	
	Proposed Pit
	Proposed Pad
	Proposed ROW
	Proposed Access Road
	Township & Section Line

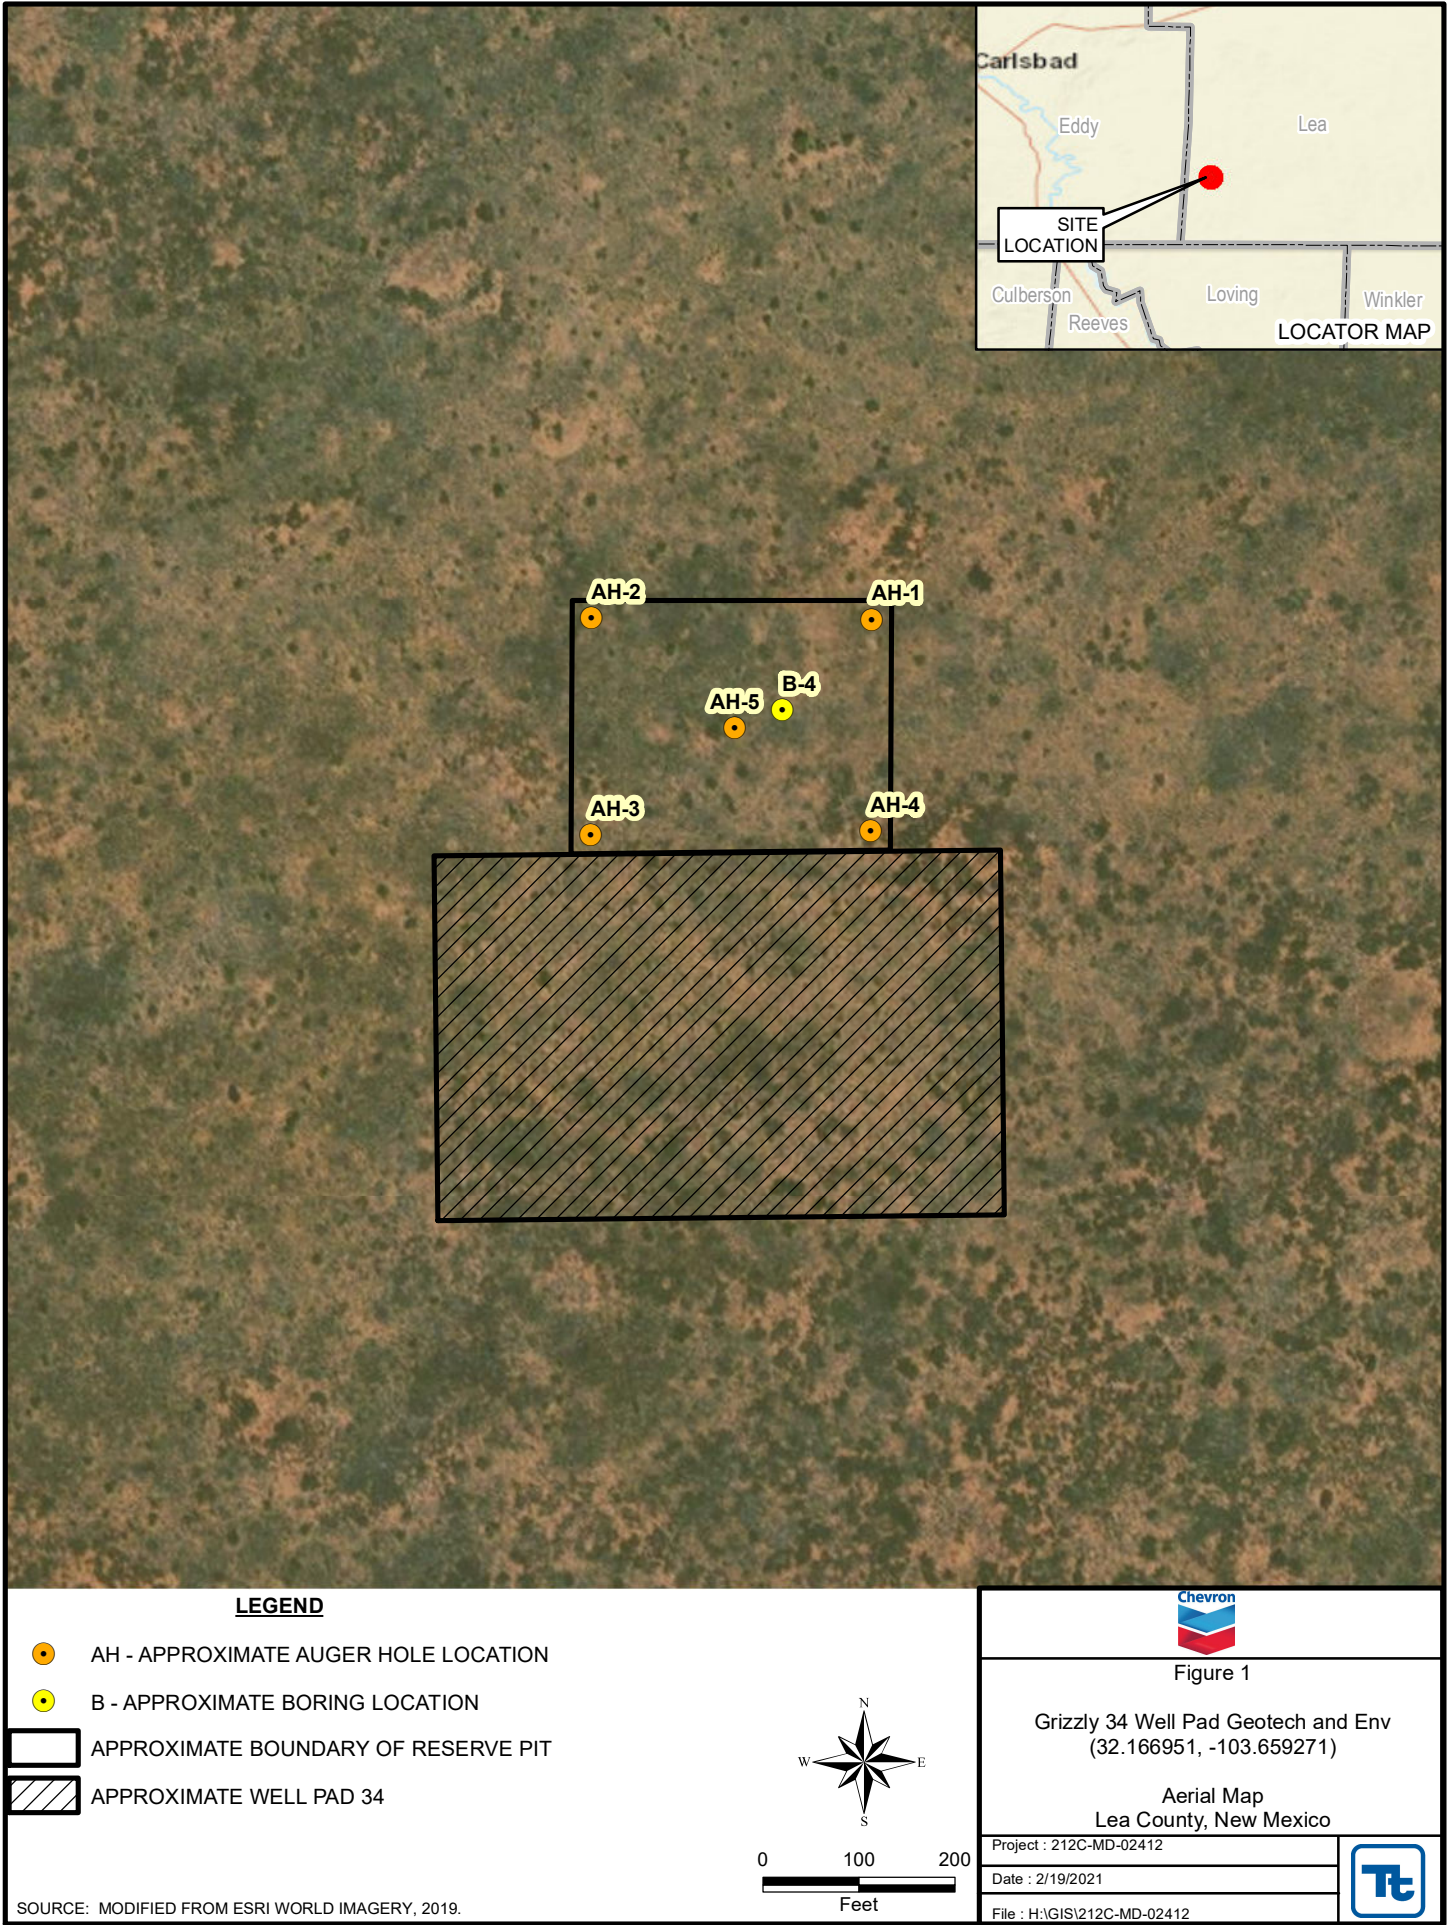
Figures

Tetra Tech Inc. (Tetra Tech) was retained by Chevron to conduct baseline environmental sampling and drill a deep boring for purposes of identifying groundwater at the proposed Grizzly 34 Well Pad Reserve Pit. The proposed reserve pit is located in Lea County, New Mexico. The GPS coordinates for the reserve pit are N 32.166950° and W 103.659270°. The site location is shown on an aerial map, Figure 1.

On February 3rd, 2021 one (1) boring, B-4, was installed to a depth of 112-feet. Groundwater was not encountered in the boring during drilling. The boring was backfilled with auger cuttings upon completion of the drilling. Standard Penetration Tests SPTs were performed at two to five foot intervals in the upper 25 feet for understanding the relative density of the soils for a future geotechnical investigation. A copy of the boring log is included in Appendix A. The boring location for B-4 is shown in Figure 1.

Tetra Tech personnel conducted the baseline environmental soil sampling on February 3rd, 2021 and a total of five (5) sample points (AH-1 through AH-5) were collected using hand-auger. Four (4) of the five sample locations were located approximately at the corners of the perimeter of the proposed reserve pit; and one (1) sample was located in the middle area of the reserve pit. All soil samples were collected at 8-12" below ground surface (bgs). The sample locations are shown in Figure 1.

Geotechnical reports from February 3, 2021 identified that one (1) boring, B-4, was installed to a depth of 112-feet (**Attachment 2 – Figure 1**). Groundwater was not encountered in the boring during drilling. The boring was backfilled with auger cuttings upon completion of the drilling. Standard Penetration Tests SPTs were performed at two-to-five-foot intervals in the upper 25 feet for understanding the relative density of the soils for a future geotechnical investigation.
