**FACILITY WIDE  
GW MONITORING  
WORK PLAN  
CORRESPONDENCE  
2020**

**RE: Approval with Modifications  
Disapproval Facility Wide Ground Water Monitoring Work Plan – Updates for 2020  
Western Refining Southwest LLC, Gallup Refinery  
EPA ID #NMD000333211  
HWB-WRG-20-012**

**Facility Wide Ground Water Monitoring Work Plan – 2020**

**Updates**

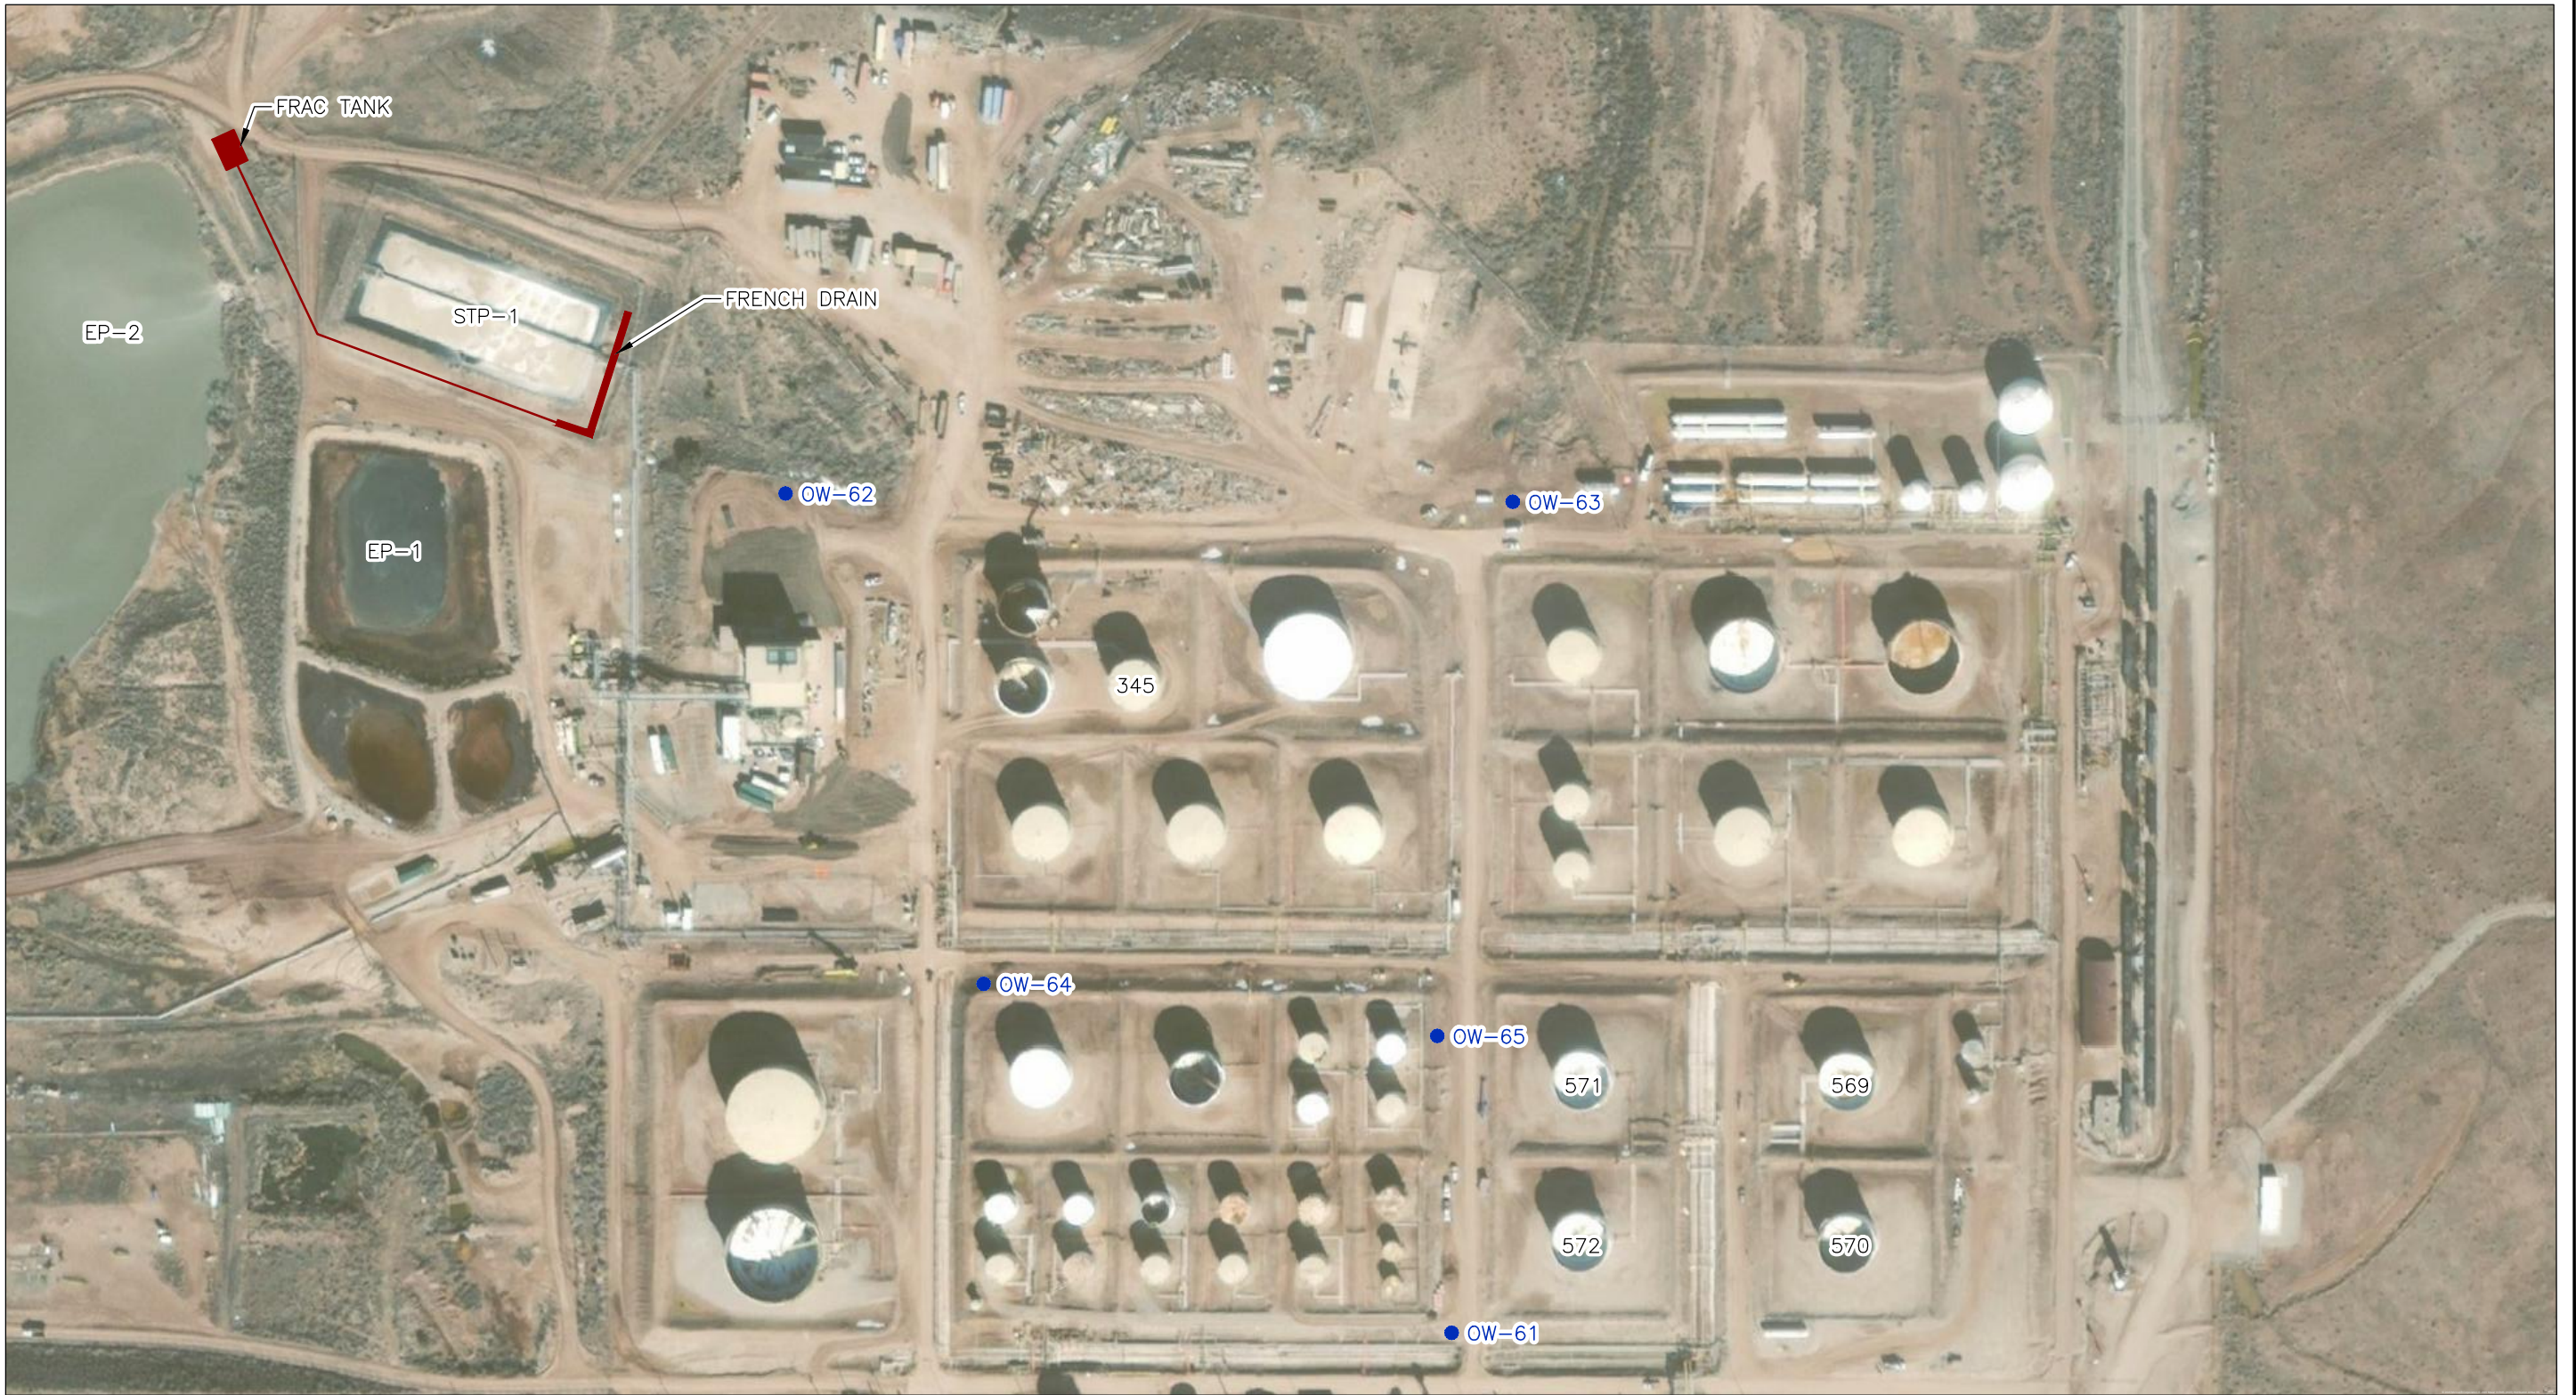
**FRENCH DRAIN LOCATION**

The French Drain flows into a PVC pipe which drains to a frac tank. The fluid (SPH and water) from the frac tank is recovered using a vacuum truck, therefore, the SPH found in the French Drain does not follow the flow path toward Outfall 001 and no additional investigation is necessary. Figure 4.1 has been added to the revised workplan to show the locations of the French Drain and frac tank.
