Annual Class III

Well Report

Llano Disposal, LLC

BW-35

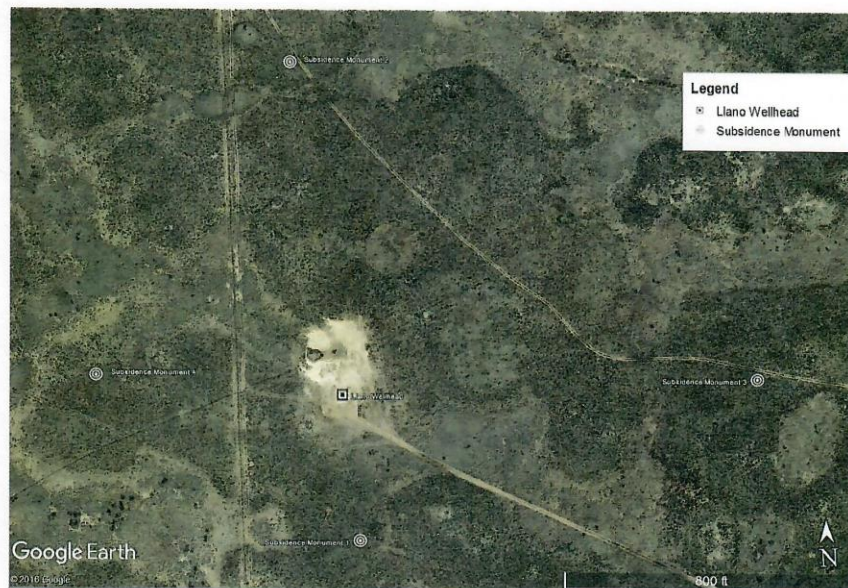
The Google Earth image and the sketch below illustrate locations of the monuments.

The positions for the four set monuments were placed based on a conversation with Carl Chavez from the Energy Minerals and Natural Resources Department. The discussion was to set at least three monuments at varying distances from the well head. The distances were to be kept to a minimum of 400 feet and a maximum of 1200 feet. The four monuments were set at differing distances in the given interval and in 4 separate directions.

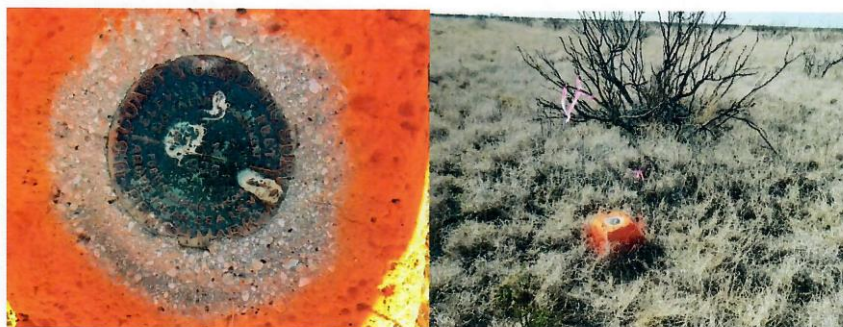
NGS Control Point CV0295 is a brass U.S. Coast & Geodetic Survey Benchmark set in concrete projecting approximately one foot out of the ground. It is stamped with an X and with the year it was set as shown below, followed by the NGS datasheet:

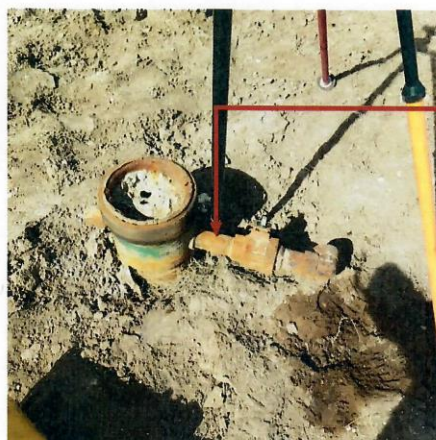
Llano Wellhead

The existing wellhead was measured on the top of the First Flange leaving the wellhead on the horizontal plane. There is an X Filed into the metal that may fade with rust.

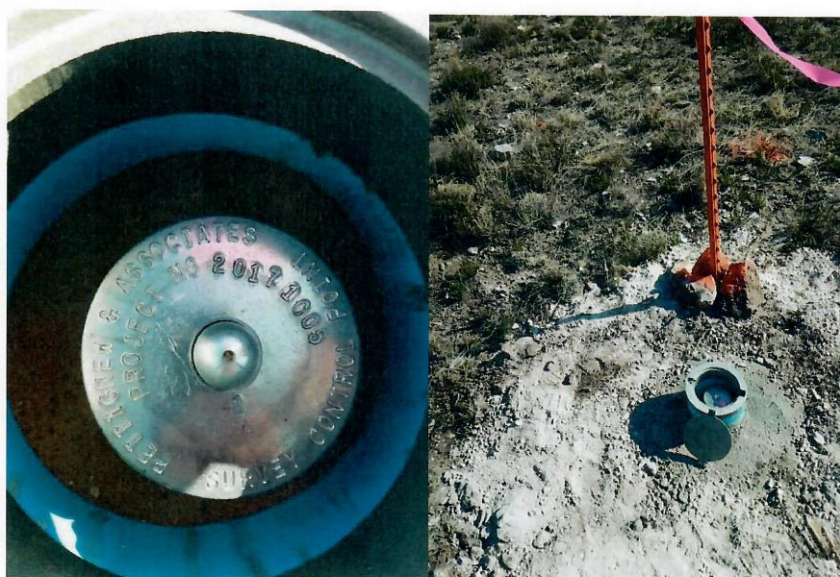
**Subsidence Monument 1**

A Berntsen three quarter inch Aluminum Top Security Sleeve Monument was set. It consists of a rod driven till refusal into a pre drilled three-foot deep hole with a twelve inch diameter. The sleeved rod is encased in six-inch PVC filled with sand, then topped with a Datum Point and an Aluminum Floating Datum Cap. It is then capped with an Access Cover that must be removed with a flathead screw driver or similar tool. The Monument is pictured below:

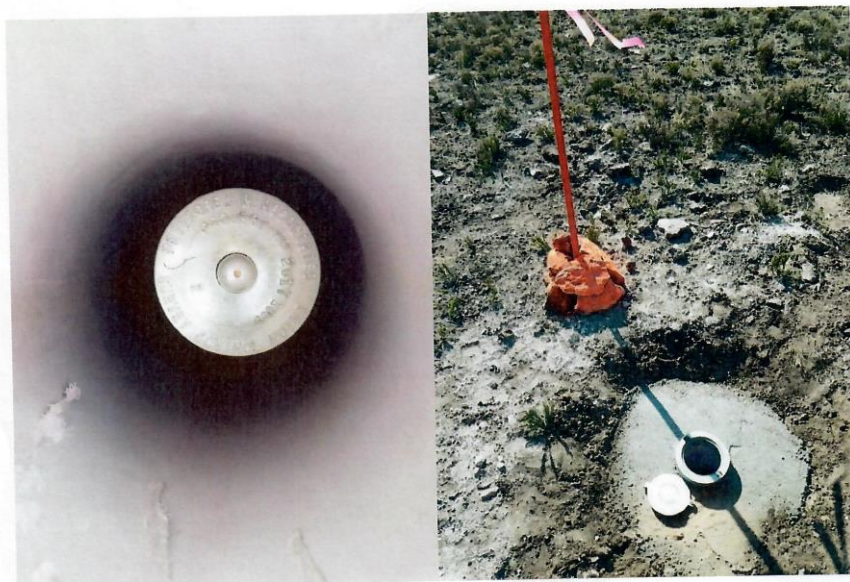
**Subsidence Monument 2**

A Berntsen three quarter inch Aluminum Top Security Sleeve Monument was set. It consists of a rod driven till refusal into a pre drilled three-foot deep hole with a twelve inch diameter. The sleeved rod is encased in six-inch PVC filled with sand, then topped with a Datum Point and an Aluminum Floating Datum Cap. It is then capped with an Access Cover that must be removed with a flathead screw driver or similar tool. The Monument is pictured below:

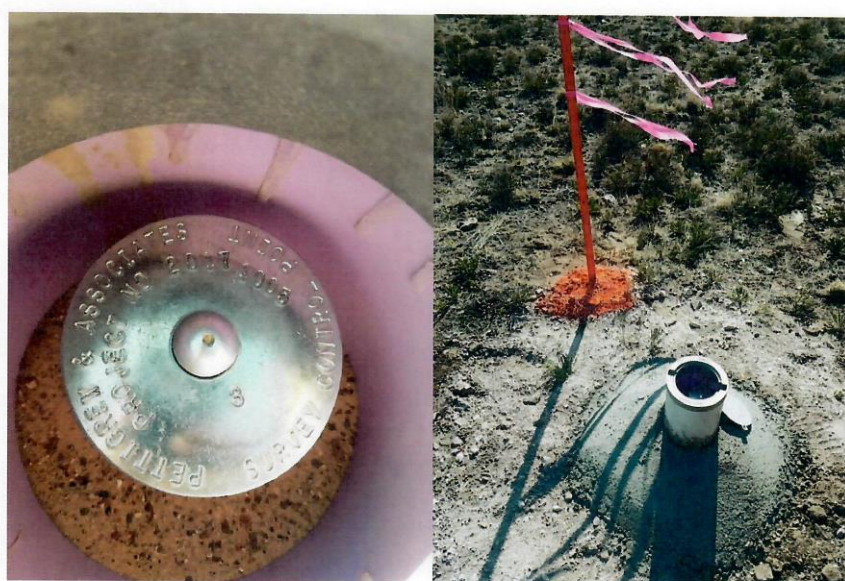
**Subsidence Monument 3**

A Berntsen three quarter inch Aluminum Top Security Sleeve Monument was set. It consists of a rod driven till refusal into a pre drilled three-foot deep hole with a twelve inch diameter. The sleeved rod is encased in six-inch PVC filled with sand, then topped with a Datum Point and an Aluminum Floating Datum Cap. It is then capped with an Access Cover that must be removed with a flathead screw driver or similar tool. The Monument is pictured below:

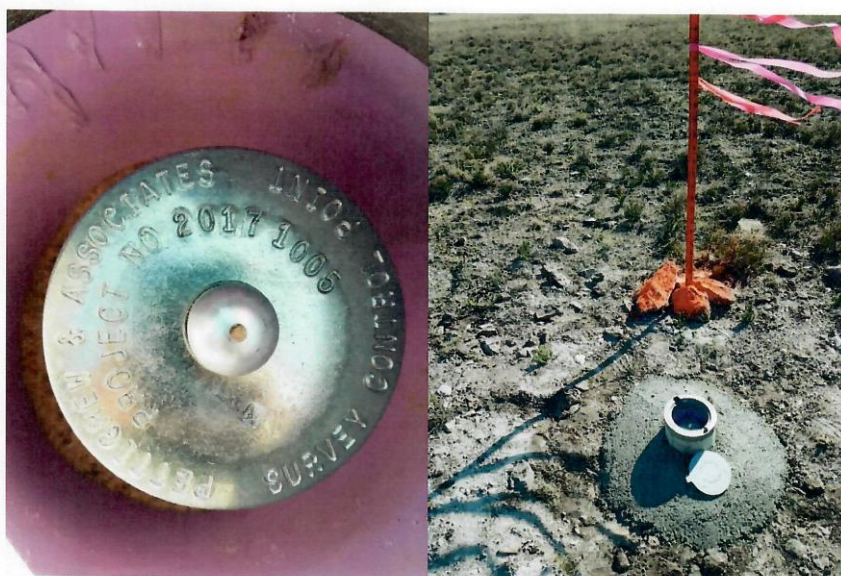
**Subsidence Monument 4**

A Berntsen three quarter inch Aluminum Top Security Sleeve Monument was set. It consists of a rod driven till refusal into a pre drilled three-foot deep hole with a twelve inch diameter. The sleeved rod is encased in six-inch PVC filled with sand, then topped with a Datum Point and an Aluminum Floating Datum Cap. It is then capped with an Access Cover that must be removed with a flathead screw driver or similar tool. The Monument is pictured below:

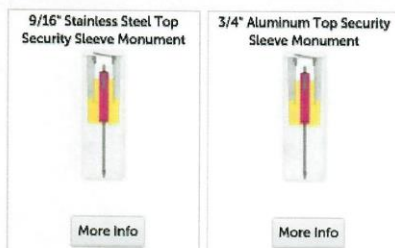
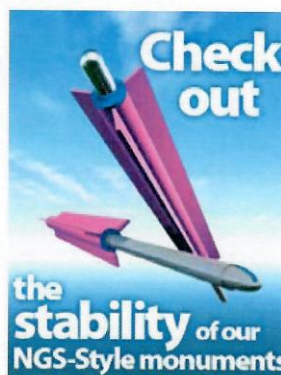
Top Security Sleeve Rod Monuments

Berntsen Sectional Rod Monument with Floating Sleeve

Berntsen's exclusive Top Security™ Sleeve 3-Dimensional Rod Monument System is specifically designed for high-precision geodetic and GPS surveys. Its patented design helps protect against excessive movements in the control monument. The Berntsen extendible rods, when driven to refusal, provide excellent vertical stability. The unique Y-shaped design of the Top Security Sleeve adds the second and third dimension to provide the most stable 3-D survey monument available.

Eliminate most common and unexpected shifts in stability by eliminating most of the direct transfer of shifts in movement from ground level or surface movement. Here's how: Rod markers (driven to refusal) have good vertical stability but can be disturbed by the natural phenomenon known as frost heave. Rod markers, installed with a greased-filled PVC pipe surrounding the upper three or four feet (900 or 1200 mm) (or more) of rod, are known to be effective in combating movement caused by frost heave but offer little protection against possible horizontal movement of surrounding earth (another major cause of differences in readings in rod markers). For the first time, Berntsen's Top Security Sleeve™ with the horizontal stability of the original Berntsen Top Security™ finned rod marker system, this is now available in a commercially available survey monument.

It's even extendible! 3' (914mm) lengths of Top Security Sleeves can also be connected together by Berntsen's exclusive End Cap Alignment Bushings and a little PVC Cement. When used in combination(s), nearly any even-foot length over six feet long (1.83m) of support for the rod marker is possible. That's innovative and flexible design at work for you.
